## Arcadian, Lake Charles Urea HP Reactor explosion Lessons to be learned

UreaKnowHow.com  
Mark Brouwer  
General Manager

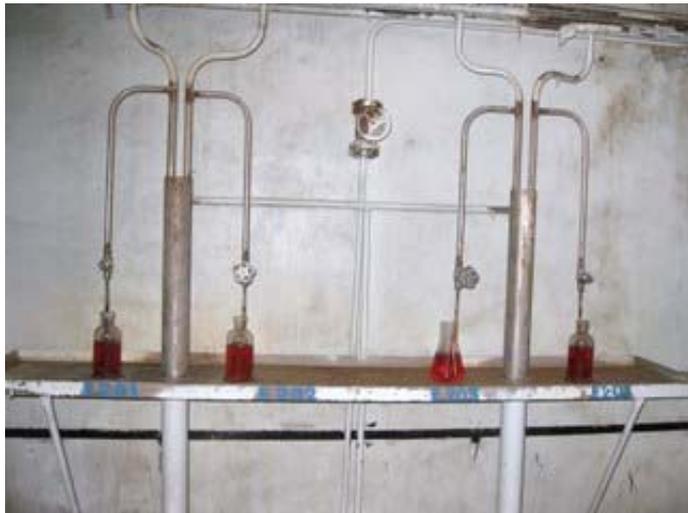
**Photo: A simple but effective way to monitor gaseous ammonia leaks from a leak detection system**

The Arcadian case shows a situation that plant operators monitor hourly visually if a leak occurs and use a logbook to register their findings. The weep holes and leak detection tubes are not connected to an analyzer, so fumes or solids can only be detected visually. Some weep holes or leak detection tubes were not reachable which makes a detection impossible or very difficult. A regular check that the weep holes or leak detection tubes are not clogged is important and impossible in case these tubes are nor reachable. Any HP equipment item with a loose liner should be connected to a proper continuous leak detection system in order that an early leak detection at a non corrosive gaseous stage becomes possible.
