AFA 18th International Annual Technical Conference & Exhibition

Bi- Metallic Stripper Failure

Mr. Ali Al-Majed

Manager, Technical Support Dept.
Saudi Arabian Fertilizer Co. (SAFCO)
(SABIC Affiliate)

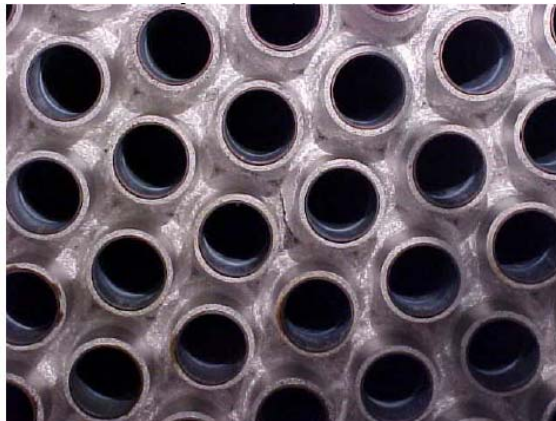
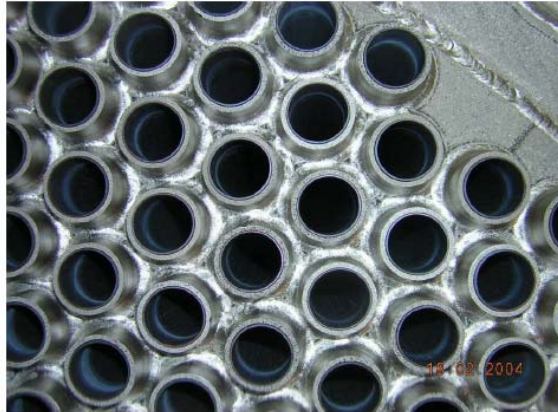
- Heavy corrosion at bottom TTS (tube to tube sheet) weld joints.
- Heavy corrosion at bottom tube sheet SS overlay.
- Heavy corrosion at tube end (25-22-2 portion).
- Zirconium portion was found intact.
- The top tube sheet and TTS welds were found intact.

The direct cause of the bimetallic stripper failure is “Inadequate Air Passivation” at the bottom channel, where 25-22-2 could not resist the severe corrosion due to non-conductive operating condition.

The root cause of the failure is “**improper design**“ of the bimetallic stripper which failed to recognize that 25-22-2 couldn't withstand the severe operating conditions prevailing in the bottom channel of the stripper. The material 25-22-2 material requires more air passivation comparing Titanium.

Corrosion at TTS welding and at tube tips

In 2003, extra Passivation air (30 m³/hr) was introduced in the outlet channel, using a separate air compressor. Subsequently corrosion rate was noticed considerably less and however, the plant was operating at a lesser load. Urgent action was taken to replace the bi-metallic stripper at the earliest, by re-tubing the old Titanium Stripper.

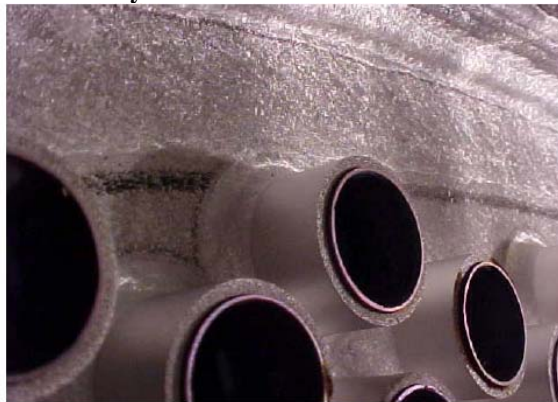
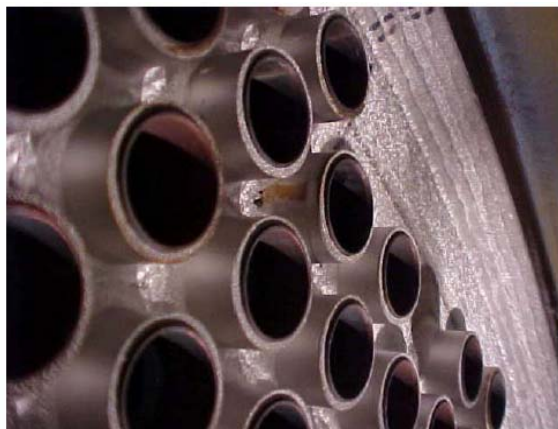
Operating conditions of bottom channel is more severe in terms of temperature, carbamate concentration and lack of Oxygen content due to stripping action. However, titanium part did not show any deterioration in the top or bottom channels. The 25-22-2 materials in the top channel were found intact. Hence, it was concluded that 25-22-2 material cannot resist corrosion for the severe condition prevailed in the bottom channel without additional supply of Oxygen.

Corrosion at Tube sheet – Weld Overlay

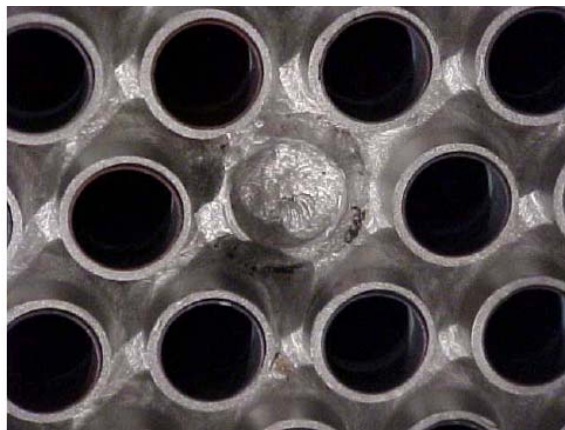
New Stripper started leaking within 11 months of operation. On internal inspection, following are observed:

Plugged Tubes
