Case histories of

ATMOSPHERIC CORROSION

Case 1: Flixborough disaster

NTT Consultancy
Giel Notten
Senior Corrosion Engineer

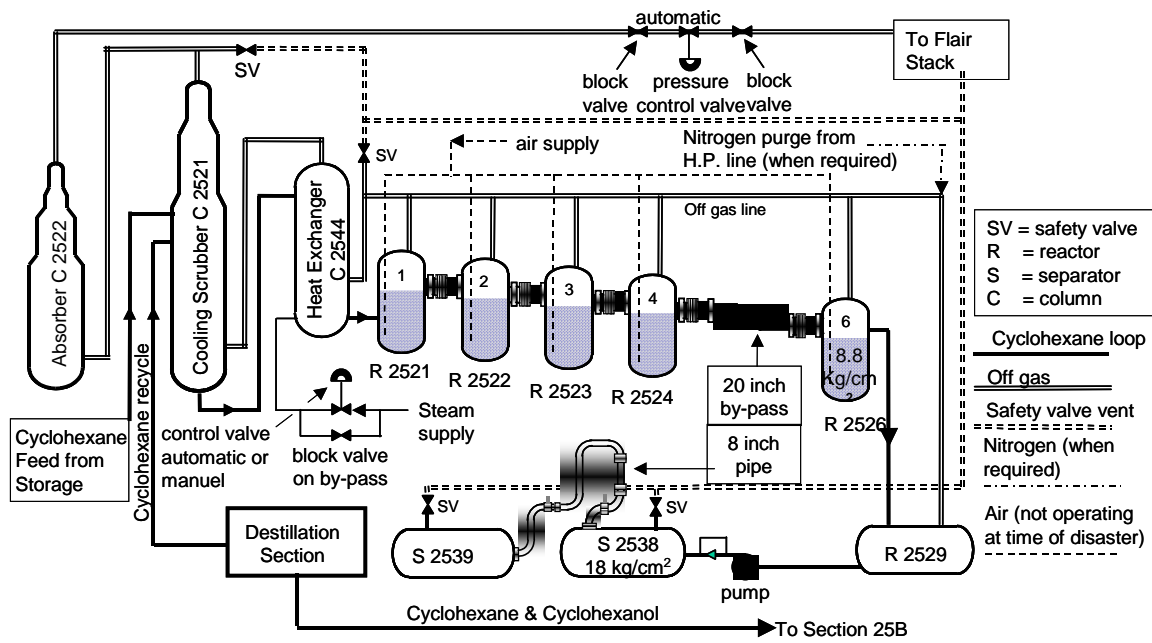
Figure 1: Simplified flow diagram of cyclohexane oxidation section

The officially accepted cause of the disaster is the mechanical failure of the "dog leg" 20 inch by-pass as shown in figure 1 and figure 2.

Figure 1 and figure 2 also show the position of an 8 inch pipe connecting two separator vessels.

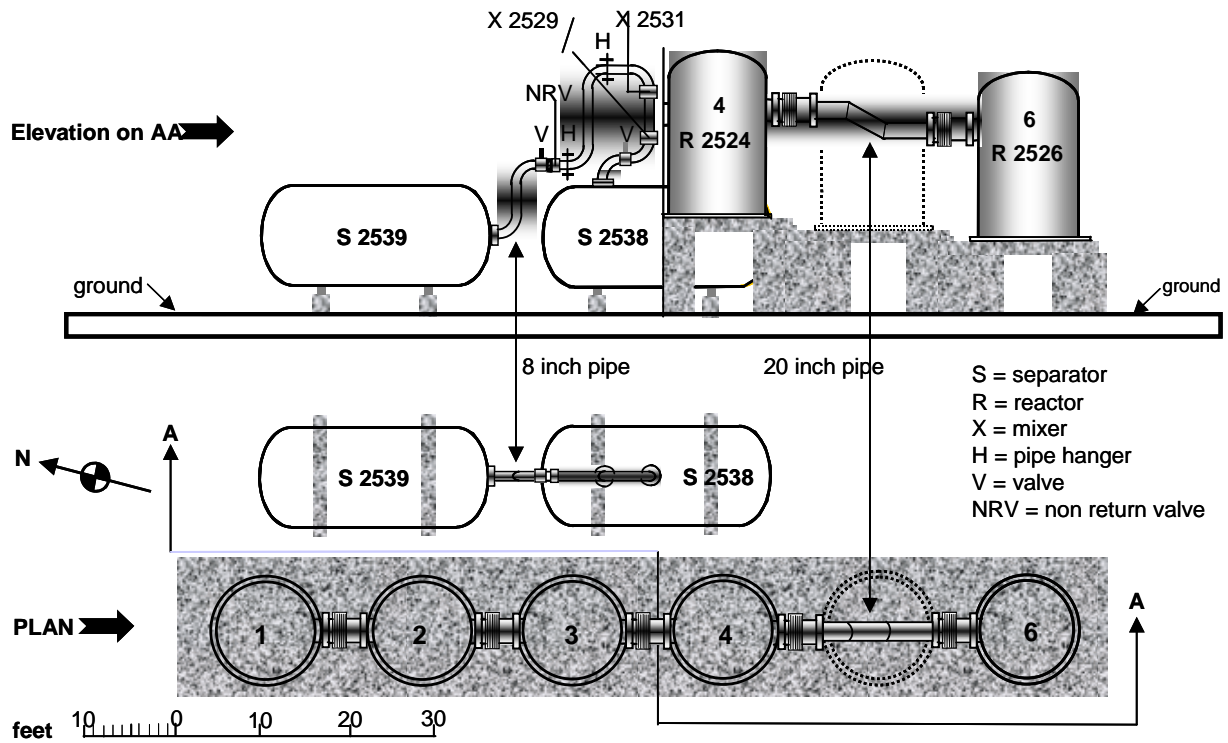
Figure 2: Simplified plan & elevation of the oxidation section

The "dog leg" by-pass consisted of three lengths of 20 inch pipes with flanges at each. The by-pass pipe was of smaller diameter (20 inch) than the reactor flanges (24 inch) and in order to align the flanges short sections of pipes with stainless steel bellows were added at each end of the by-pass. Under pressure these bellows tend to squirm or twist. It was not appreciated that the pressurized assembly would be subject to a turning moment imposing lateral (shear) forces on the bellows for which they are not designed. The assembly as constructed was of unknown strength and did not comply with the British Standard.

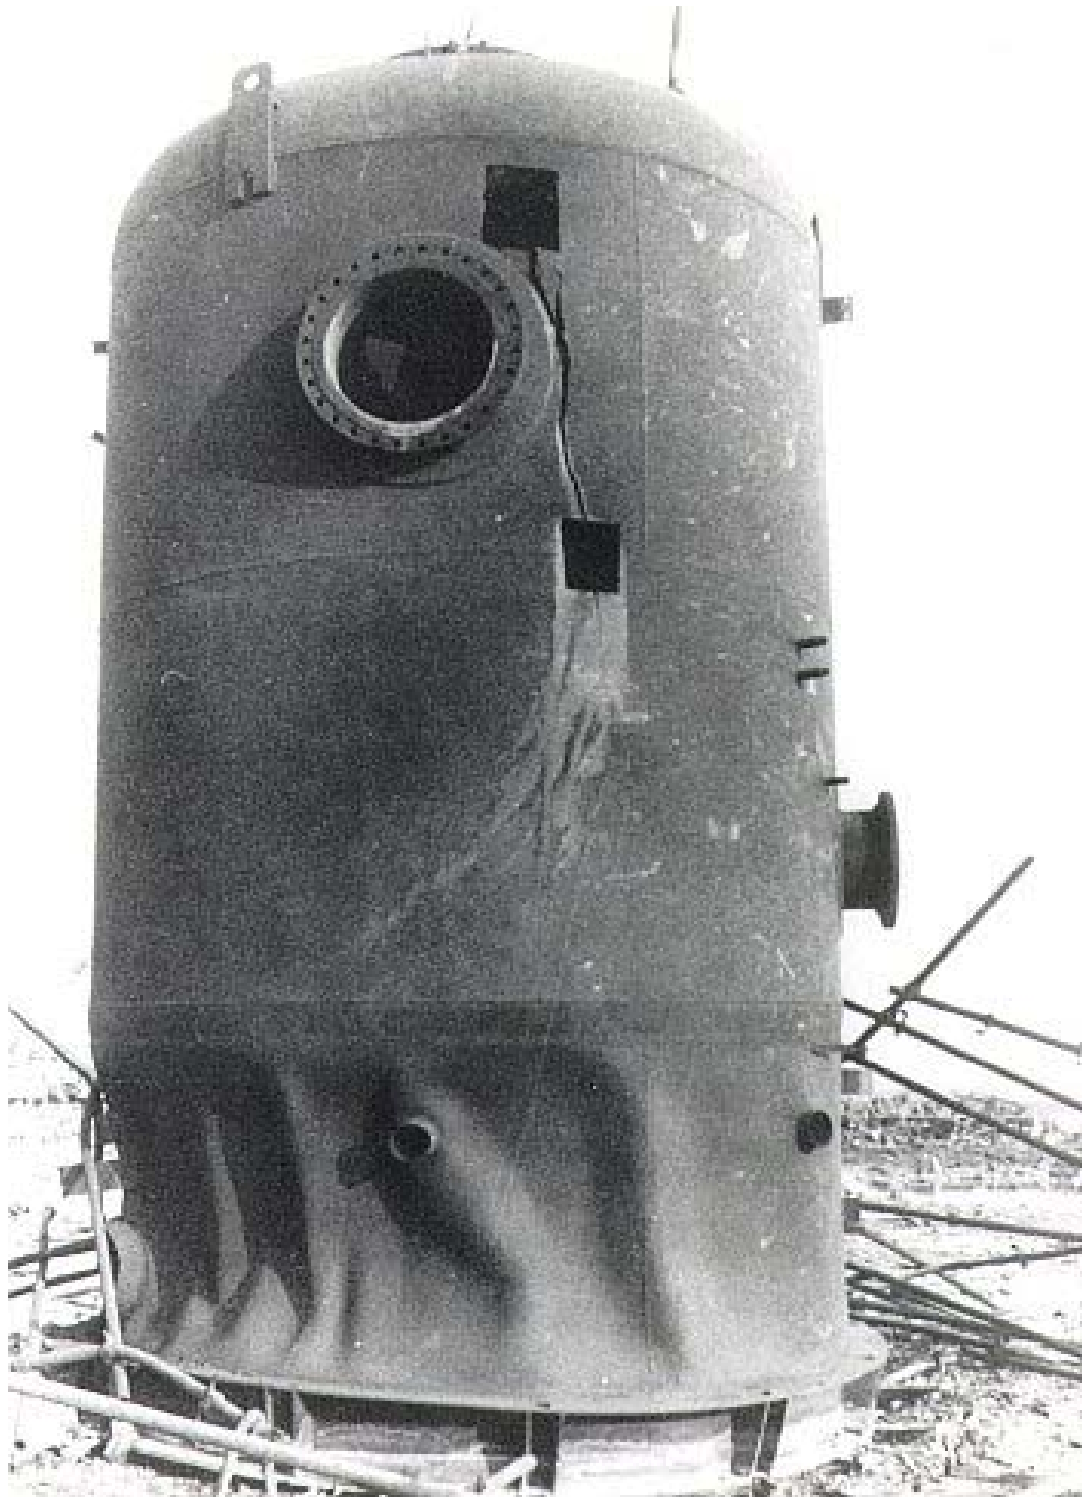
Due to a small cyclohexane leakage via the transition of the Mitchel agitator on top of the reactor there was a risk of explosion. To eliminate the risk of explosion it was decided to install a spray nozzle above the reactor. The water used for spraying was cooling water which was treated with nitric acid to maintain the pH level at the desired level.

About six months after installing the spray nozzle on the No. 5 reactor a leakage was observed due to cracking as shown in photo 1.

Photo 1: Nitrate SCC in carbon steel reactor due to ingress of cooling water used for sprinkling.

- Avoid additional wetting of insulated equipment by water which is contaminated with nitrate
- Take care of a watertight insulation cover sheeting
- Apply a protective coating system if there is a risk of atmospheric corrosion
- Be aware of the risk of liquid zinc embrittlement at elevated temperatures (e.g. during a fire).

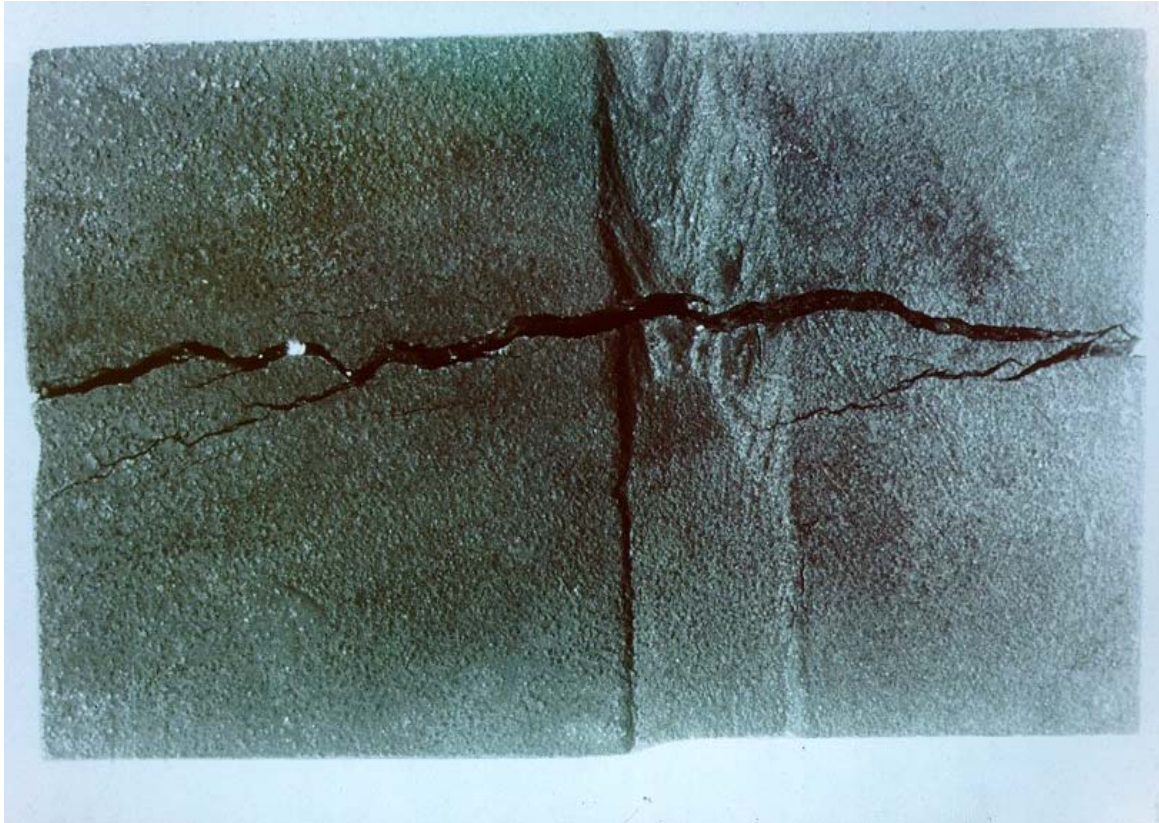
For investigation to the cause of cracking some samples were cut out of the reactor wall. These samples with branched cracking are shown in photos 2 and 3.

Microscopic examination indicated that the cracking in the carbon steel was caused by nitrate stress corrosion cracking.

Photo 2: External nitrate SCC in carbon steel reactor.

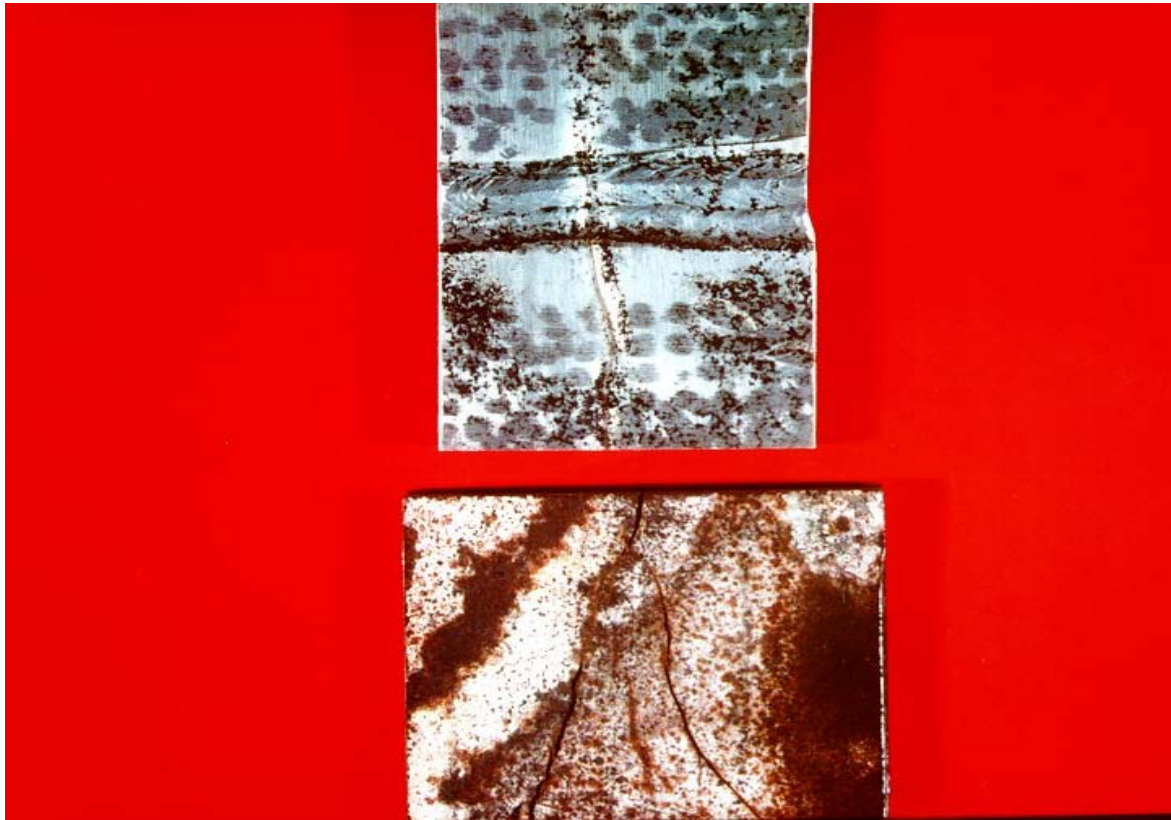
Photo 3: External SCC in carbon steel reactor; internally stainless steel clad.
