Severe Nitrate Stress Corrosion Cracking in HP reactor of a Urea plant

NTT Consultancy
Giel Notten
Senior Corrosion Engineer

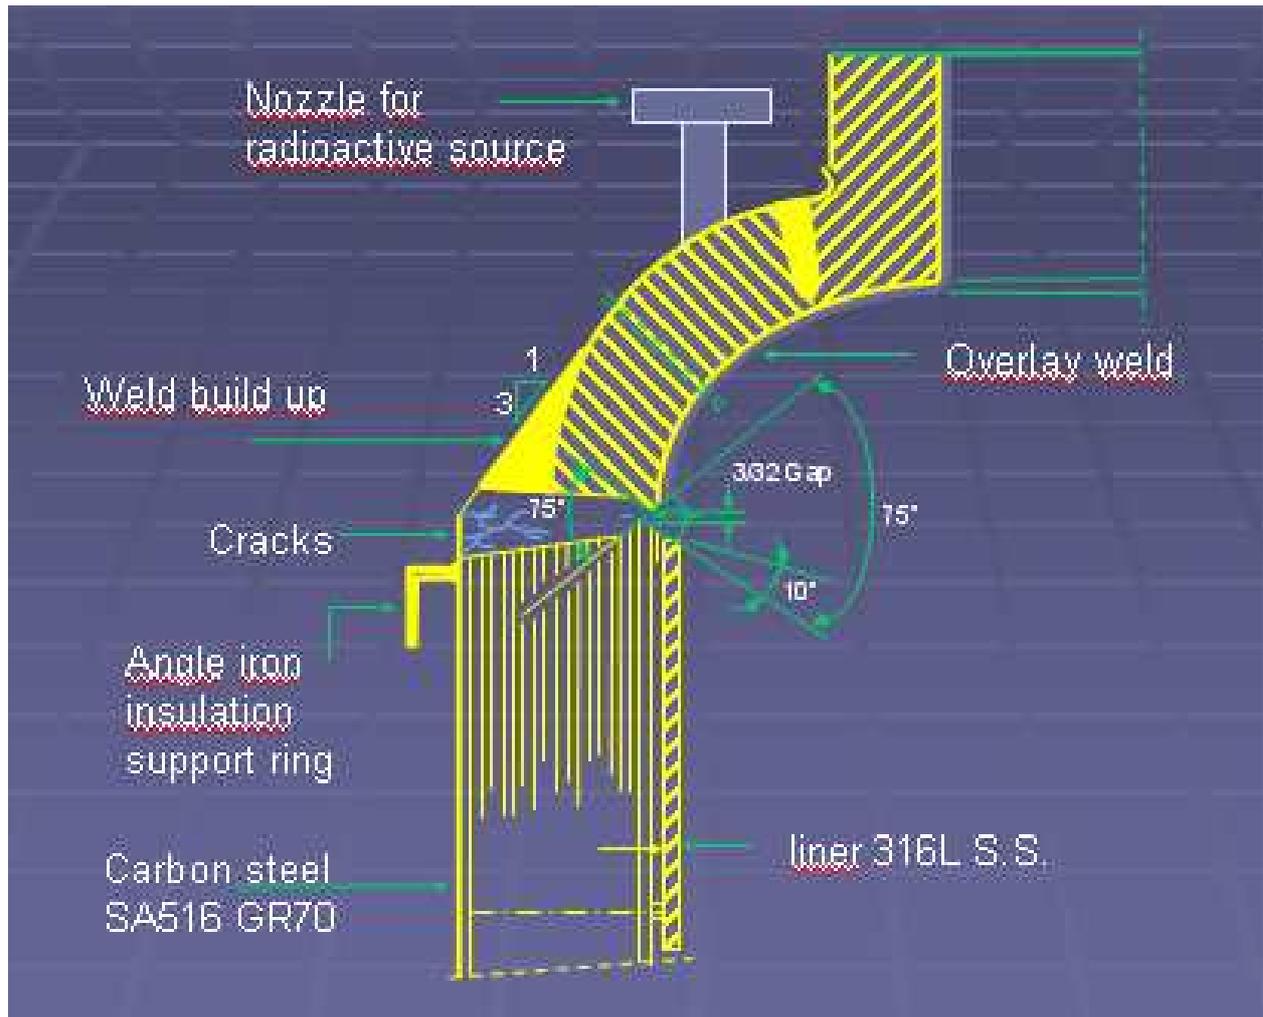
During a turnaround magnetic particle inspection (MPI) was performed on welds and heat affected zones of welds at the outside of the top section of the HP reactor of a urea plant. The MPI inspection revealed presence of cracks which were located in the circumferential weld of the top hemi-head to the shell of the reactor. The cracks extended up to some 2000 mm in circumference of the reactor. The depth of the cracks reached already about half of the wall thickness of the reactor. The location of the cracks is indicated in Figure 1.

Figure 1: Location of cracks in the carbon steel shell in the top of reactor of Urea plant

It was observed that the aluminum cover sheeting of the insulation was severely damaged, especially around the manway nozzle and the nozzle for the reactive source. Rainwater could easily enter the insulation material.

On the vessel wall a thick salt deposit layer was present, most pronounced in the area of cracking, below the location of the nozzle for the reactive source.

Remarkable is the presence of the angle iron insulation support ring just below the circumferential weld where stress levels are most high. The insulation material just above this angle iron will be wet during long periods.

1. Take care of a proper aluminum cover sheeting to avoid ingress of water contaminated with nitrate and/or urea.
2. In case of risk of nitrate (or urea) contamination carbon steel equipment and piping operating at temperatures in between -10 and +240 °C have to be coated.
3. The angle iron insulation support ring should be fixed on the carbon steel shell in area with a lower stress level.

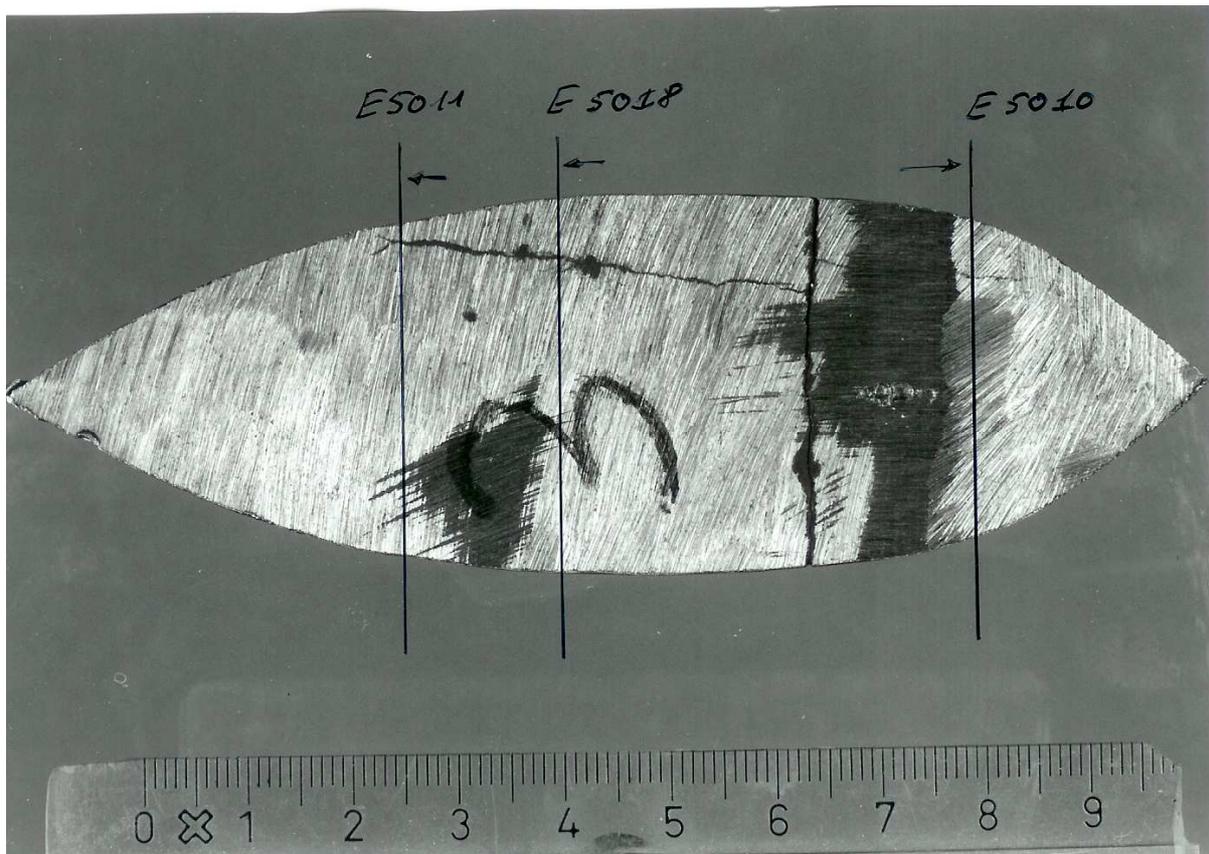
Photo's 1 and 2 show the cracks present in boat sample 3 which was examined by Stamicarbon.

Photo 1: Cracking at outer surface of boat sample out of reactor wall of urea reactor

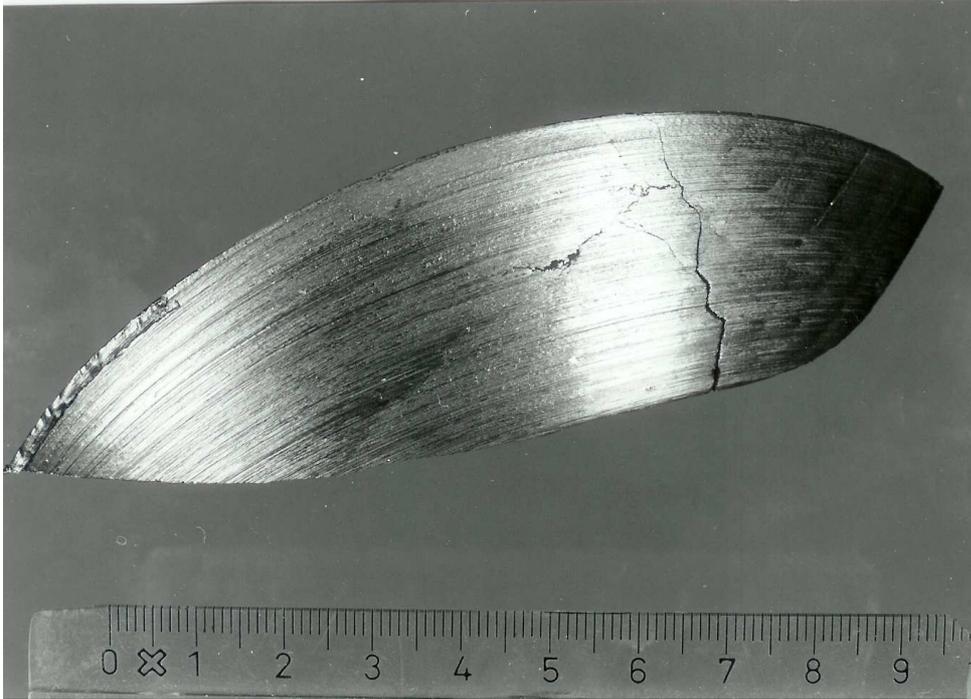
Photo 2: Cracking in depth of boat sample

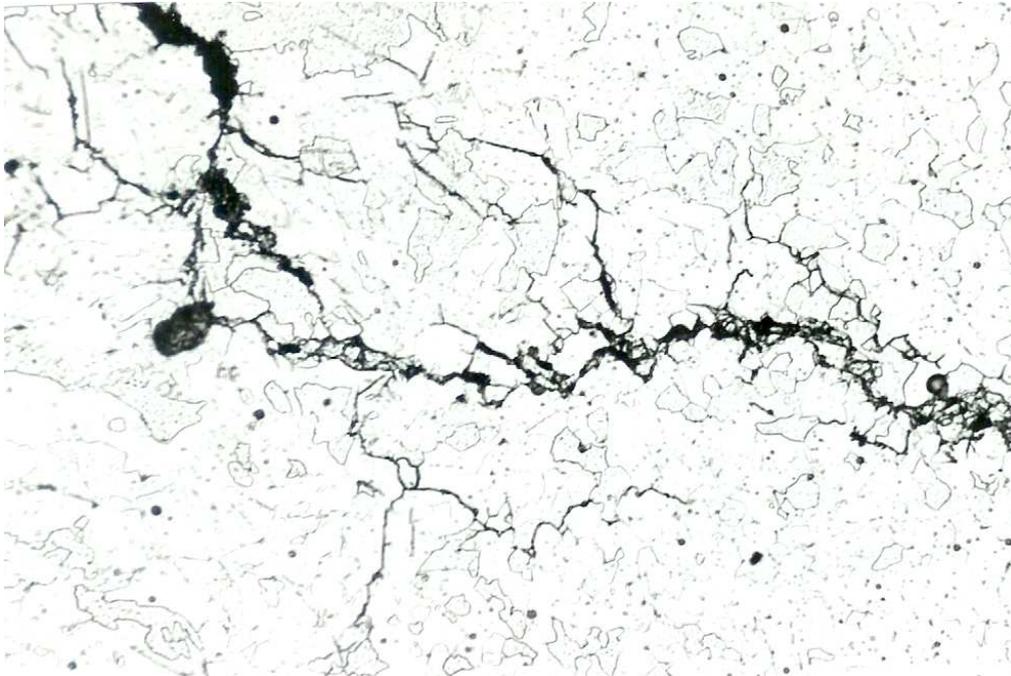
Microscopic examination revealed a branched crack pattern with trans-granular and, predominant, inter-granular propagation as shown in Photo 3.

Photo 3: Predominantly inter-granular cracking weld deposit material of seam weld (etchant: nital).

Based on the presence of high amounts of nitrate as well as the results of the microscopic examination it was concluded that the cause of cracking is nitrate stress corrosion cracking.

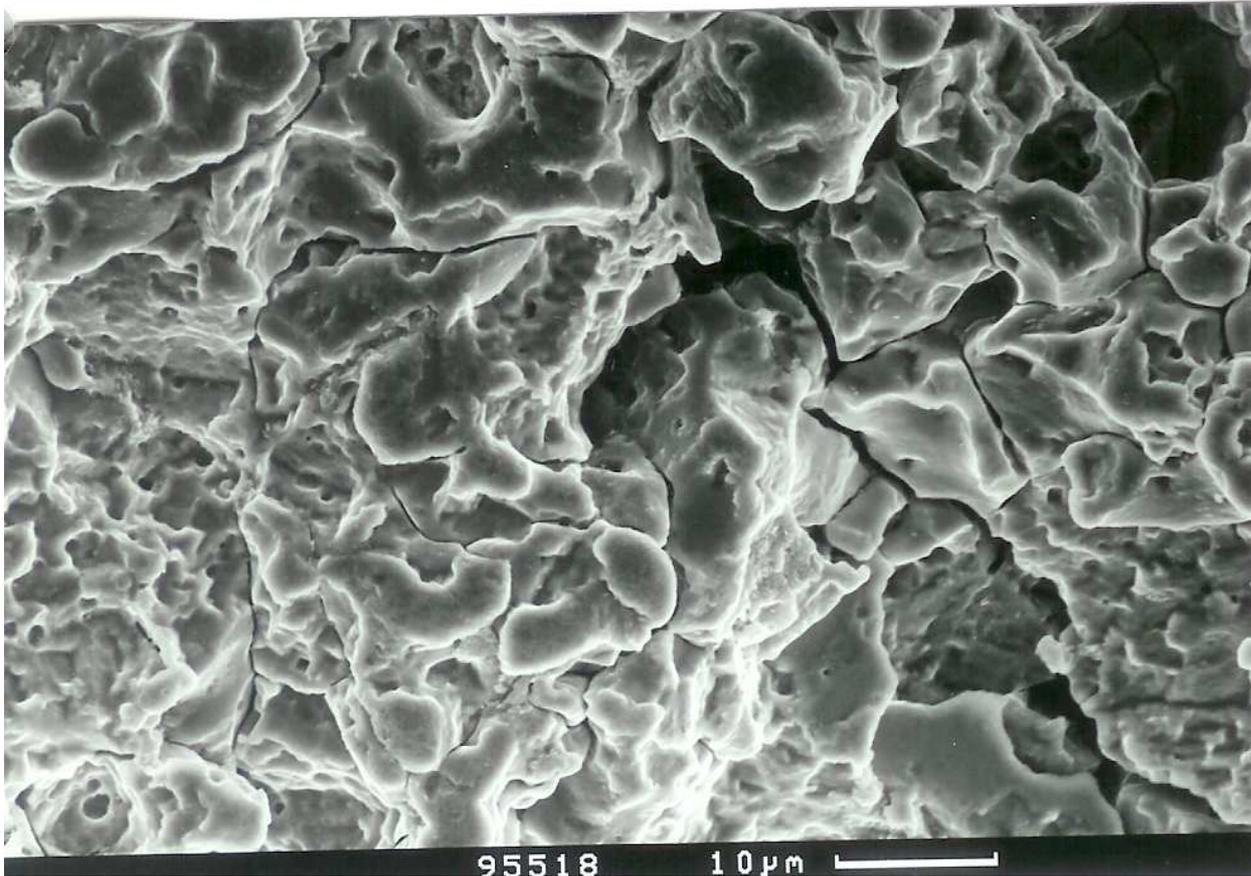
Photo 4 shows a SEM picture of the inter-granular propagation of the cracks. In the boat sample examined by Stamicarbon only cracks were found in weld deposit material. The weld deposit material has a normal dendritic casting structure.

Photo 4: SEM picture of inter-granular crack propagation
