Troubleshooting Case:

Failure to raise the 1st stage evaporator outlet temperature

Mr. Zhao Chengang
Cangzhou Dahua Co., Ltd., Cangzhou, Hebei, 061000
People's Republic of China

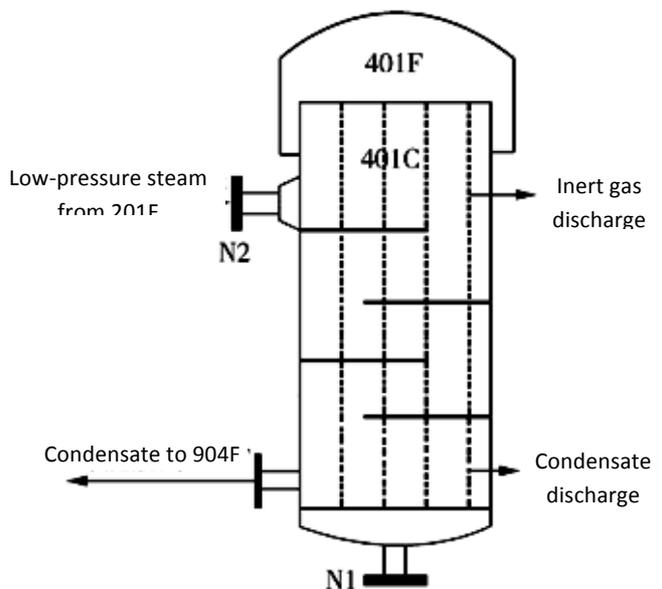
Figure 2: Scheme of the evaporation separator

It can be seen from Figure 2 that steam enters via nozzle N2 and heats evenly through 4 baffles, increasing the temperature of urea solution in tubes. If any baffle has come off or has been deformed, steam distribution in 401C will be affected. During the overhaul in 2007, a baffle in the middle was unripped for a check and found that it was intact. But we could not unrip the entire equipment for all the 4 baffles, so other baffles remained unchecked.
