FIORDA – Fertilizer Industry Operational Risks Database is launched.

Dan Cojocaru – AmmoniaKnowHow.com

Mark Brouwer – UreaKnowHow.com

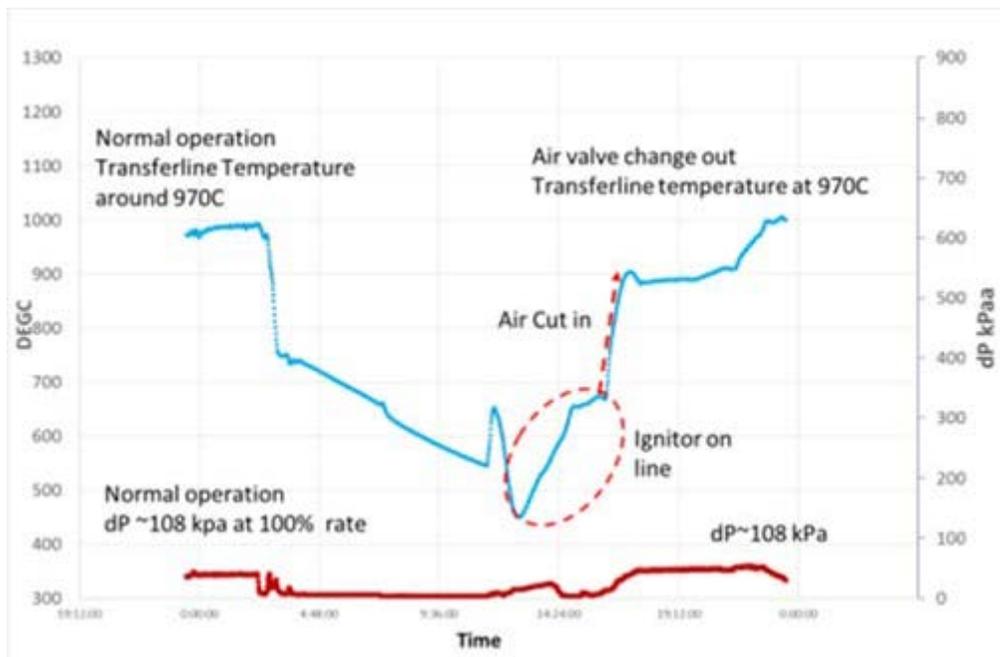
Attached trend 1: Normal temperature and pressure drop profile during start-up of the secondary reformer.

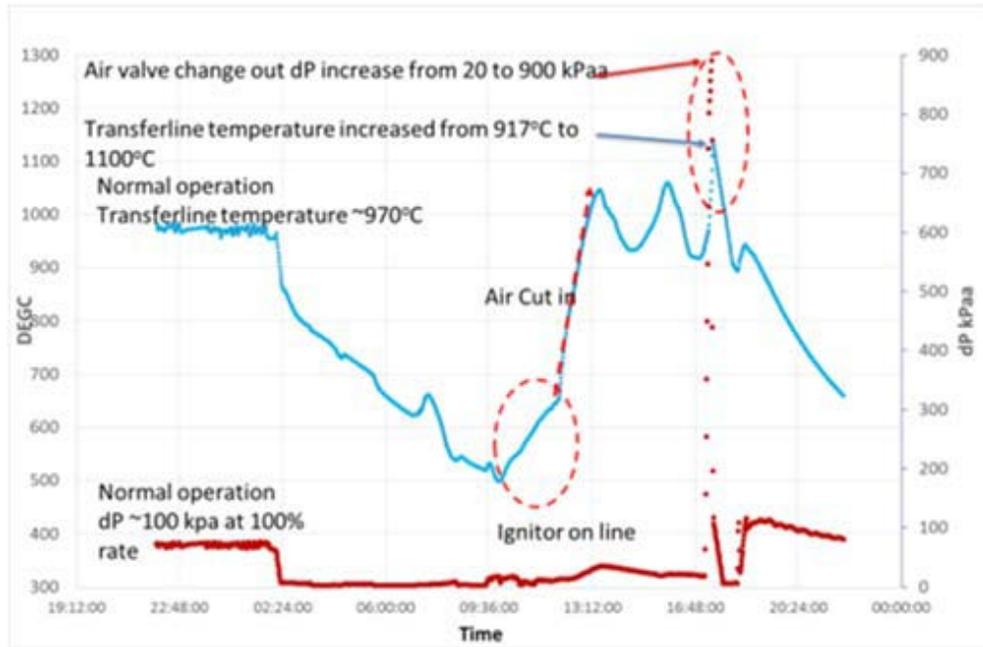
A high pressure drop across the inlet and outlet of the secondary reformer in the ammonia plant suddenly occurred. The plant was shut down to determine the cause.

Examination of the failed dome revealed that the bricks had primarily sheared at an angle close to 90 degrees to the major axis of the dome. It was concluded that the refractory dome failed as a result of high thermal stresses introduced as a result of the different thermal expansion between the refractory brick dome and the water-cooled vessel shell. The design had no allowance for thermal expansion.

Attached trend 2: Pressure drop increase from 20 to 900kPa and temperature during the start-up.

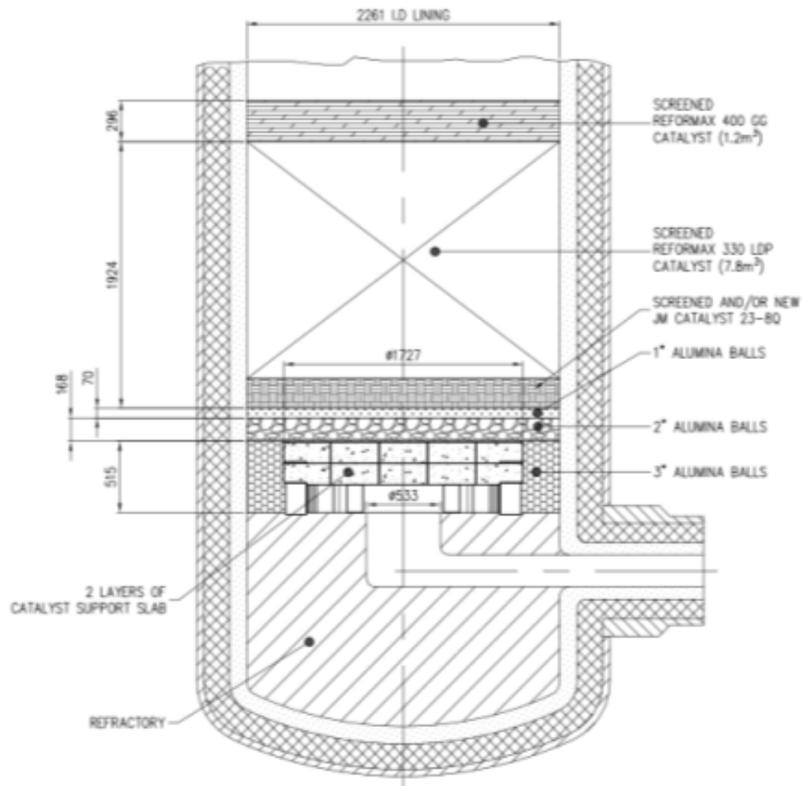
Attached Figure 1: The new design for catalyst support for the Site 1 secondary reformer

The dome was replaced with a novel design using readily available alumina blocks. The plant was returned to service 30 days after the incident. [Ref 1]

Mitigation Safeguards	<p>Review and consider alarm and trip sequence for high pressure drop on secondary reformer to limit the damage of internal refractory liner.</p> <p>Perform a Root Cause Failure Analysis to identify the cause of multiple plant trips that result in rapid automated depressurization and lead to additional material stress.</p>
Corrective Recommendation	<p>When the incident occurred at ammonia plant in Site 1 the plant had suffered numerous issues and a spare refractory dome was not available. For a dome the bricks designs vary between each row and as result it is not possible to get delivery of high alumina bricks urgently off the shelf. In addition, it was considered highly risky replacing the dome with the same design considering the history of the vessel.</p> <p>The company has a secondary reformer at Site 2 that has a catalyst support structure made from alumina blocks spaced in lattice to allow gas flow. This had been in service for 10 years and no major issues had been seen. A number of alternative designs were considered. It was decided to create a structure out of alumina blocks similar to that at Site 2 using readily available material. Design is shown in attached Figure 1</p>

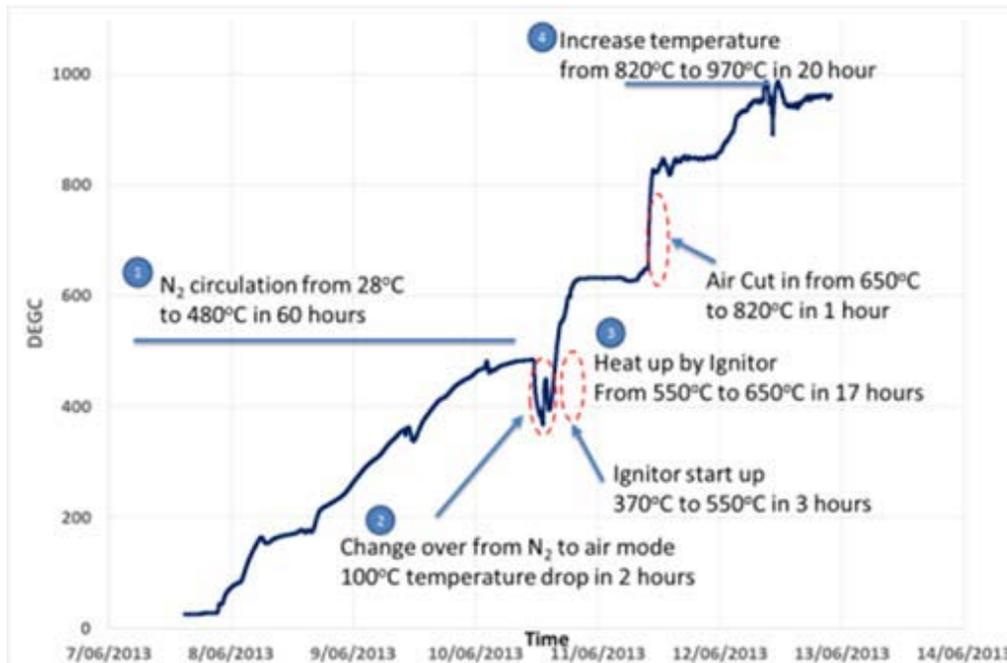
Attached trend 3: Refractory dry out and initial startup of the secondary reformer after the installation of the new catalyst support structure over a five-day period

<p>The new installed dome and repaired refractory required a very delicate dry out process this included four major steps as shown in attached trend 3. The catalyst support structure was installed, new catalyst was used and the plant was returned to service 30 days after the incident. Since installation the pressure drop has been within normal design window ranging from 101 to 108kPa (14.6 to 15.6psi). The support structure was inspected in March 2014. Upon inspection by a refractory expert it was seen that the refractory was in serviceable condition with no areas of spalling or significant cracking. Minor repairs were required to the refractory on the associated transfer piping to remove minor hotspots.</p>
<p>Lesson Learnt</p>	<p>The Site 1 catalyst support dome failed as a result of high thermal stresses introduced as a result of the different thermal expansion between the refractory brick dome and the water-cooled vessel shell. The design had no allowance for thermal expansion and high number of thermal cycles. The dome was replaced with a novel design using readily available alumina blocks and the plant was returned to service after being shutdown for 30 days.</p>
