The 12th subject under discussion is oil fouling of the High Pressure stripper in a urea synthesis.

Problem No. 12 Oil fouling of the High Pressure stripper in a urea synthesis

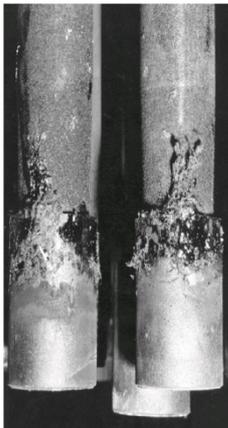
During normal operation the leak of water or oil to the process side should be minimum by proper maintenance procedures. In case of an upset oil fouling can cause bigger problems than water, at least in stripping plants. Even during an upset the amount of water from the pumps is much less than from the carbamate recycle. Please remind the liquid holes in the liquid dividers in the top of the stripper act as a kind of filter for the whole synthesis section. Oil will be stripped also in the stripper at the high temperatures and the heavy boiling part of the oil will collect around the liquid holes.
