## CO<sub>2</sub> compressor corrosion and scaling problems

Mr. Shi Chen  
Petrochina Ningxia Petrochemical Company  
Ningxia, Yunchuan  
People's Republic of China  
Date: 3 September 2009

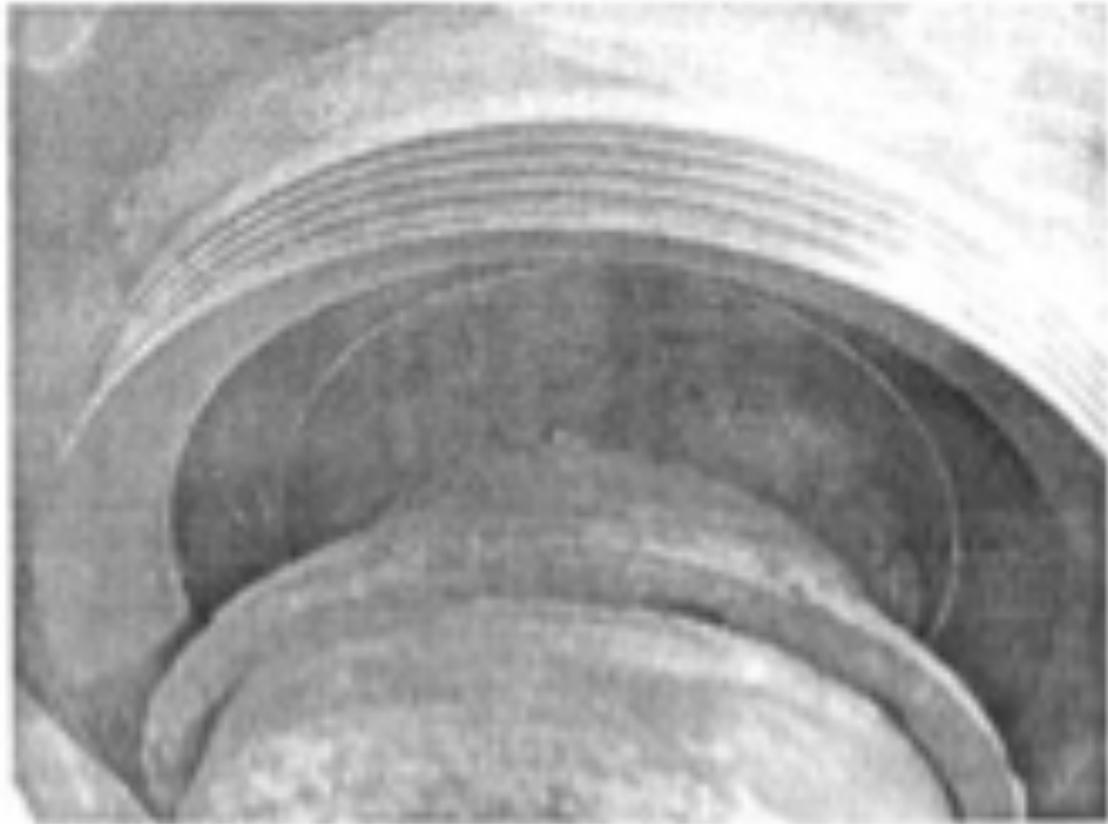
图 1 宁夏石化公司 CO<sub>2</sub> 压缩机组  
三段入口流道损伤图片

In September 2007 during the CO<sub>2</sub> compressor inspection, they found at three sections of high-pressure cylinder that the rotor entrance flow channel were severely eroded (see Figure 1), and they were forced to sent these to compressor manufacturing company Shenyang Blower to carry out the necessary repairs.

The tiny water droplets and the larger CO<sub>2</sub> flows created a water hammer effect at the entrance of the compressor and caused severe mechanical erosion damage of the flow channel.
