The AXO WELDING and GPIC partnership: A benchmark in realizing high safety standards and high on-stream figures

ABDULMUNEM ALNAJJAR, NADER ALABBASI
Gulf Petrochemical Industries Co.
Kingdom of Bahrain

MAURO ORSINI
AXO WELDING SRL
Alfonsine (RA), Italy

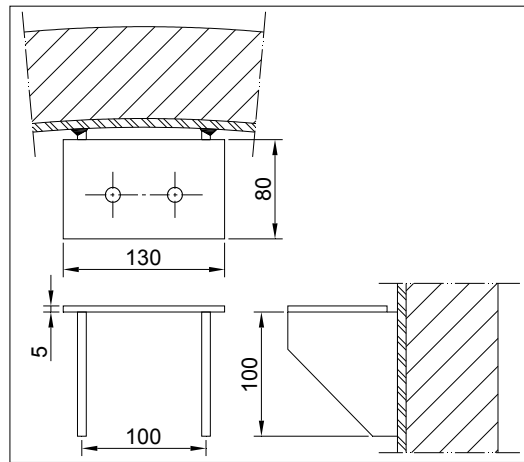
Fig. 2: design of reactor tray supports

In spite of the great deal of dedication that GPIC, the Main Contractor, and the Process Licensor put in the procurement process, in the reactor these first four inspections evidenced a worrisome corrosion phenomenon that, albeit in an initial status, showed a marked progression rate over time. The corrosion affected:

To fulfill all these requirements GPIC decided to begin a relining project and – at the same time – to replace all tray supports. The material of the new liner and supports would be improved to 25.22.2CrNiMo – which has proven to have a much lower corrosion rate at the process conditions of SAIPEM reactor – and the design of the new supports would be changed to that shown in figure 5, in order to make it easier to inspect them.

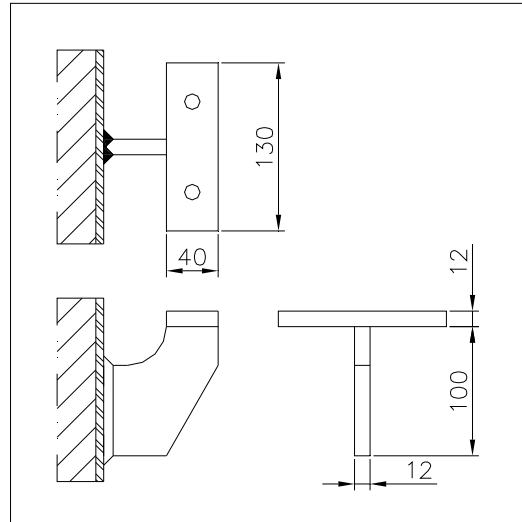
Fig. 5: design of new tray supports

On the light of the findings of the first four inspections, in planning turnaround 2003 the focus was totally on improving the reactor, with the main concern being the corrosion process in progress. Addressing the corrosion on the tray supports was a matter of extreme urgency, because a leak in the welds between the

supports and the liner might not reach the leak detection system with potentially catastrophic consequences. On the other hand there was also a need to rectify the liner welds and to stop (or significantly slow down) the rapid progress of the corrosion, and to do all that within the time-window of the turnaround.

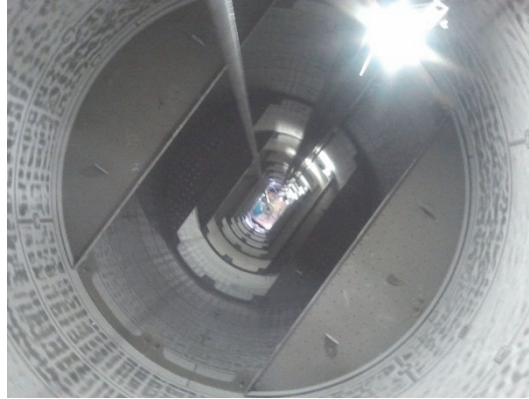
Fig. 7: work in progress inside the reactor

The planned modification required an extensive amount of work to be carried out inside the reactor, a potentially dangerous environment where the hazards typical of a confined space sum up with the hazards of working at height. The solution adopted to address this HSE issue consisted in:

- A cable-intercom system to guarantee good communication between the workers inside the reactor and those on top and outside it.
- A specifically procured, low-voltage illumination system based on a number of lamps attached to a single cable.

Figure 7 shows the inside of the reactor as seen from the top manway, after the implementation of the actions.

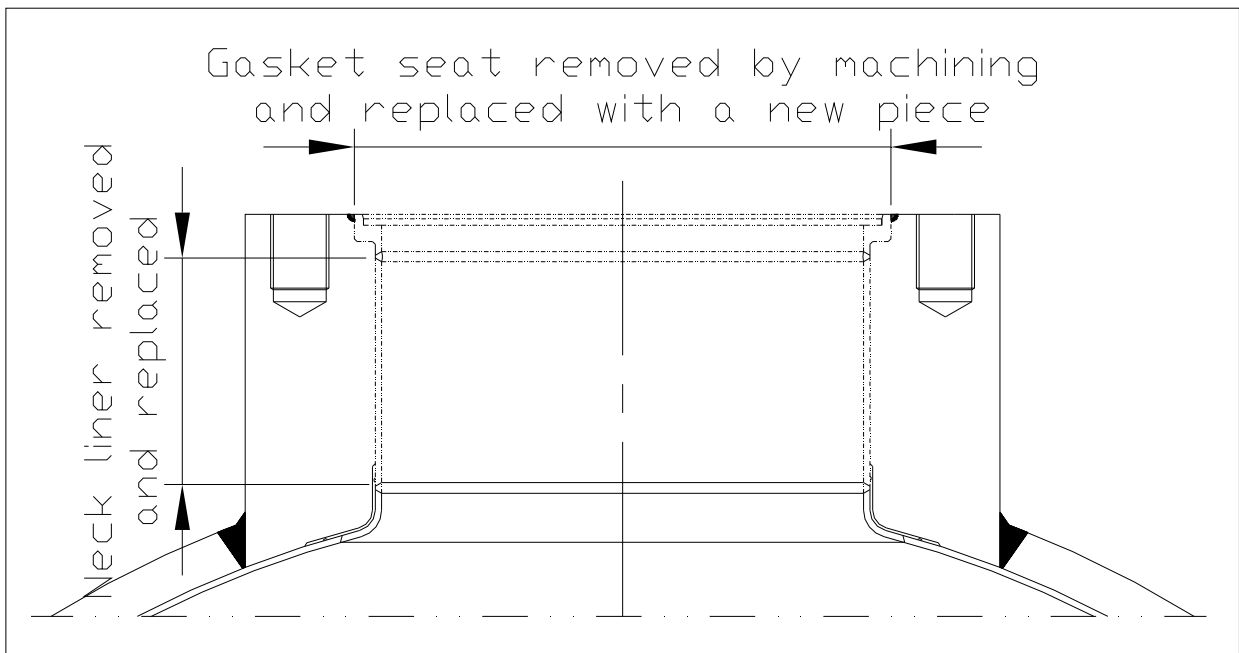
Fig. 8: scheme of relining of manway

Equipment	Item	Problem or hazard to prevent	Aim of preventive action	Detail of preventive action	Notes
Urea Reactor	R-8201	Corrosion on the sealing surface of the manway cover and on the liner of the manway neck	Prevent leaks Increase the equipment safety and reliability	Replace gasket seat and nozzle liner on top manway	Material upgrade to 25.22.2CrNiMo
		Corrosion of liner plates and liner welds	Increase reliability of equipment and on-stream time.	Install new liner on top dome and above tray #1	Material upgrade to 25.22.2CrNiMo
		Knife line corrosion in the HAZ of liner welds	Prevent leaks Increase safety and reliability of equipment	Perform extensive repair of welds of original liner	Welding process: manual GTAW Filler material: 25.22.2CrNiMo
		Thinning out of sieve trays due to corrosion	Prevent the loss of production volume due to decreased conversion of carbamate	Procure and install sieve trays No. 4, 5, 8, 9, 10, 11, 12, 13 and 14 (9 Nos)	Material upgrade to 25.22.2CrNiMo

- The replacement of the stainless steel ring that forms the seat of the manway gasket (see figure 8)
- The relining of the top dome and the area above tray #1
- The replacement of some trays

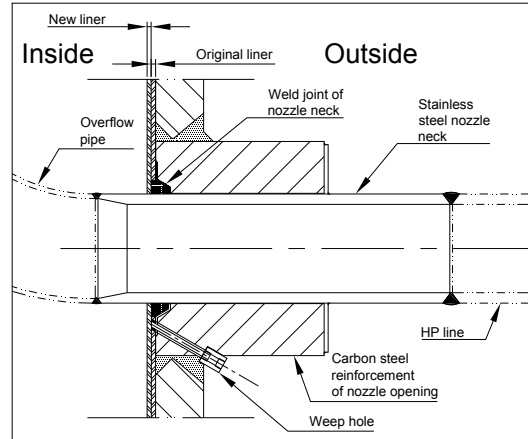
Fig. 10: initial layout of N1

Note: The area around nozzle N1 had already been subject to relining. The initial layout was as shown in figure 10

During this turnaround the most critical activity was the replacement of solution outlet nozzle N1, for which we followed this procedure:

1. Using a manual grinder, cut free the nozzle neck from the high pressure pipe outside the reactor and from the internal overflow pipe
