Successful Repair of a Severely Damaged HP Scrubber Sphere

Alex Scheerder, Jan Geerlings
Stamicarbon BV, The Netherlands

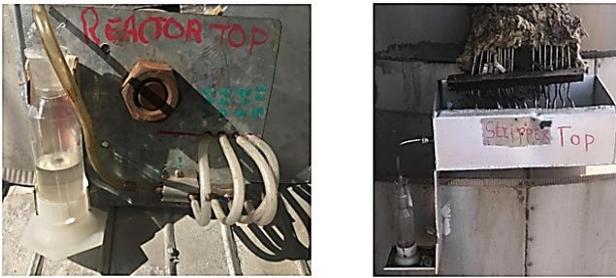
Figure 2. Leak detection system; bottle is filled with Phenolphthalein solution. Colorless at low pH, turns pink at $pH > 8$

The severe corrosion of the pressure bearing part of the sphere is due to the fact the liner leakage preceding this corrosion could not be noticed probably due to chocking of leak detection holes. This demonstrates the importance of a reliable and robust leak detection system.

Nowadays Stamicarbon recommends using state of the art leak detection system, which is based on continuous forced air flow fed to an ammonia analyzer (so-called pressurize system), which can be connected to the DCS system (see also Reference [1]). The principle of the pressurized system is presented in Figure 21 and 22.

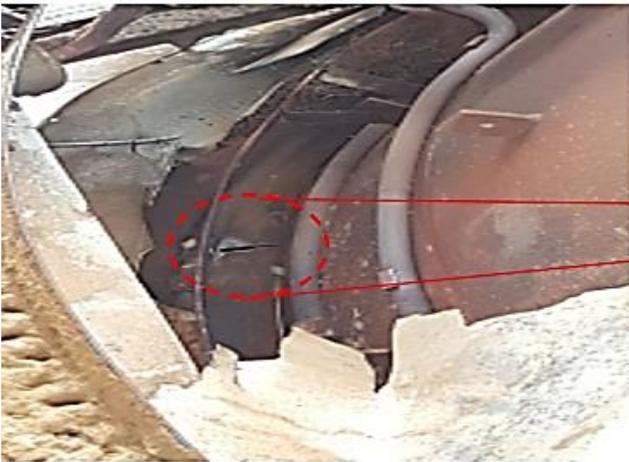
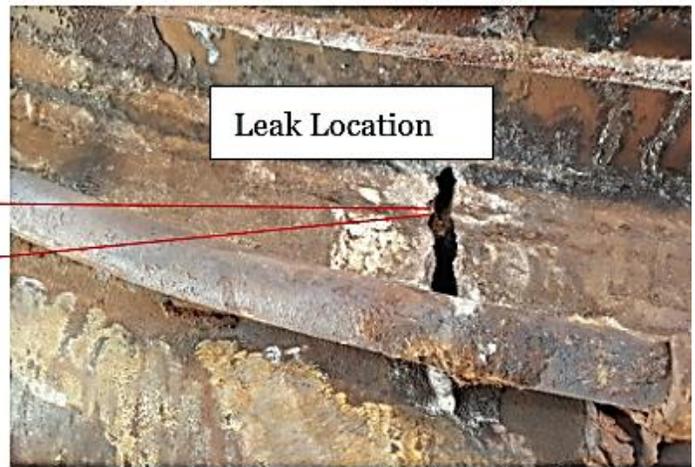
At the beginning of February 2018, a leak to the atmosphere was observed in the spherical dome part of the HP Scrubber, which resulted in the plant being stopped to attend to the leak, see Figure 3.

Figure 3. leak spot at the outside of spherical dome

It was also concluded that the leak in the corrosion resistant barrier was not detected, which resulted in late detection and consequently severe corrosion of the carbon-steel part. The incident can be classified as a near miss. Fortunately, in this case the corrosion of the pressure retaining part resulted in a so-called “leak-before-break” scenario (LBB), allowing the plant owner to timely shut down the plant to avoid catastrophic failure.

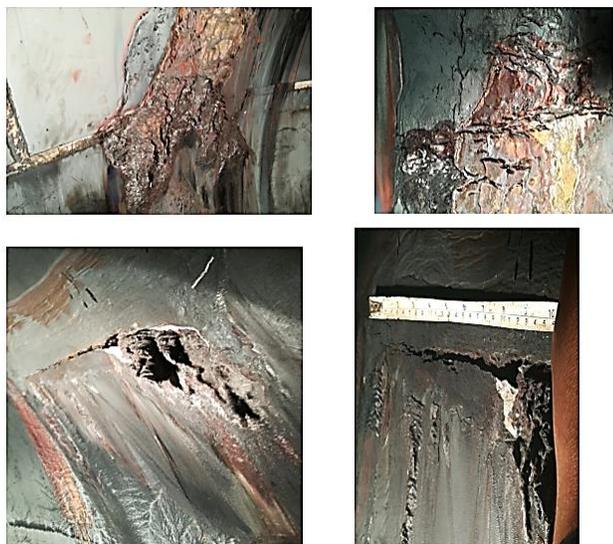
Upon opening the spherical dome (February 7th), severe corrosion and large amounts of corrosion products was observed on the 316L UG liner, as can be seen in Figure 5.

Figure 5. 316L UG Liner plates covered with large amount of corrosion products

Based on these observations it was decided to remove and replace all liner segments. After removal of all liner segments the Wet Fluorescent Magnetic Particle Test (WF-MPT) revealed many cracks in the carbon-steel pressure shell, as can be seen in Figure 7. Also, it became clear that the leak detection system (grooves and holes) was partly blocked by corrosion products, making the system unreliable.

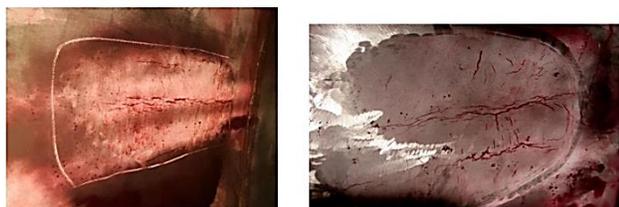
All corrosion products were removed by grinding. Dye Penetrant Testing (DPT) revealed large number of cracks in the liner, see Figure 6.

Figure 6. DPT of the liner revealed many cracks in the 316L UG liner

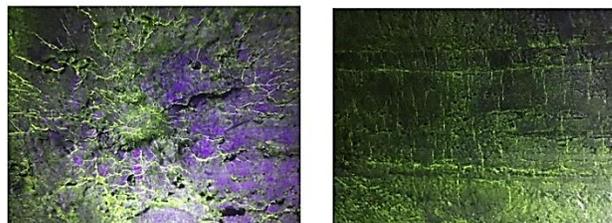
Figure 7. WF-MPT revealed many cracks in the carbon-steel pressure shell

Ammonium-carbamate entering the space behind the liner started to corrode the carbon-steel. This resulted in localized wall thinning of the carbon-steel pressure shell as was observed in the sphere. The observed cracks in the carbon-steel are believed to be related to hydrogen. The hydrogen is originating from the corrosion of the carbon-steel due to the presence of ammonium-carbamate. Following reactions play a role:

Atomic hydrogen (H) is capable of diffusing through steel and the cracking failure mode is called hydrogen induced stress corrosion cracking (HISCC) or hydrogen induced cracking (HIC). The presence of Sulphur found on the back side of the liner sample promotes the entry of atomic hydrogen into the steel. The atomic hydrogen diffuses in the lattice to areas with increased tensile stresses brought about by the presence of notches, the microstructure (martensitic), geometric discontinuities and flaws in the lattice. The presence of hydrogen in the metal lattice reduces the toughness and resistance to fracture. Especially the high-tensile steel used for the Sphere is susceptible for hydrogen induced cracking. Hydrogen induced cracks are also known to propagate slowly.

All cracks were removed by grinding under guidance of WF-MPT testing, see Figure 16. Since the carbon-steel was loaded with hydrogen, grinding was done carefully in order not to propagate the cracks or the formation of new cracks. The time needed to remove all cracks was approx. 11 days.

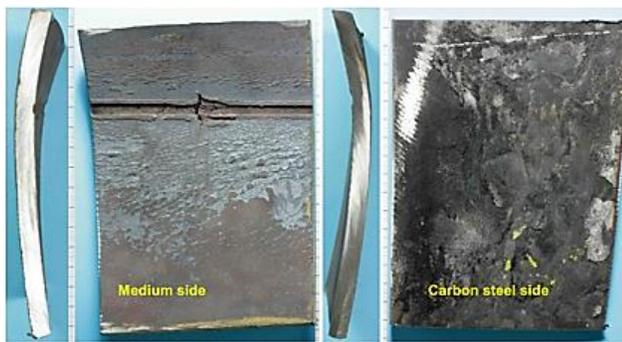
On the process medium side, the liner plate was partly covered with a blue oxide layer. Local absence of an oxide later indicates condensation of gasses on the liner surface (see Figure 8).

Figure 8. Liner sample (S09176); medium side covered partly with blue oxides. Backside covered with black oxides

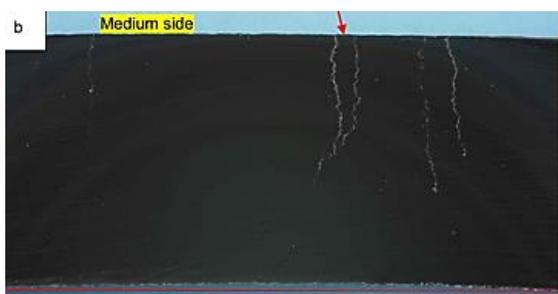
The back side of the liner plate was covered with black corrosion products. The cracks started from the process medium side and progressed almost perpendicular to the back side, see Figure 9.

Figure 9. Cracks starts at medium side

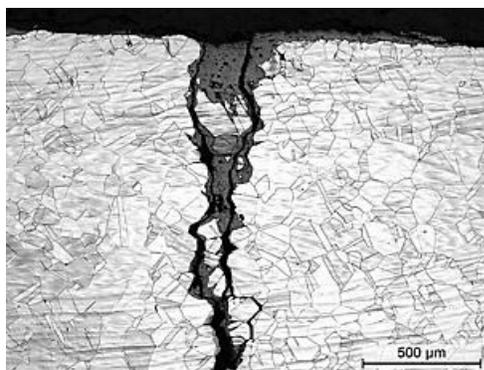
Microscopic examination of the cracks shows that the cracks are intergranular stress corrosion cracks, which are filled with corrosion product (oxides), see Figure 10. This indicates that the cracks propagated slowly.

Figure 10. Intergranular stress corrosion cracks with oxides inside the cracks

The leakage in the 316L UG liner was due to intergranular corrosion cracking, initiated at the process medium side of the liner. Since the inner surface was plastically deformed (strain) and the presence of oxides in the cracks indicated that the failure mode was so-called Strain Induced Intergranular Cracking (SIIC). This failure mode has been observed in other urea equipment lined with 316L UG liners in the gas phase area.

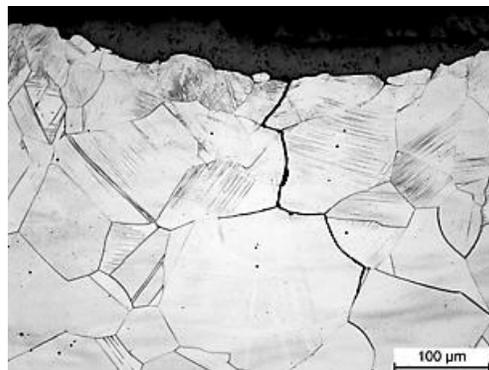
At the liner plate surface (process medium side) typical deformation patterns in the austenitic grains are visible, see Figure 11. This indicates strain in the material.

Figure 11. Typical deformation pattern in the austenitic grains indicating cracks starts at surface plastically deformed

This plastic deformation of the liner is mainly due to the bending of the liner plates during manufacturing. However, also temperature and pressure cycles (start-stops) could play a role as well.

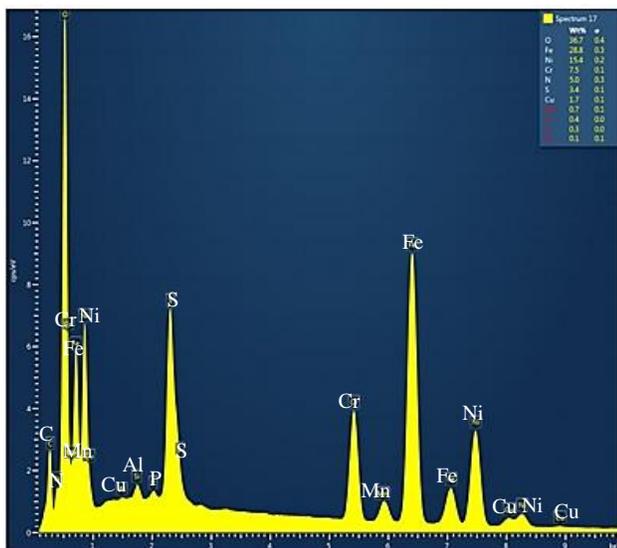
Examination of the corrosion products found at both the process medium and the backside of the liner shows they consist mainly of iron oxides (corrosion product). However, at the backside of the liner also Sulphur, Copper and Nitrogen are found, see Figure 12.

Figure 12. EDX spectrum of the elements found in the corrosion deposits at the liner backside. Apart from the normal elements found in 316L UG material, foreign elements such as Sulphur, Copper and Nitrogen are found

The origin of the Sulphur and Copper is unclear. The presence of ammonium-carbamate trapped behind the liner also attacked the liner at the backside; i.e. intergranular corrosion attack is observed.

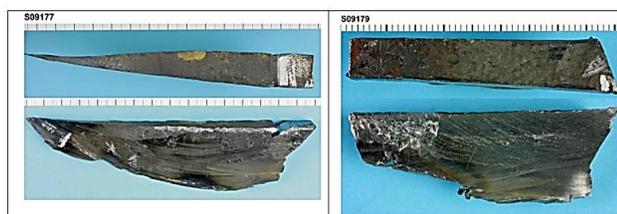
Figure 13. Two boat samples from carbon-steel sphere; left hand side S09177, right hand side: S09179

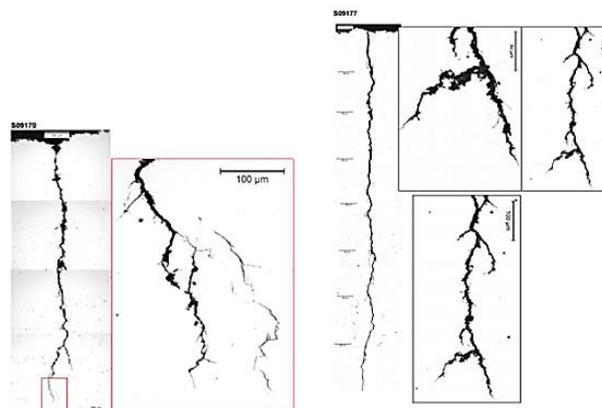
Metallographic examination of both boat samples indicated branched trans granular stress corrosion cracks, see Figure 14. The corrosion products were mainly containing iron oxides, but also traces of Sulphur were found. In the crack itself

oxides are found, which also indicates that the crack propagated slowly.

Figure 14. In both boat samples trans granular stress corrosion cracks are visible.

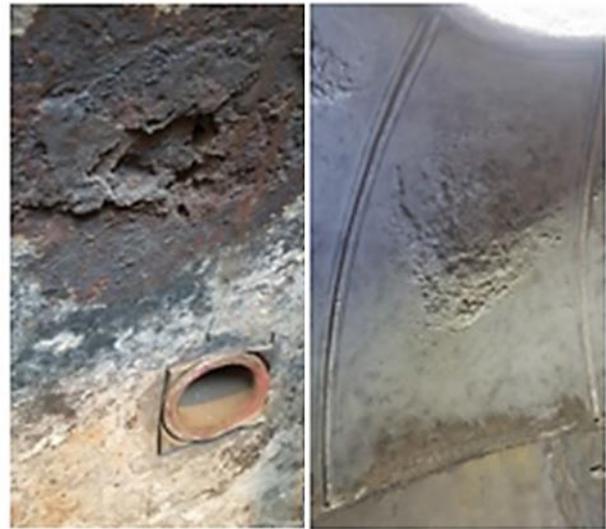
Figure 15. Left side before cleaning, right side after cleaning

First the existing liner segments were removed from the sphere. The inner surface was cleaned from rust and debris, see Figure 15.

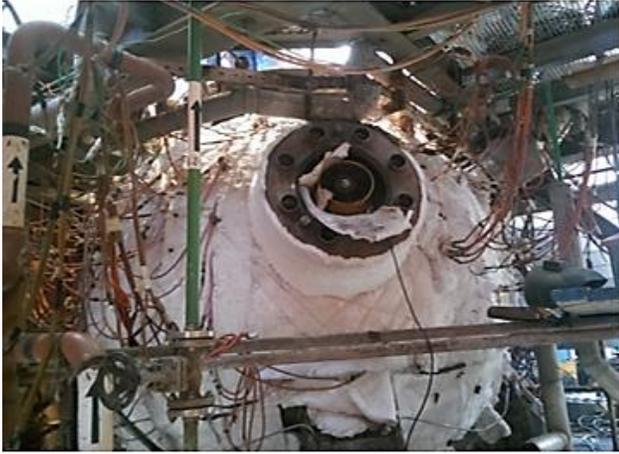
Figure 17. Insulation wrapped on all ceramic fiber heating elements

To avoid crack propagation during repair welding, the pressure shell was heated for approx. 2 hours to outgas any hydrogen still present in the carbon-steel.

Repair welding was done at a pre-heat temperature of approx. 120 °C (248 °F). A heating system was installed at the outside of the sphere, see Figure 17.

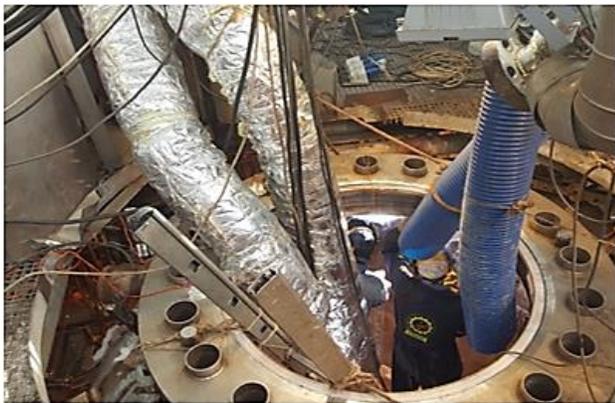
Figure 18. Repair welding in progress

Covered electrodes (SMAW: AWS E7018 type) were used with low hydrogen content to minimize the uptake of hydrogen during welding. An impression of the repair activities is presented in Figure 18. The time needed to repair all grinded areas was approx. 6 days.

After completing the repair welding, the temperature was increased again to soaking temperature (approx. 300 °C, 572 °F) for some time to outgas any uptake of hydrogen during welding. Finally, the temperature was lowered to ambient and after waiting for 48 hours the repaired zones were

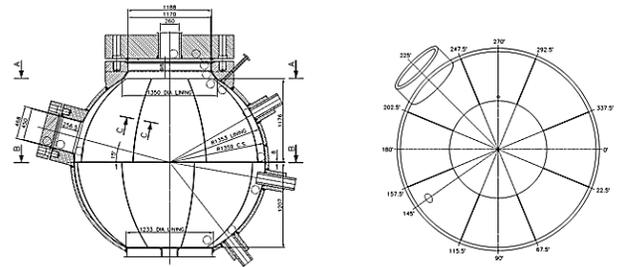
Figure 19. Schematic overview of the 16 liner segments to be installed. Right hand sketch shows 8 segments in top half

The liner in the HP scrubber sphere is divided in 16 pre-shaped segments, as can be seen schematically in Figure 19.

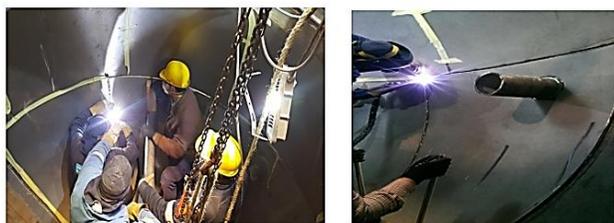
Figure 20. Installation and fit-up of liner segments in top part of the sphere.

The new liner plates are 6 mm thick X2CrNiMoN 25.22.2. The liner plates were delivered with an over length. The plates were cut to fit the existing buttering layers. Welding was done by Gas Tungsten Arc Welding (GTAW) method using matching filler wire. The installation and welding of all liner segments took about 11 days. Some impressions of the liner installation are presented in Figure 20.

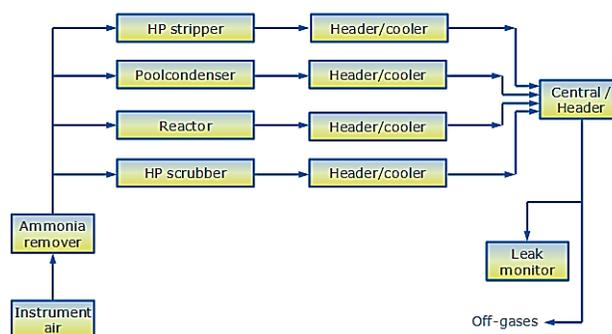
Figure 21. Principle of the pressurized leak detection system (schematic overview for a Stamicarbon pool condenser plant)

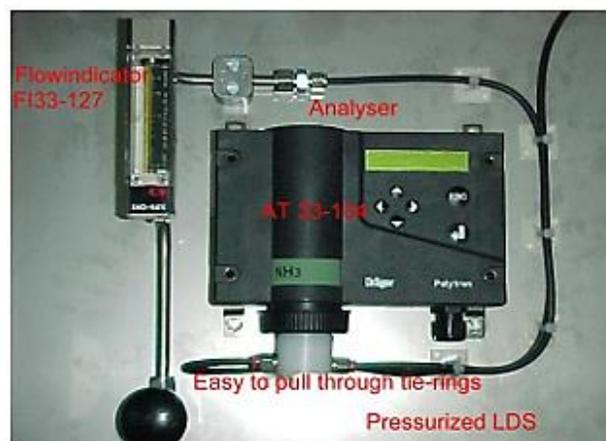
Figure 22. Ammonia analyzer
