Urea Reactor Liner Leakage - A Case Study

P.A. Wasekar, S.N. Saha, T.K. Batra and Jagdeep Shah Singh
National Fertilizers Limited, Vijaipur, Guna, Madhya Pradesh

Abstract

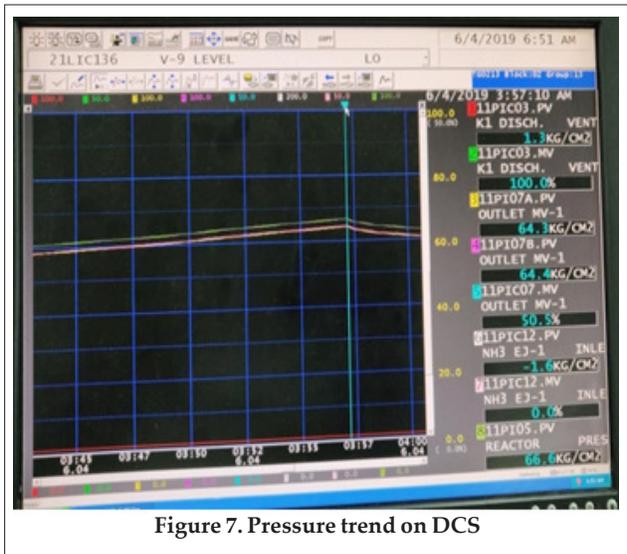
Figure 7. Pressure trend on DCS

Subsequent to repairs, HP loop hydro test was initiated. It was observed that HP loop pressure was not increasing beyond 65 kgcm⁻², rather started decreasing (Figure 7). It was noticed that condensate was coming outside from 1st segment (L-seam) of the reactor from inside the insulation. Immediately insulation was removed and it was noticed that the outer shell plate of 08 mm got ruptured from its vertical weld joint (400 mm in length) at 1st segment (L-seam) (Figure 8).

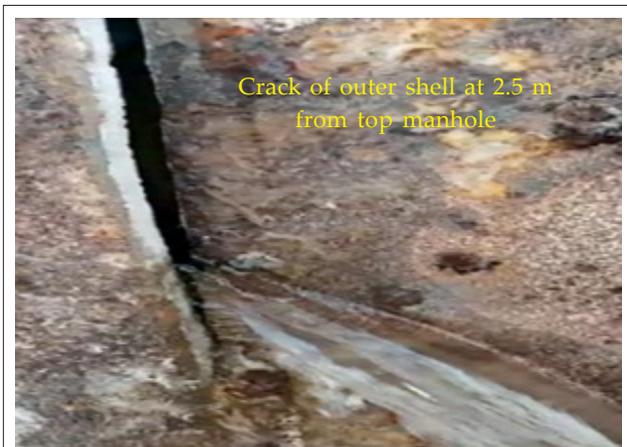
Figure 8. Condensate coming out from vertical weld joint at 1st segment (L-seam)

System hydro-test water entered through the damaged portion of newly welded TSR cleat of the first tray into the coiled layers and reached up to the last layer of 8 mm. As the vent holes and vent tube of the segment were in plugged condition, this resulted in pressurization of the outer shell course, causing rupturing of the 8 mm outer layer vertical joint. The coiled layer welding remained intact, otherwise it could have unwinded.

- i. The outer shells (8 mm) of first and fifth segment were removed and replaced with new semi-circular shells made of 16 mm CS plate (SA516 Gr70) in NFL Vijaipur workshop (Figures 12 and 13).
- ii. The TSR leaky point was removed in rectangular shape of size 300 x 200 mm (Figure 14) to ensure that the internal layers of the reactor is not damaged and replaced with new patch plate, with separate weep hole for monitoring patch plate liner and welding.

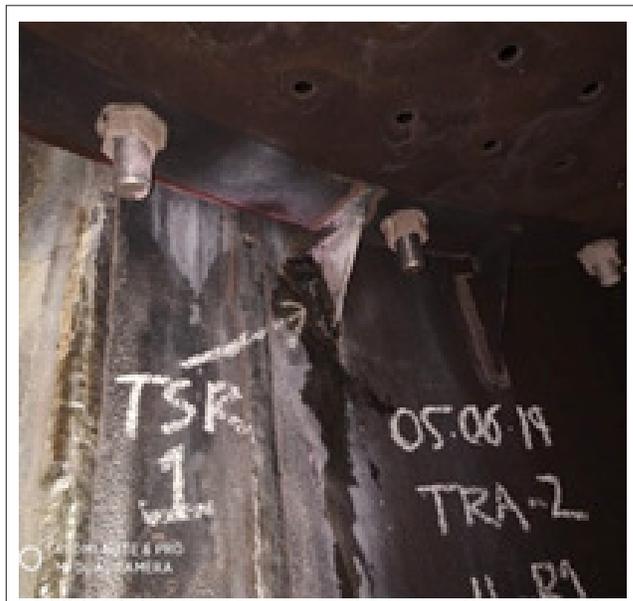
Figure 9. Condensate coming out from TSR 1st tray

Hence, HP loop was depressurized and draining was carried out and top manhole cover was removed for internal inspection. Simultaneously, tray manways were opened from 1st to 5th tray. To detect the leaky portion inside the reactor, DM water was supplied through flexible hose from outer ruptured portion of the shell course and thorough physical (visual) inspection was carried out inside the reactor. It was found that water was coming out through 1st tray's TSR's newly welded cleat (Figure 9). After insulation removal, it was also noticed that there was bulging on outer (8 mm) layer at the first and fifth segment from the top of the reactor (Figure 10). Vertical joint of 1st segment outer shell 8 mm layer welding was found in ruptured condition and bulging of longitudinal pad plate of 5th segment was also noticed.

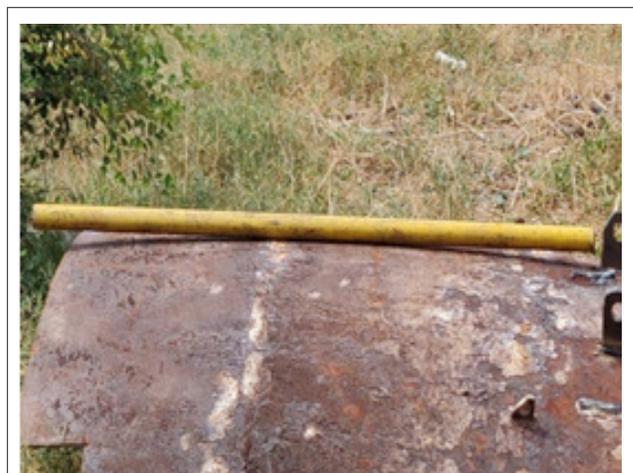
Figure 10. Bulging of outer shell

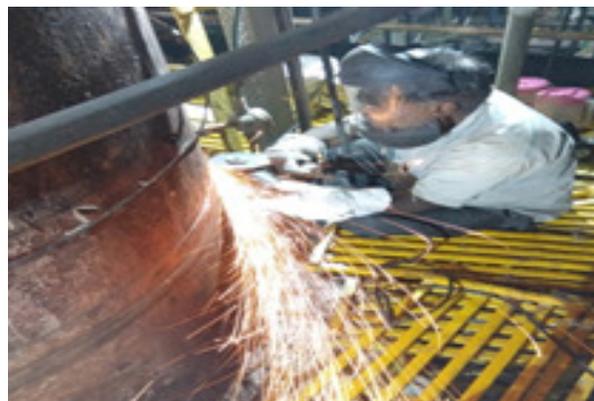
Figure 12. Outer 8 mm shell removal of 1st and 5th segment

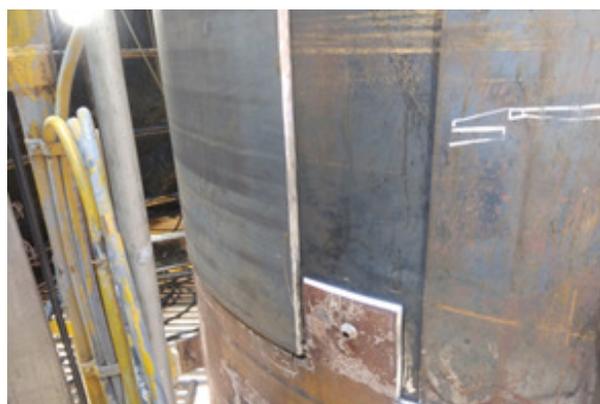
Figure 13. New outer 16 mm shell installation in progress

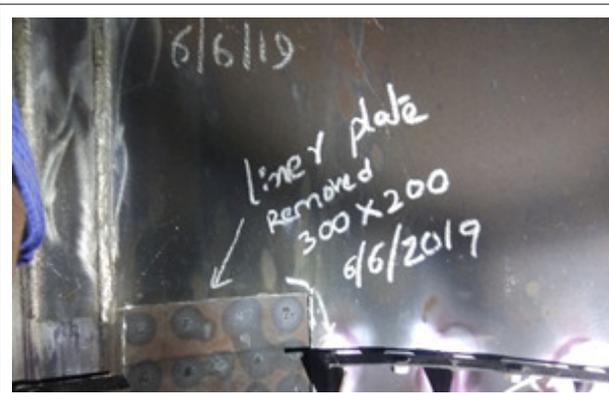
Figure 14. Liner plate removed (300 mm x 200 mm) from the leaky point

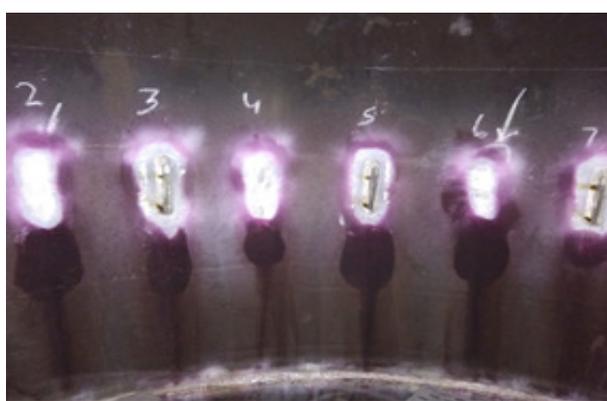
Figure 15. Old TSR and cleats removed and repaired

- iii. The first to fifth TSR as well as its all cleats were replaced with new one (Figures 15 and 16).
- iv. The longitudinal pad plate of the fifth segment was replaced (Figure 17).

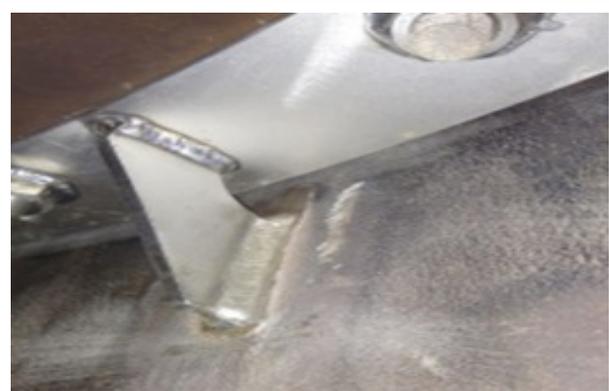
Figure 16. New TSR and cleats installed

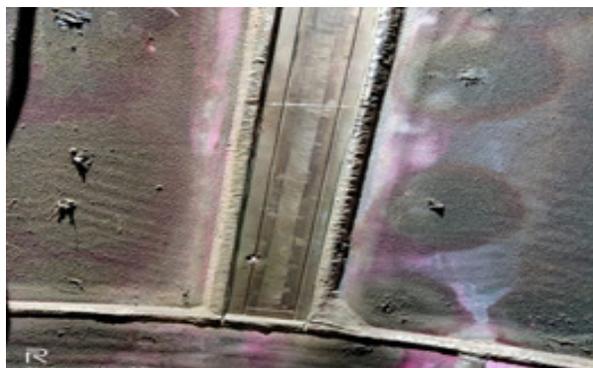
Figure 17. Longitudinal pad plate of the 5th segment removed

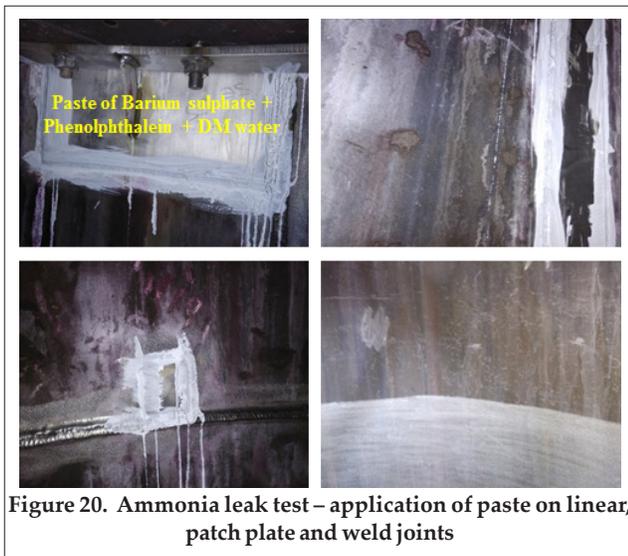
Figure 20. Ammonia leak test – application of paste on linear, patch plate and weld joints

After air test, the complete system was purged out using nitrogen and then ammonia was charged to carry out ammonia test, the system was kept at hold for 12 hours at a pressure of $0.3 \text{ kg cm}^{-2}\text{g}$, to ensure the permeation of ammonia through leakage and cracks. Paste of barium sulphate, phenolphthalein and demineralized water, which changes the color from white to pink in presence of pH change, was applied on the reactor surface for leakage detection (Figure 20).

No defects were noticed. Subsequently, hydro test of HP loop was carried out. During hydro test, physical inspection of weep holes and vent tubes/vent holes was carried out and no abnormalities were found.

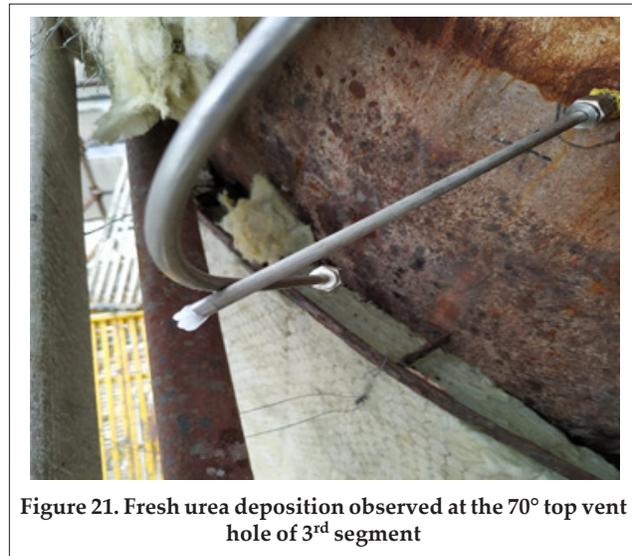
Figure 21. Fresh urea deposition observed at the 70° top vent hole of 3rd segment

Reactor feed in was carried out on 08-07-2019 at 0300 hours and prilling lined up at 0730 hours. Thorough physical inspection of the reactor weep holes as well as vent holes/vent tubes were carried out. Fresh urea deposition was observed at the exit of 70° top vent hole of 3rd segment. It was noticed that fresh urea melt was accumulating at the exit of the said vent hole (Figure 21). Again plant shutdown was taken. After draining/depressurization and flushing of HP loop, reactor manhole cover was removed. Manways up to 4th tray were opened for inspection and repairing the internal defect.

Grinding of longitudinal and circumferential seam weld joints was carried out keeping weep holes system and vent tubes/vent holes system pressurized with instrument air at $0.3 \text{ kg cm}^{-2}\text{g}$. One pinhole was found on C- seam weld joint of 3rd segment. Patch plate was welded over pinhole point (Figure 22), after performing NDT test and clearance received from mechanical team & M/s. L&T for leak test by air and

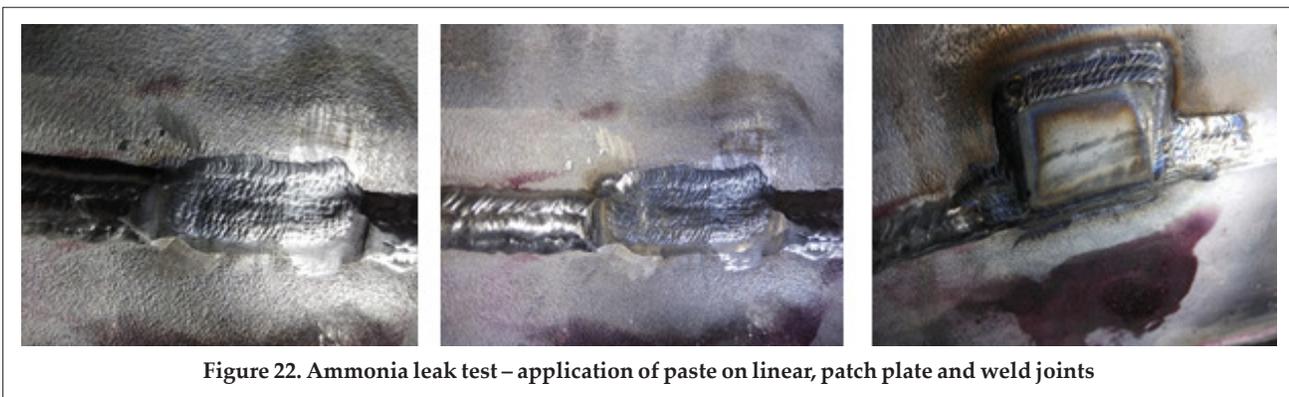
Figure 22. Ammonia leak test – application of paste on linear, patch plate and weld joints

ammonia on 12-07-2019 at 0200 hours. This time air & ammonia tests were performed at $0.4 \text{ kg cm}^{-2}\text{g}$ for 2nd and 3rd segment and $0.3 \text{ kg cm}^{-2}\text{g}$ for 4th segment which was completed on 12-07-2019 at 2120 hours. No leakage was found with air and ammonia leak test. Further, hydro test of reactor was carried out but water started coming out through 70° vent tube and 250° vent hole (bottom) of 3rd segment at HP loop pressure of $90 \text{ kg cm}^{-2}\text{g}$. Leakage rate (number of drops per minute) was measured to detect the leakage source whether it is leaking from inside of reactor or accumulated water from the coiled layer of 3rd segment. Leakage rate was measured while increasing the HP loop pressure up to $145 \text{ kg cm}^{-2}\text{g}$ and then reducing to $120 \text{ kg cm}^{-2}\text{g}$ and held at that pressure for 4 hours for measurement of leakage rate. But nothing could be concluded from this. Finally system was depressurized and drained. Air leak test as well as Helium test was carried for 2nd, 3rd and 4th segment on 19th and 20th July.
