# Catastrophic Fire in Ammonia Plant Compressor Room

*On September 29<sup>th</sup>, 2011, 4 hours after the start-up of the ammonia plant at GPN Grand-Quevilly, a hydrogen leak followed by a fire occurred on a 1 inch synthesis gas line on the discharge side of the synthesis gas compressor. The plant was tripped immediately, the plant personnel were evacuated to a safe location, and the fire was finally extinguished about 90 minutes later, after depressurization and nitrogen purging of the synthesis loop. The damages to the compressor room were considerable, but no one was injured and there was no release of toxic chemicals or pollutants outside the plant. The fire could be seen several miles away, and there was a large media impact locally. The root cause of the leakage was the failure of the yoke bushing on a 1 inch forged steel manual valve. The cost of the reconstruction was more than 16 million € (\$20 million USD) including implementation of additional safety measures. The total length of the shutdown was 11 months. The mother company of GPN, TOTAL, has performed a complete safety review of the plant.*

**Patrick Le Calvé**  
GPN, Grand-Quevilly, France

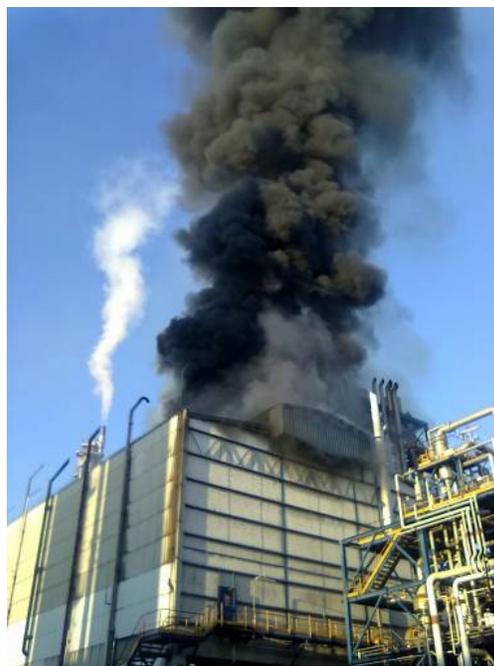
At 8:33 a.m., three fire detectors located in the compressor room alarmed simultaneously. The alarm is reported both in the control room and in the site fire station. On the video monitor in the control room, the flames could be clearly seen, thus confirming the fire alarm (Figure 1). As far as it could be seen, the fire was located on the discharge side of the compressor.

At 8:57 a.m., the roof of the building, partly consisting of transparent polycarbonate plates, began to burn producing a heavy, black smoke. The smoke could be seen several kilometers away. The fire then propagated to the process gas vents located nearby.

*Figure 1. The roof of the building on fire*

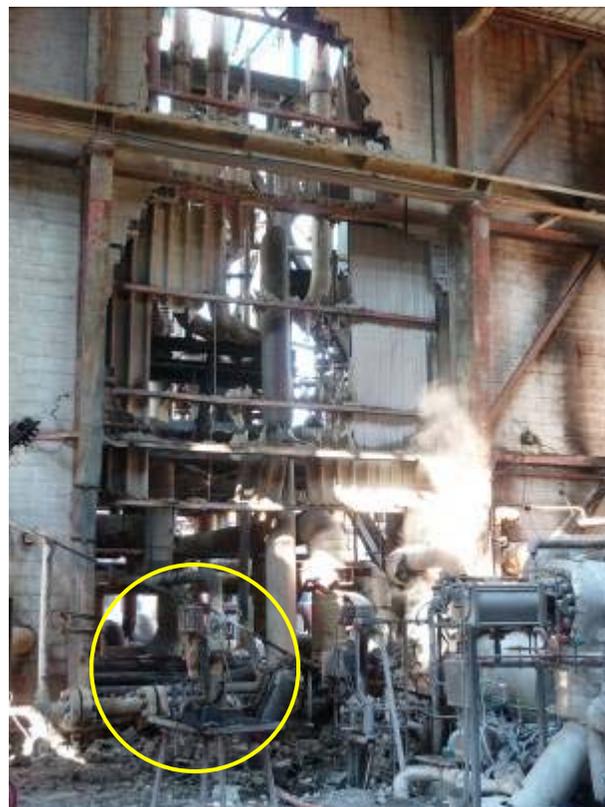
- The main compressor discharge line was apparently intact, only the small bore piping

was damaged. Two small process lines were broken (see Figure 2).

Figure 2. View of the west wall of the building in front of the compressor showing the origin of the fire

The origin of the fire was quickly identified. It was a 20 MPag (2900 psig) high pressure syn-

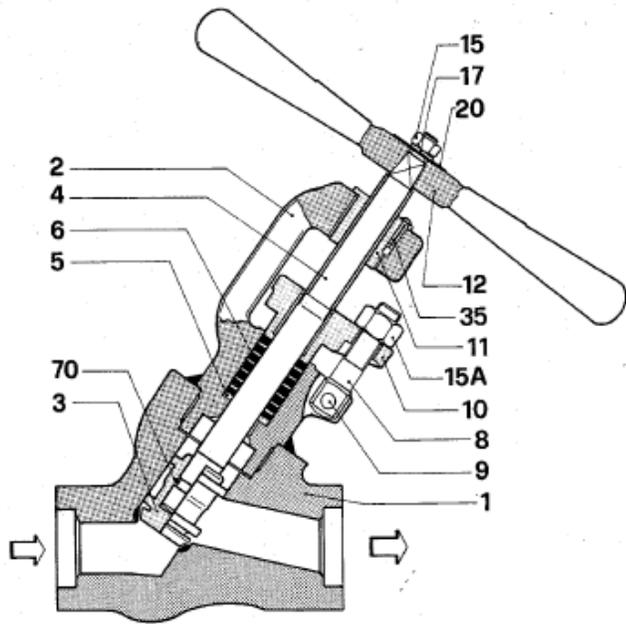
Figure 5. 1 inch welded bonnet forged steel valve, ASME class 2700 lbs

The valve was last visually inspected by the site Material Inspection Department in July 2011 (together with the main process gas line). It had been operated a couple of hours before the incident occurred. At that time no leakage or apparent defect had been noticed, except that the operators reported that the valve was unusually hard to operate.

The examination of the 1 inch valve revealed the following (see Figure 5 for reference):

- The valve had no mechanical defect.
- The graphite packing was still present and in relatively good condition.
- No component was damaged or distorted except for the stem (but this distortion was due to the valve hitting the main piping after the 1 inch pipe ruptured).
- The yoke bushing (#11) and its grooved rivet (#35) were missing.
- The thread in the bonnet was still intact, which means that the bushing was screwed off and not pushed out.

1. Grooved rivet (#35) was missing.
2. Nearly complete unscrewing of the yoke bushing (#11) during operation of the valve.
3. Rupture of the last thread as a consequence of the internal pressure rise during the normal start-up process.
4. Vibration of the stem (#4) and loss of tightness of the packing.
5. Gas leakage and ignition.

This valve was installed in 1989, and was in service for 22 years, but was only manipulated once every plant start-up. What is not known is whether the rivet had ever been present (inadequate fabrication and quality control) or if the rivet had been removed in the past during valve maintenance and not reinstalled (incorrect maintenance). Even if the rivet was not present, a large number of manipulations are necessary to obtain the complete unscrewing of the bushing, which could explain why the failure did not happen before. Only a careful examination of the valve by a specialist could reveal that this very small part was missing.

### Inspection of Manual Valves

A complete visual inspection of all manual valves on flammable gas lines was also performed. This inspection was conducted together with a valve specialist, a pressure vessel inspector, and a plant operator. A total of 1290 manual valves have been inspected as part of this program. The items reviewed in this program include the following:

Every valve has now been identified with a tag number, and a report sheet has been completed for each valve. During the initial inspection, no other manual valve was found with a rivet missing or bushing partly unscrewed. The inspection was, however, quite valuable as 187 valves were repaired and 69 valves (mainly < 2 inches) showed various non-conformities and were replaced.

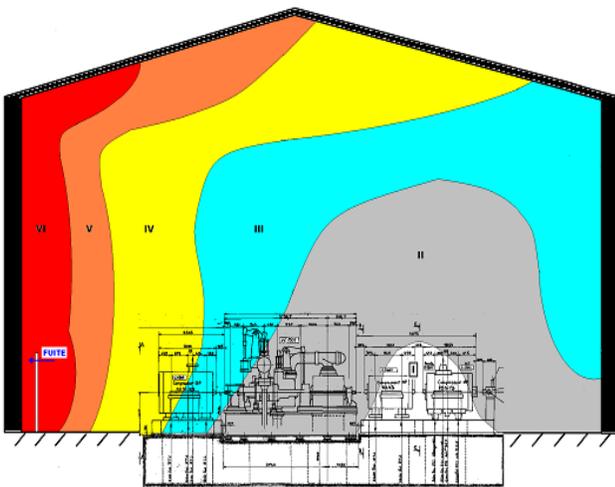
The identification of the damaged equipment has been done according to API 579-I / ASME FFS-1 2007 Fitness for Service Part 11. Based on visual inspection, cartography of the temperatures has been performed and 6 areas have been identified. These areas have been classified on the temperature that the equipment had been exposed. For each area, the nature of the controls to be done was defined, depending on the material and the design temperature of each piece of equipment.

Figure 6. Isothermal curves (side view)

In order to save time, it was decided to proactively replace all carbon steel piping and steel structures exposed to temperatures above 430 °C (areas V and VI) without further inspection.

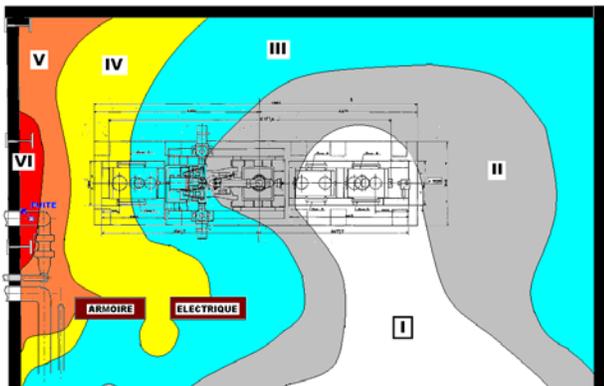
Figure 7. Isothermal curves (top view)

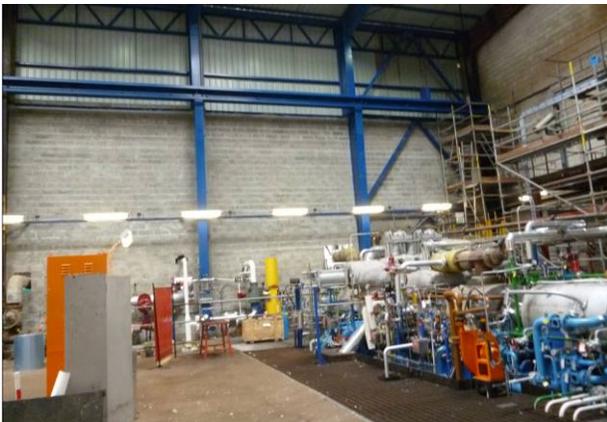
Figure 8. View of the compressor room after reconstruction

- One third of the compressor room building, from the floor to the roof, was dismantled and rebuilt, including replacement of the steel frame. During the construction work, a temporary structure was installed to hold the rest of the building together and protect the equipment from the weather.
- A complete overhaul of the synthesis gas and the refrigeration compressors, including auxiliaries, was performed. The low pressure case of the syngas compressor, which was exposed to temperatures between 200 °C and 430 °C, was dismantled and completely inspected. It showed no internal damage, and only the bearings and the gas seals required replacement.

- All electrical, instrumentation cables, and cable trays from the control room building to the compressor room were replaced. In total 40 km (25 miles) of cable was installed.
- All the synthesis gas compressor instrumentation, including sensors, control cabinets and turbine governor were replaced. A total of 210 sensors were replaced.
- The damaged piping and valves were replaced or repaired depending on the results of the inspections. A total of 150 m (500 feet) of piping (up to 40 mm, or 1.6 in thick) was replaced.

The total cost of the reconstruction and repair was 5.3 million € (\$6.9 million USD). Of this total, 3 million € (\$3.9 million USD) was paid by the insurance company. Figure 6 shows the reconstructed compressor building.

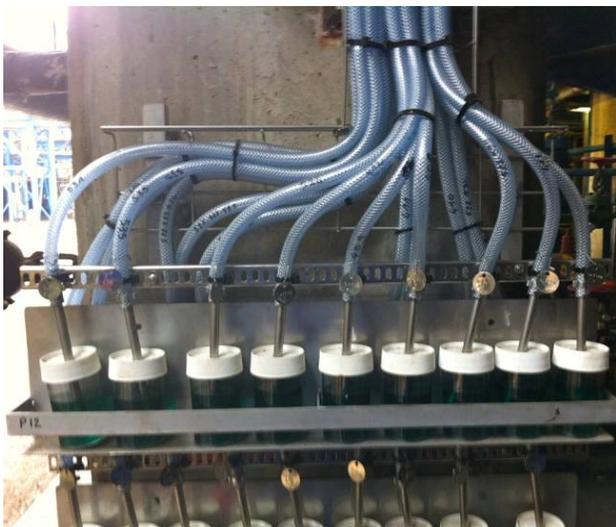
*Figure 7. Example of leak detection system on high pressure flanges (each individual vinyl hose is connected to a flange, and identified*

*with a metal tag. The tag number is referenced on the plant drawings).*

- High pressure flanges leak detection - each high pressure flange on the synthesis gas compressor and on the synthesis loop has been fitted with a leak detection system consisting of a closed box, with a vinyl hose connected to a bubbling bottle. Operators can immediately identify a leak during their rounds. A total of 509 flanges have been equipped with such a system (See Figure 7).
