Oil contamination
at
Khorasan Petrochemical Company, Iran

Majid Mohammadian
NPC PIDEMCO
Iran

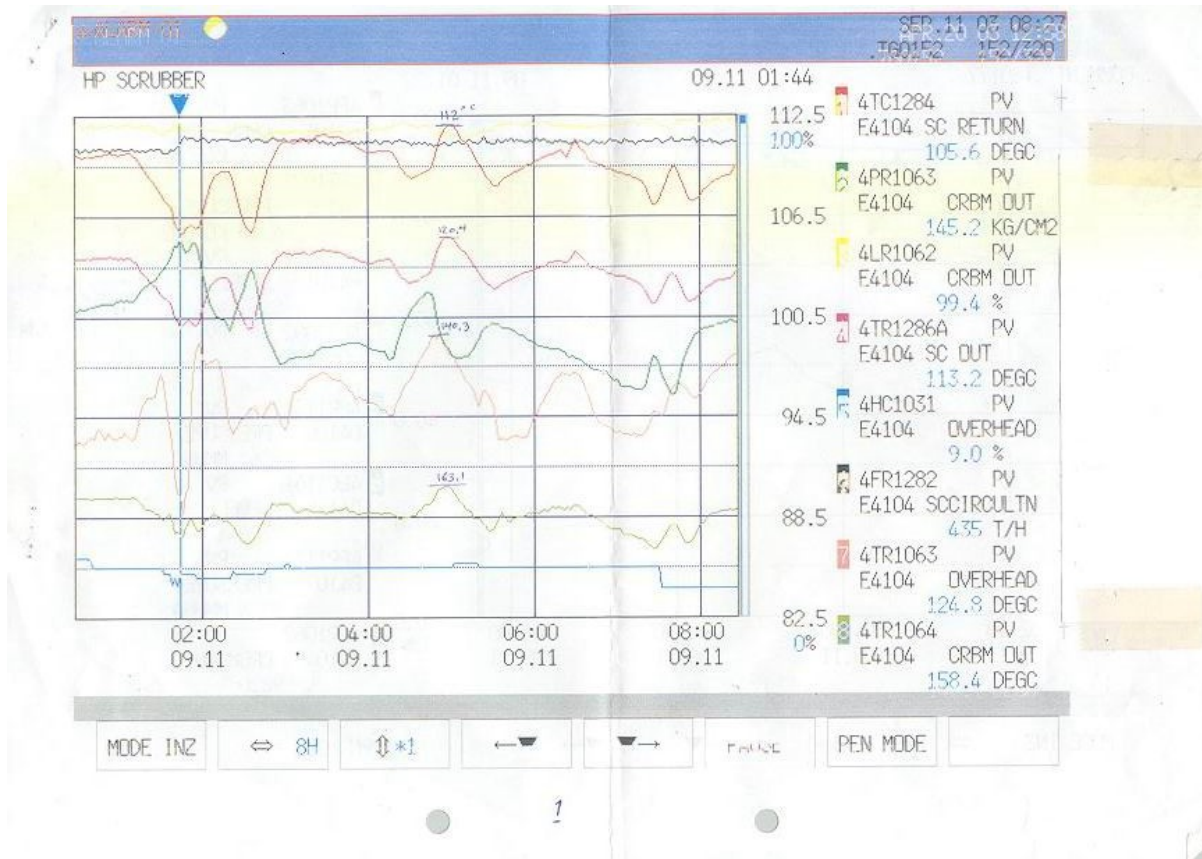
Graph 1: Trends of important process parameters part 1.

Graph 1 shows:

- Increase of synthesis pressure (4PR1063)
- Decrease of HP scrubber gas outlet temperature (4TR1063)
- Decrease of tempered cooling water loop temperature (4TR1286 and 4TC1284)

The increase of synthesis pressure and the simultaneously decrease of the HP scrubber gas outlet temperature including the decrease of the temperature of the tempered cooling water loop of the HP scrubber brings up the idea of a partial blockage of the outlet gases of the HP scrubber. We know that this blockage can occur at lower N/C ratios (figures of 2.7 and less) but at that time the synthesis ratio was about 3.2, so the blockage in outlet pipe of HP scrubber was firstly rejected.

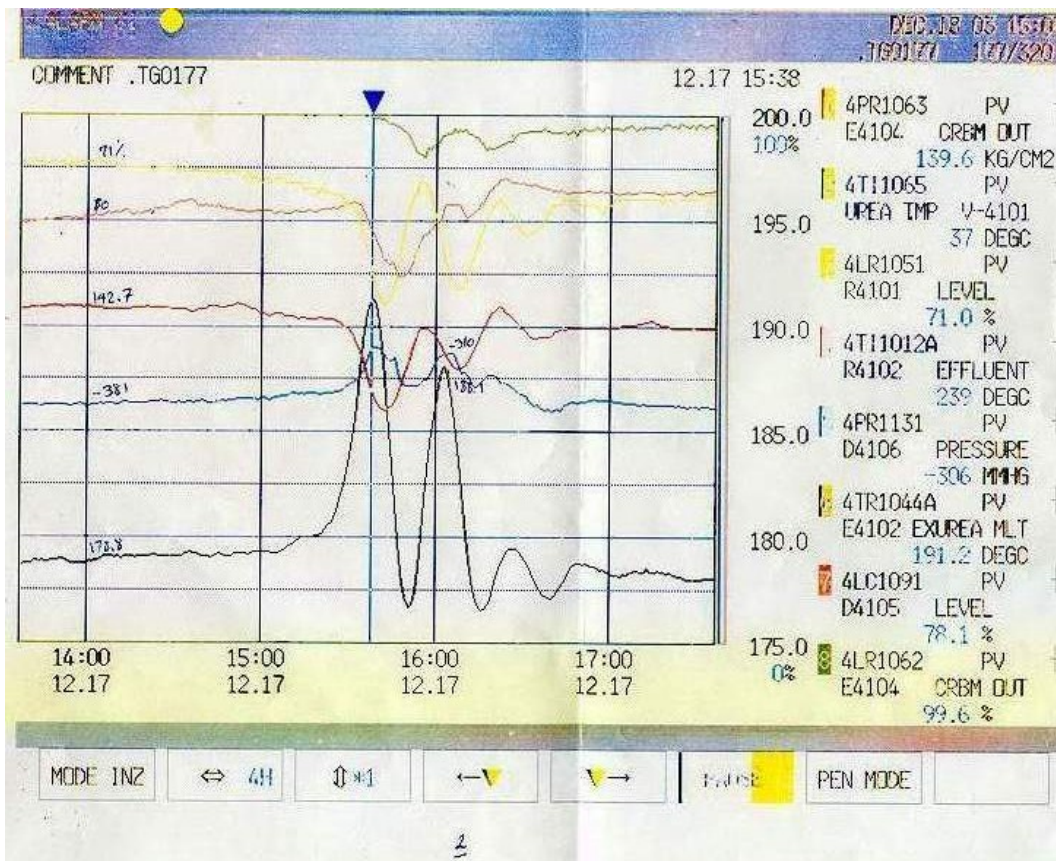
Graph 2: Trends of important process parameters part 2

The liquid outlet temperature of HP stripper (4TR1044A) increased from 178°C to 191°C as can be seen in Graph 2.

Graph 2 also shows that the increase in the liquid outlet temperature of the HP stripper happened at the same moment as a sharp decrease in the reactor level (4LR1051).

We know that a high temperature of the stripper liquid outlet can be caused by one of the reasons:

- High steam pressure in shell side of the HP stripper
- High liquid level in the bottom of HP stripper
- Disturbance in liquid film of the stripper tubes

The third one must have happened in our case because the HP stripper liquid level and shell side steam pressure were constant at that time.
