Leak Detection Systems in Urea Plants

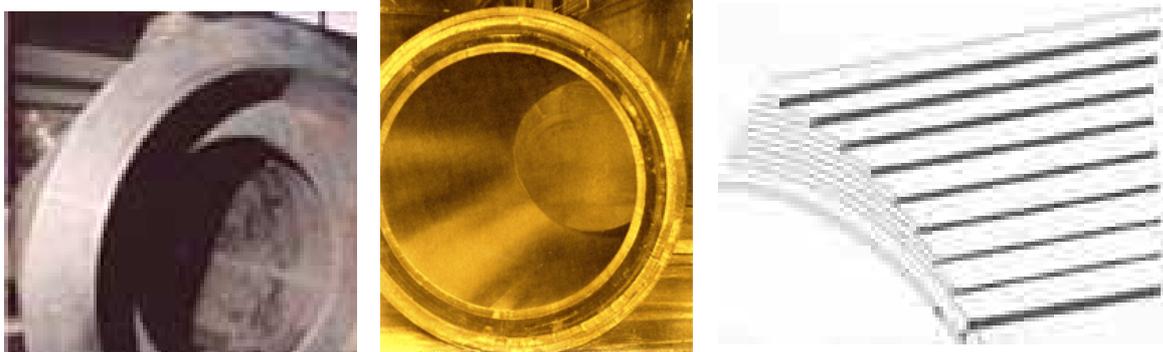
The function of carbon steel part is to resist the high pressure at which the process operates. The carbon steel wall can be typically a solid wall type, multi wall or a multi layer type.

Pictures: mono wall (left), multi wall (middle) and multi layer (right)

In these pressure vessel walls leak detection holes are drilled to be able to detect a possible leak. Be aware of the fact that in a multi layer also weep holes are drilled; that might lead to confusion.

These weep holes are blind holes drilled in the multilayer and serve during the fabrication and allow the pressure vessel to breath during operation.

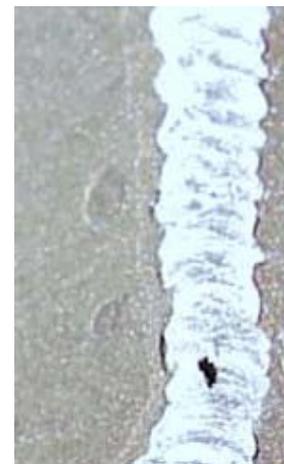
Crevice corrosion typically occurs in liner welds or in welds of the clips of internals to the liner. For example clips of trays in a reactor or gas/liquid dividers in heat exchangers. Many times the wormhole is a sub surface defect and is not detected during the fabrication process. However after a certain period of operation and after some passive corrosion the worm hole opens and carbamate can enter the worm hole (crevice). In the crevice no refreshment of oxygen is secured, the oxygen gets depleted and active corrosion with higher corrosion speeds starts. Another area for crevice corrosion risks are in cracks which can be a result of heating up and cooling down cycles.

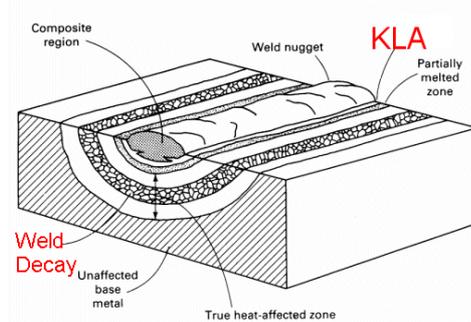
Knife-Line Attack is a form of intergranular corrosion, razor sharp and present between the weld and the liner. The attack appears razor-sharp and hence the name of "knife-line" attack.

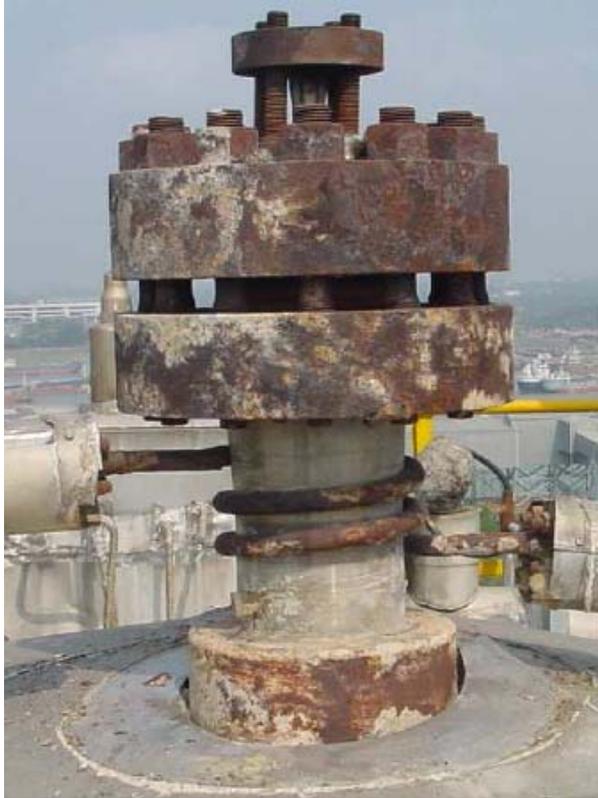
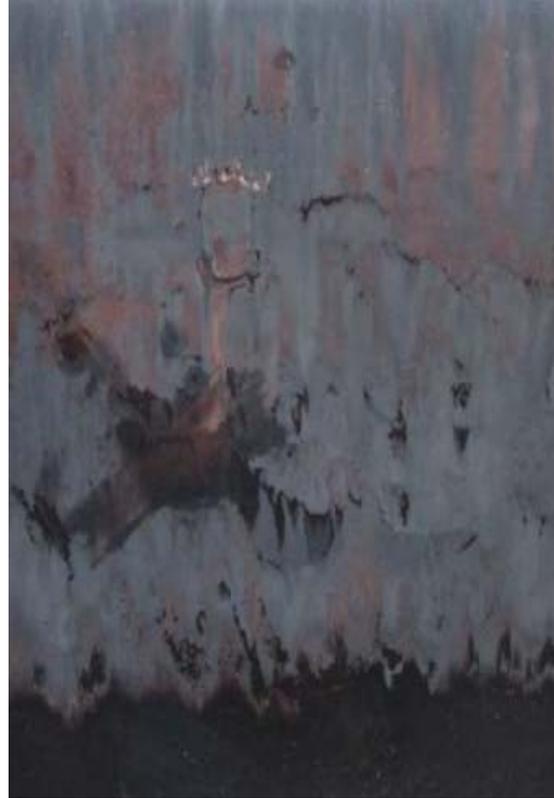
Pictures: Bad insulation of a nozzle (left) can cause condensation corrosion (right)

However when condensation of gasses occurs in the gas phase a carbamate liquid will form in which no oxygen or hydrogen peroxide is present. Due to the lack of oxygen the passive layer on the liner will not be maintained and active corrosion of the liner starts.

Thus the areas in High Pressure equipment vessels where a gas phase is present during normal operation are critical for this type of corrosion. These parts of the vessels should be traced and well insulated.

Condensation corrosion will occur in the gas phase at locations where a cold sink is presents (nozzles, man way covers, lifting lugs, stud bolts) and/or where the tracing and insulation of the vessel is not in good condition.

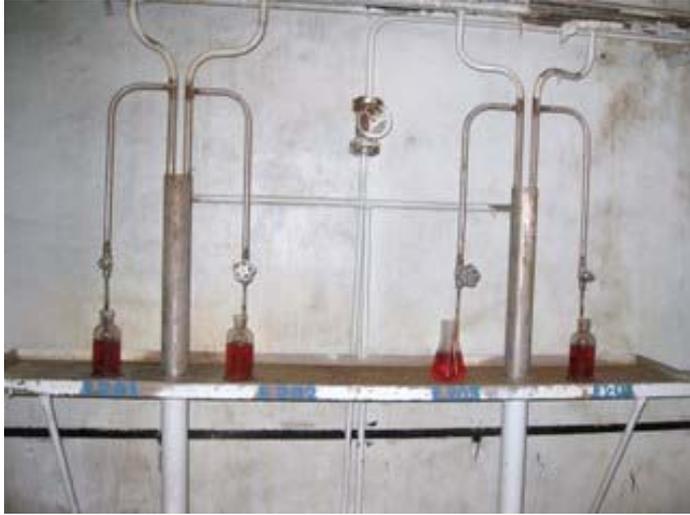
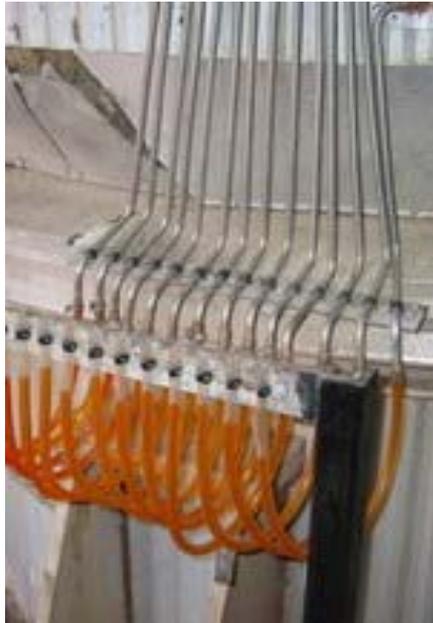
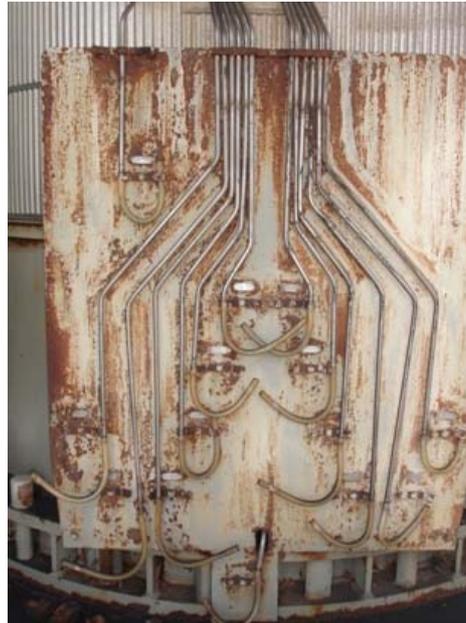
Pictures: Different Leak detection systems

Second the visible part of the leak detection system differs also from one plant to the other: some plants flush with air, others with carbon dioxide, again others with steam and some even wait until fumes exit the leak detection tubes, some use as an indicator of a leak a bottle with phenolphthalein, others an ammonia detector and again other measure the conductivity.

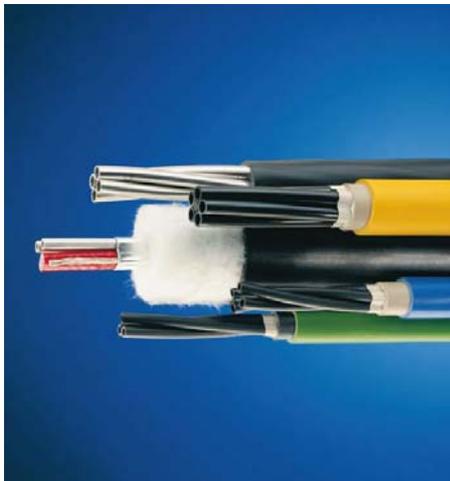
The use of traced sample line bundles might be a good alternative, like shown in the picture below.

Picture: Traced sample lines

It is important as indicated here above to avoid condensation of vapors in the leak detection lines. So it is advisable either trace (minimum temperature should be the crystallization temperature of carbamate 153 °C) and insulate the lines or install the lines below the insulation of the HP equipment. Both options have their disadvantages but the choice not to connect the leak detection tubes to a leak detector and rely on visual detection of leaks is in my view not acceptable.
