Case histories of
ATMOSPHERIC CORROSION
In Ammonia & Urea Plants

NTT Consultancy
Giel Notten
Senior Corrosion Engineer

Case 1: Rupture of carbon steel HP CO₂ line in Urea plant

Case 2: Serious external (crevice) corrosion behind clamp in carbon steel HP ammonia spill back line

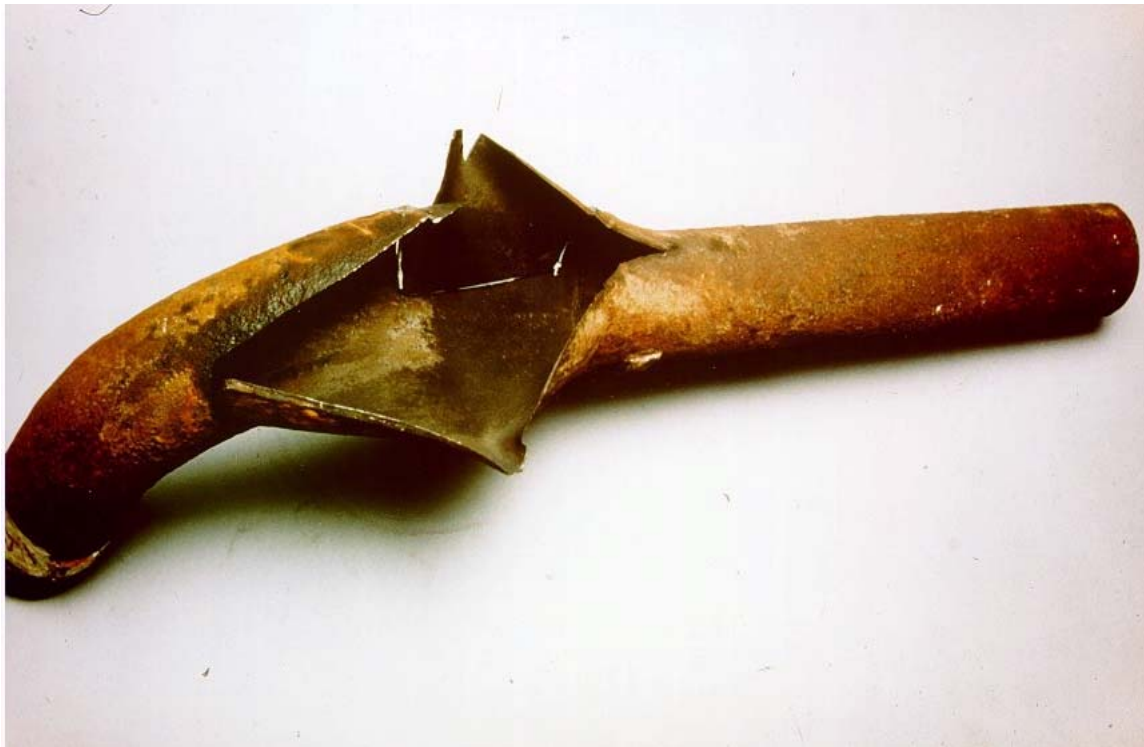
Photo 1 shows the ruptured high pressure carbon steel pipe. Rupture was caused by severe external overall corrosion and crater type attack. At process (CO₂ gas) side no corrosion was observed. The insulated pipeline was not coated.

Photo 1: Atmospheric corrosion in HP CO₂ pipeline from urea plant.

Rupture of the carbon steel HP CO₂ line was due to corrosion under insulation.

Insulated carbon steel at concerning temperatures of 70 °C has to be protected by a coating system.

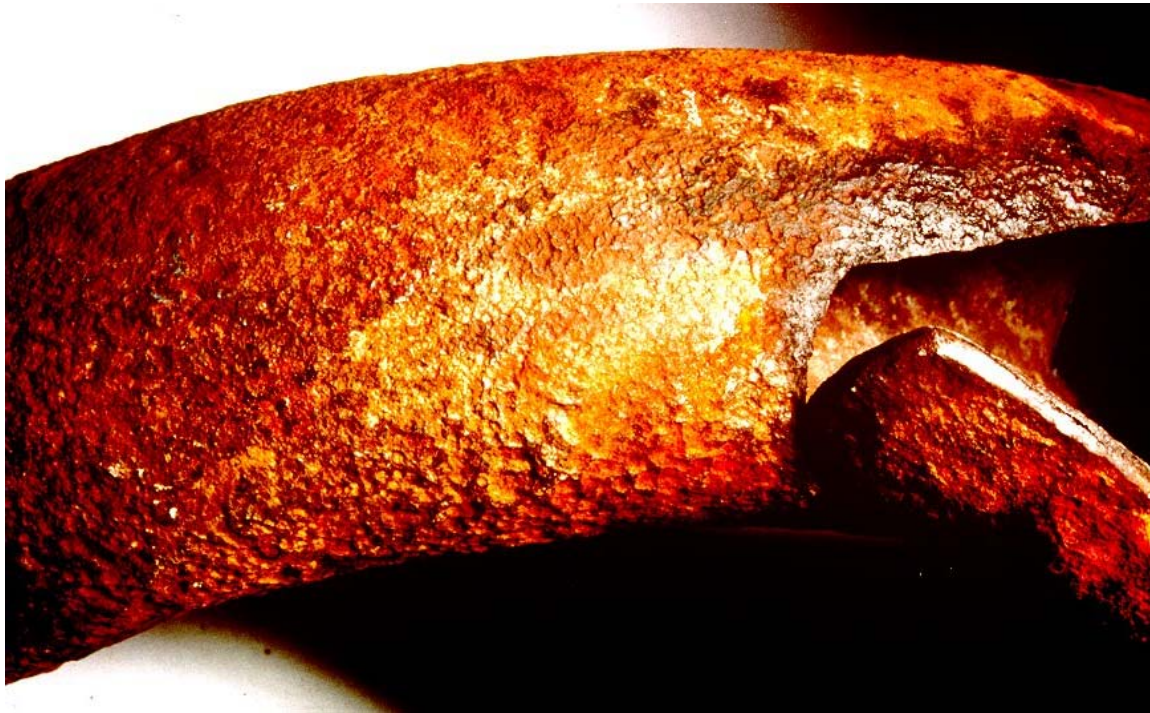
Photo 2: Crater-like attack

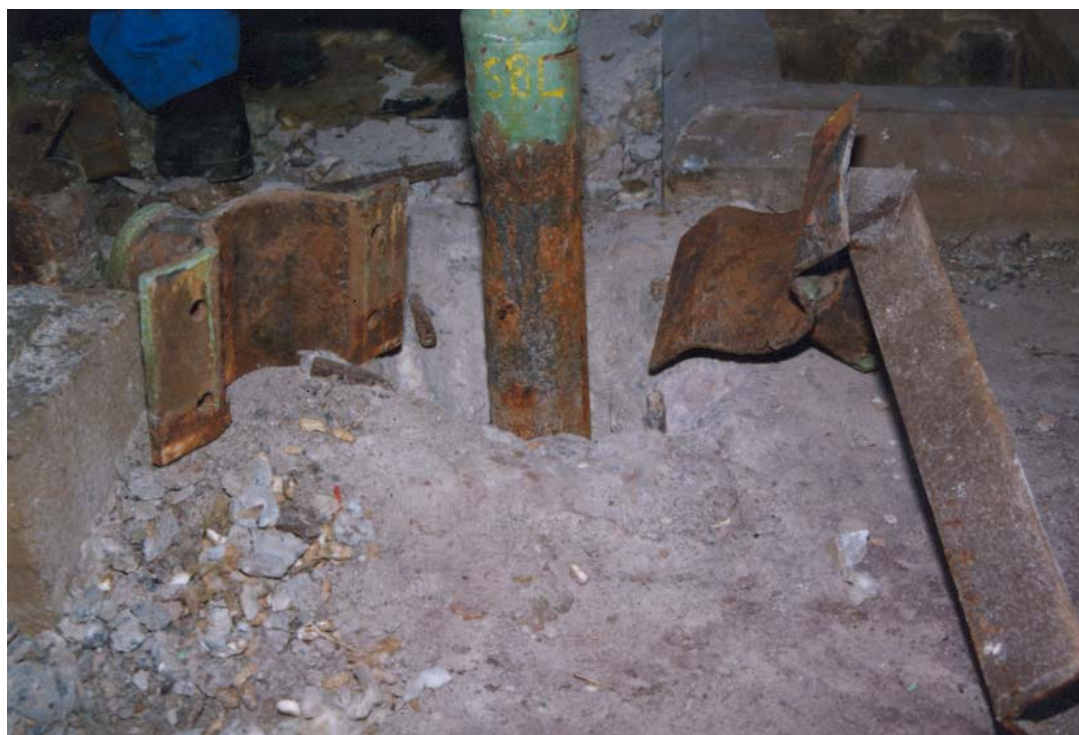
The corrosion occurred in a crevice between a clamp and the carbon steel high pressure line at location of a run through a concrete floor.

Due to the severe crevice corrosion the wall thickness was decreased from original thickness of 11 mm to locally 6 mm. The thickness required for strength was already trespassed; probably rupture did not yet occur as a result of presence of the clamp around the pipeline.

The severe crevice corrosion could occur due to flush water used for flushing the concrete floor.

Photo 3: Crevice corrosion at carbon steel ammonia spill back line

- The severe decrease in wall thickness of the ammonia is due to crevice corrosion in the area of the clamp; at this location no protective coating was applied.
- The corrosion occurred as a result of wetting during flushing the floor.

- Apply a protective coating system on the pipeline also in the area of the clamp
- Apply a glass fibre tape between the pipeline and the clamp
- Avoid wetting of the pipeline during flushing the floor.

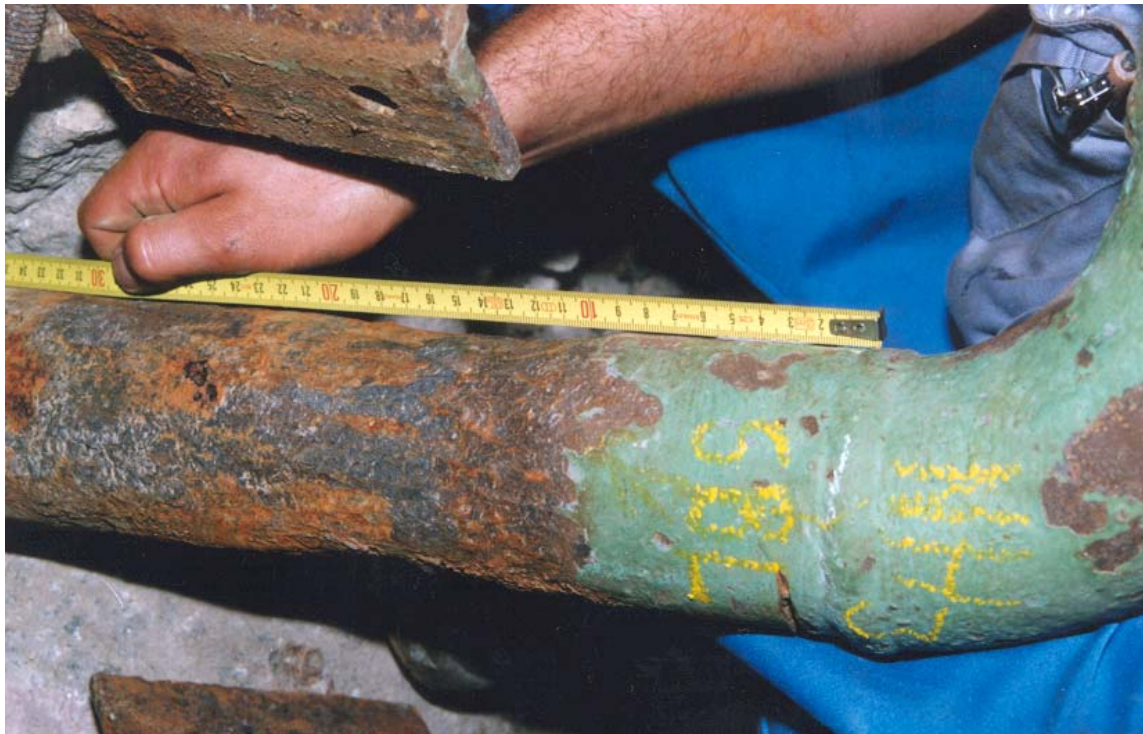
Photo 4: Severity of external corrosion at carbon steel ammonia pipeline
