Rupture of HP urea reactor due to external Nitrate Stress Corrosion Cracking

NTT Consultancy
Mr. Giel Notten
Senior Corrosion Engineer

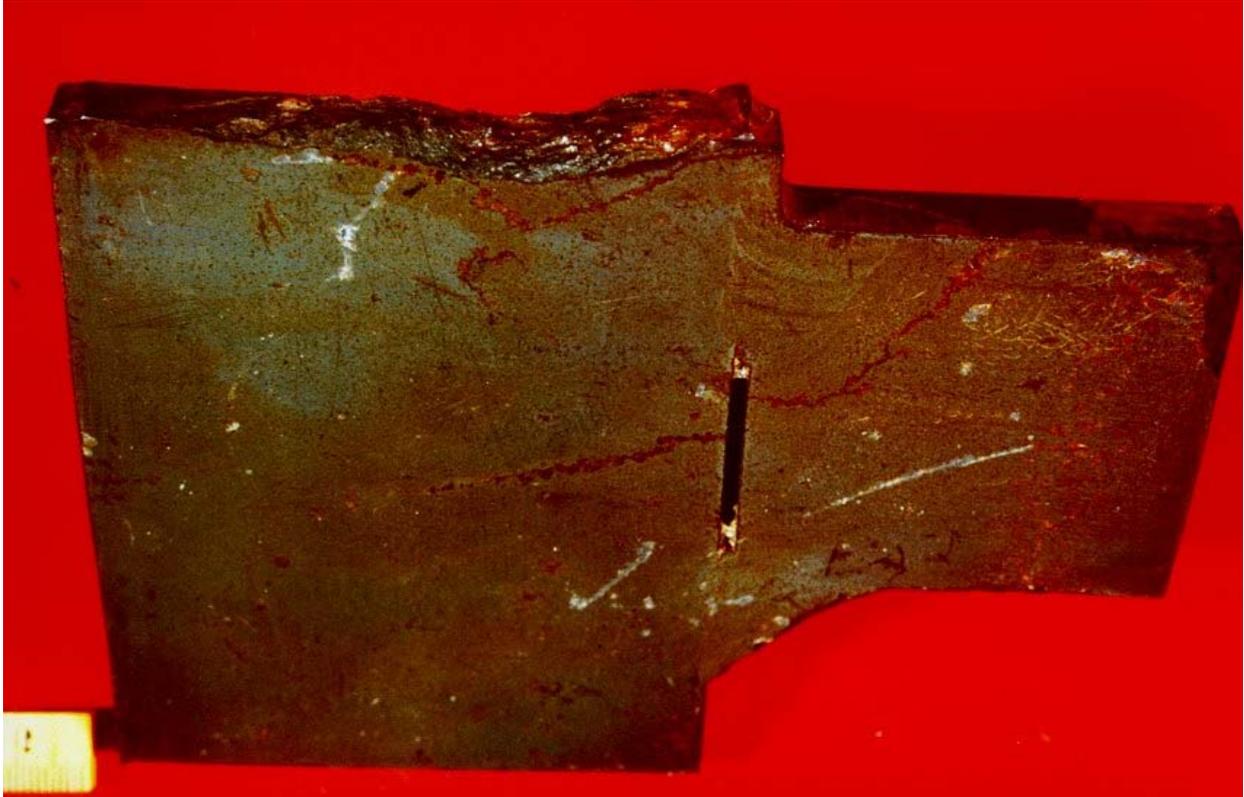
During start up after a turnaround a rupture occurred in a high pressure reactor of a conventional urea plant. The on-stream time of the reactor was about 15 years. The fracture surface in a segment out of the reactor is shown in Photo 1.

Photo 1: Fracture surface in segment out of the wall of a ruptured HP reactor of a conventional urea plant

Microscopic examination did show clearly that the rupture was caused by branched, intergranular cracking. Analyses of the salt deposit present on the wall of the reactor revealed presence of some 3000 ppm nitrates.

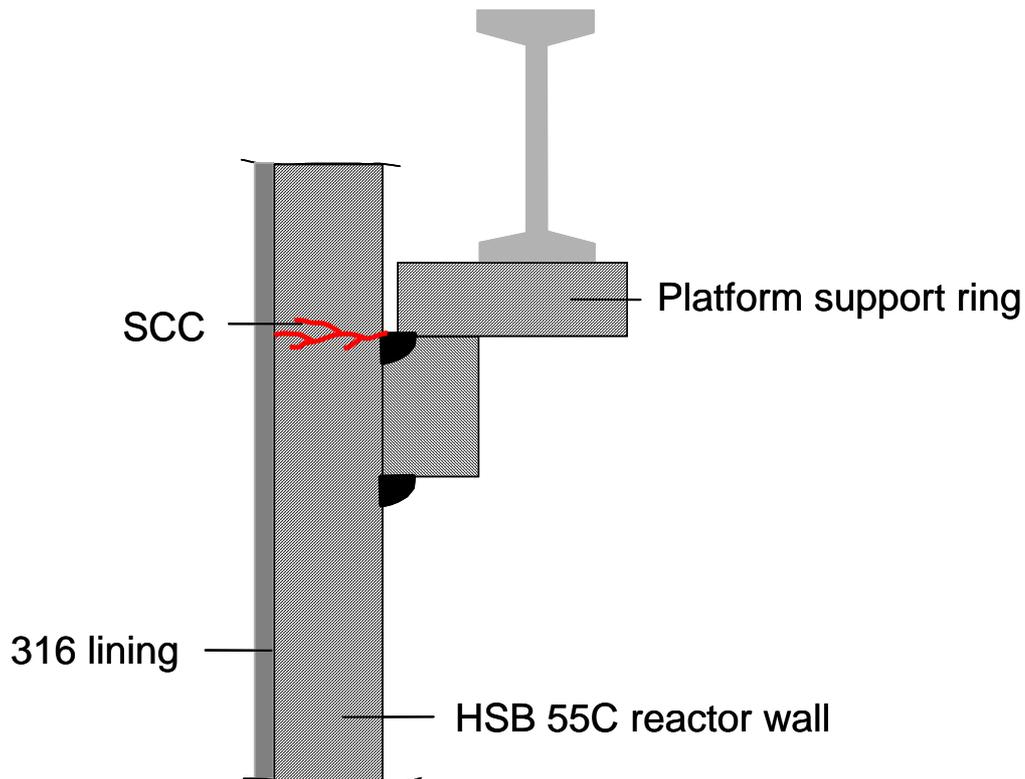
The construction detail in Figure 1 illustrates that the cracking occurs at location of presence of a platform support ring where penetration of rainwater is likely to occur.

Figure 1: Construction detail of HP urea reactor vessel.

- The rupture of the HP urea reactor vessel is caused by nitrate stress corrosion cracking.
- Rainwater with traces of nitrates could penetrate the insulation cover sheeting at location of the platform support ring.

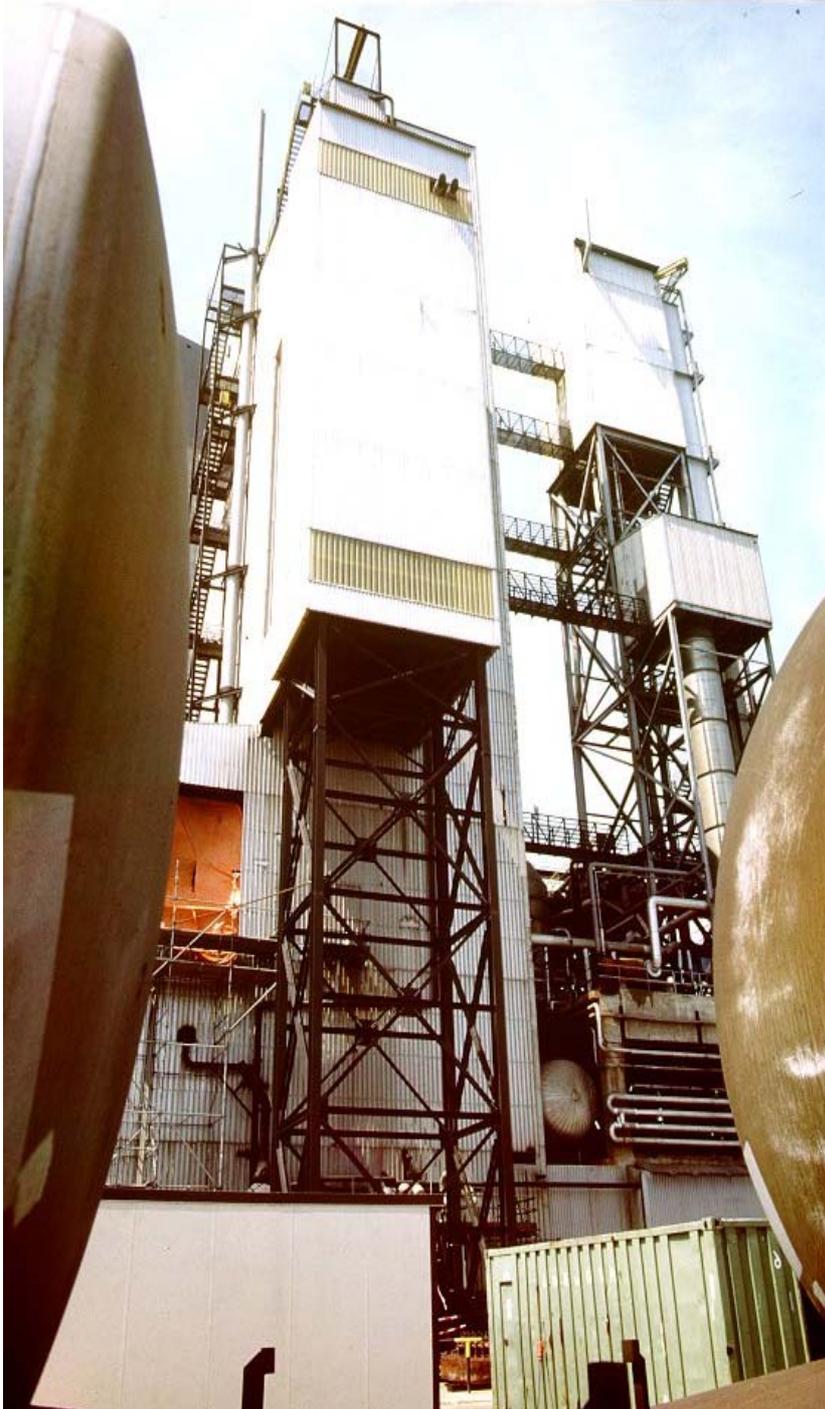
Photo 2: Indoor design of HP equipment of urea stripper plant by means of aluminium cabins

- Avoid penetration of nitrate containing rainwater through the aluminium cover sheeting by proper application of cover sheeting.
- Apply a protective coating system or change from outdoor equipment to indoor equipment by construction of aluminium cabin around equipment as shown in Photo 2.
