# Erosion-corrosion of carbon steel in wet steam

W. M. M. Huijbregts \*

Materials Performance October, 1984, pg 39-45

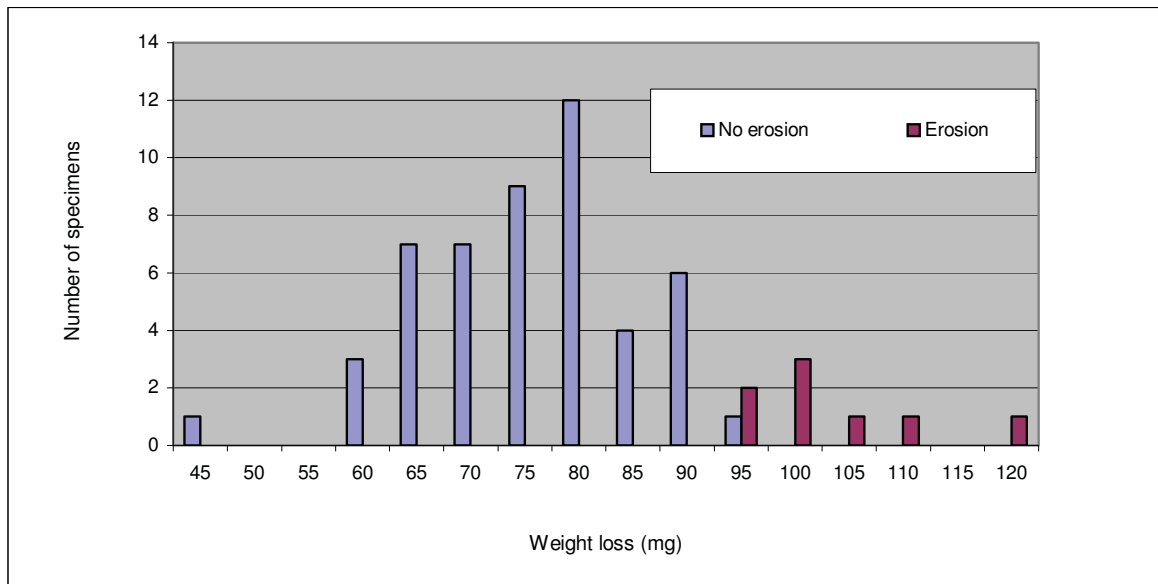
Figure 3 - Frequency distribution of measured weight losses after exposure- Full black indicates that the specimens were obtained from in-service failures because of erosion-corrosion.

Detailed chemical analyses were conducted for all steels. The analyses were all done in the same way by the same staff. Compositions and weight losses after exposure are given in Table 1. The table shows higher weight losses with a decrease in Cr, Cu, and Mo content. The frequency distribution of weight losses is given for the three steel categories in Figure 3: the in-service failures are shown in full black.

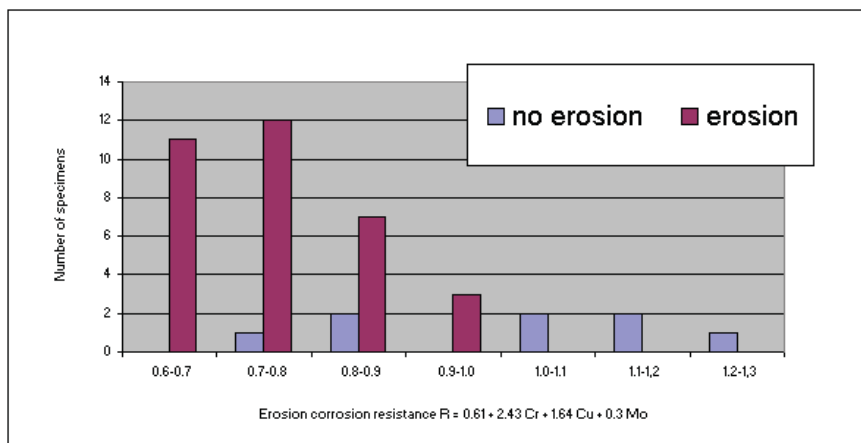
Figure 4 Frequency distribution of the calculated erosion-corrosion resistance R for the steels from the in-service failures. • R erosion-corrosion resistance  $R = 0.61 + 2.43Cr + 1.64Cu + 0.3Mo$

Table 2 gives a survey of the cases, and Figure 4 shows the frequency distribution diagram.

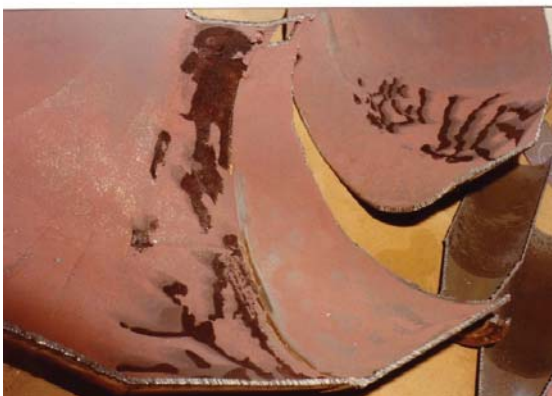
**Cases 6, 7, and 8.** A pipe behind the BWR water separator was constructed by welding bent steel plates (Figure 5).

Figure 5 - Case 6: The wet steam pipe after the pre-water separator. The pipe was welded of bent steel plates. One plate had been corroded severely ( $R = 0.67$ ). The adjacent noncorroded plates had higher resistances ( $R = 0.89$ ).

One of those plates had been attacked severely (specimen 56). The other plates, both upstream and downstream, had not been attacked (specimens 21 and 25). The corroded plate showed a different chemical composition. The resistance of this steel was 0.67, whereas the values of the non corroded plates were much higher, 0.89.

The low and high pressure water separators, the prewater separator and the wet steam tubes in the BWR were replaced by stainless steel components in the last few years, before the erosion-corrosion tests were finished.

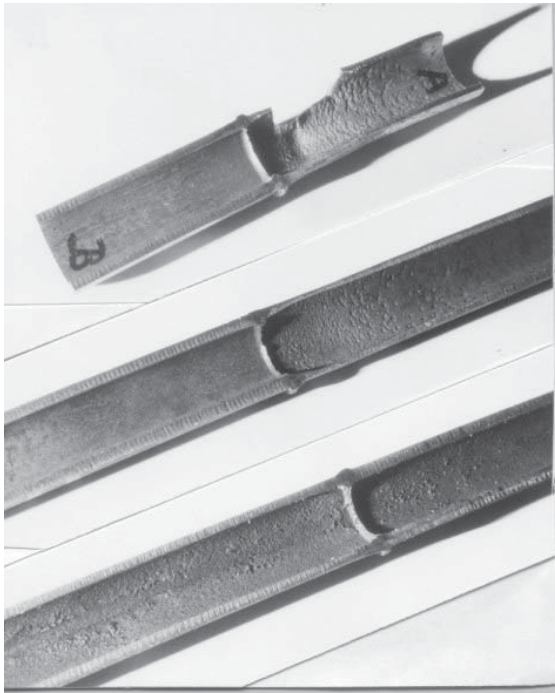
**Case 11.** In a high pressure preheater, erosion-corrosion was found downstream behind several butt welds (Figure 7). The inner diameter of the 15Mo3 steels amounted to 20 mm, and the weld heights for the three tubes were 1.8, 1.55, and 1.7 mm. The removed tube parts, upstream of the butt welds, had good erosion-corrosion resistance, while the downstream parts had lower values. Two tubes were corroded severely, one having had a leakage. One downstream tube, however, did not show corrosion visually, and this steel contained more Cr, Cu, and Mo.

*Figure 7 - Case 11: Tubes from the high pressure pre-heater. Erosion-corrosion downstream from the butt welds: (a) leakage ( $R = 0.81$ ), (b) erosion-corrosion ( $R = 0.84$ ), and (c) no erosion-corrosion ( $R = 1.01$ ).*

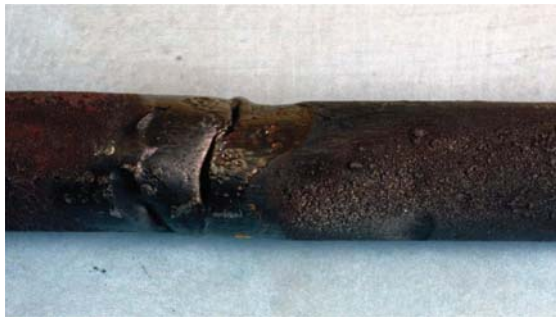
**Case 13.** The preheater of a power station suffered local corrosion near the support plates (Figure 8). Coarse magnetite crystals were found adjacent to the corroded area. Scanning electron microscope photographs of these crystals are shown in Figure 9. Precipitation of such coarse iron oxide crystals is often observed with erosion-corrosion.

*Figure 8 - Case 13: Erosion corrosion of preheater tubes near support plates. Coarse crystalline magnetite was found ( $R = 0.93$ ) next to the erosion-corrosion place.*

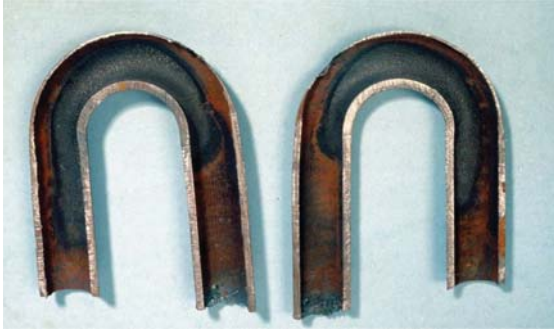
**Case 17.** There was heavy erosion-corrosion in the economizer tube bends of a waste-heat boiler (Figure 11). Steaming occurred in the economizer. This could also be concluded from some damaged tube surfaces where erosion-corrosion occurred on the outer radius and steam blanketing occurred on

the inside. The water film had come loose from the inner radius surface where coarse magnetite crystals had formed. Sample composition shows the erosion-corrosion resistance of this steel to be low, this being one of the causes of the leakage ( $R = 0.68$ ).

Figure 11 - Case 17: Erosion-corroded tube from a steaming economizer ( $R = 0.68$ ).
