CO₂ pressurized box-up A new technique to averting shutdowns on corrosive service leakages

MUHAMMAD IDREES, MEER SALMAN MUDDASAR
Engro Fertilizers Ltd
Pakistan

This paper is presented at the Nitrogen & Syngas Conference 2013 in Berlin.

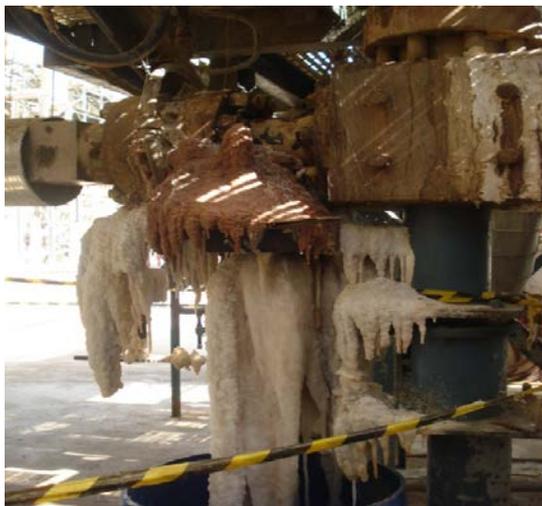
Fig (ii): Solid Carbamate mass encapsulating

Deposit mass helped in containing the leakage for some time, as it sealed the flange. In the meantime, various options were explored to avoid evident shutdown of urea plant.

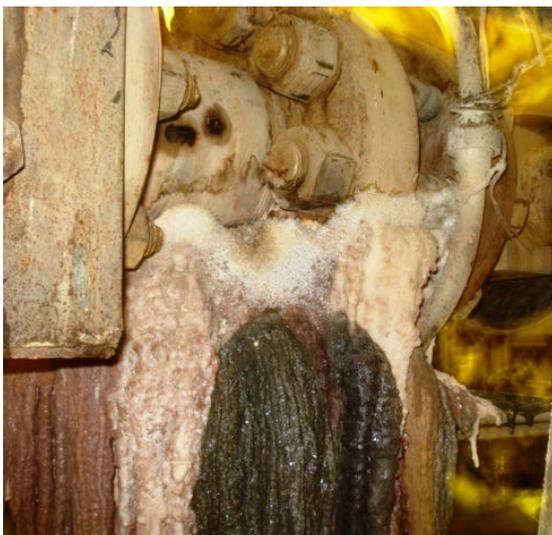
Fig (iii): Carbamate deposition with air sparge

An air sparge was installed along the flange to cool the carbamate mass and transform it into solid pile that will frame the flange and will hold the carbamate seepage. This suggestion seemed to be working since after installation of air sparger, carbamate rock formed outside CS flange and contained the solution from coming out. Obviously, the leakage of NH₃ and CO₂ to the atmosphere was stopped due to crystallization of ammonium carbamate. However, this was not a guarantee that the flange leakage had stopped. There was a real risk that behind the crystallized product (crevice) corrosion was continuing. Beside the crevice corrosion at the stainless steel gasket area it could not be excluded that corrosion was occurring at strength bearing carbon steel flange which might have introduced a higher risk, so the air sparge was removed. In the interim, world renowned corrosion and material experts were contacted to give their verdict so that more than 90 hours of production loss can be saved. International experts and vendors suggested going for immediate shut down of the plant to avoid catastrophic failure of liquid out flange of high pressure urea stripper. It was in May 2012 when situation aggravated and fumes started coming out of flange with leak extent rose to 100dpm.

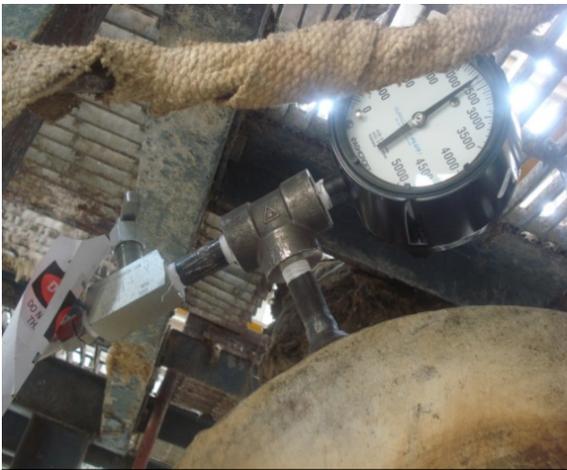
Fig (v): Pressure Indication for Positive

In order to provide an immediate health check of high pressure box up, the drain bleeder was kept slightly opened, so that CO₂ coming out of it could be hand-felt all the time, endorsing that positive pressure than process side had been maintained inside and ensuring that leak is properly sealed. Also a pressure indicator was installed on HP box up to log pressure delta between CO₂ pressure in the box-up and pressure of stripper outlet stream. This delta was another check that leaking point is intact. In case, the delta had reduced that would have indicated the extension of leakage point and hence the extent of leakage.

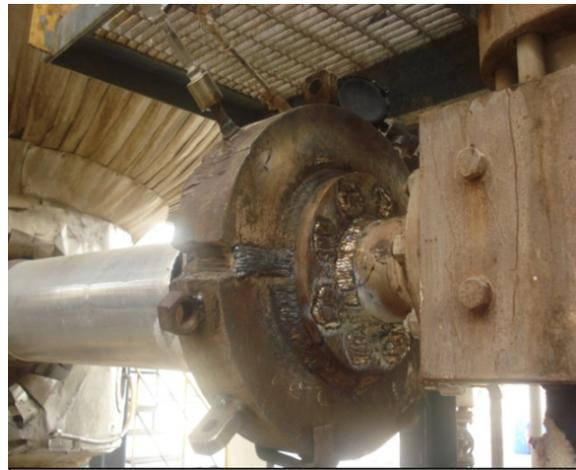
Fig (vi): Commissioned CO₂ high pressure box up

The Operations team refused to give up to the situation and strived to resolve the issue. Various brain storming sessions were kept on going during this course to bring out-of-the-box solution that eventually, came in with the form of pressurizing the CS box up with a gas having a pressure higher than that of the process, sealing the surface from direct corrosive mass attack. In-house fabricated carbon steel box up was finally decided to be installed over flange with high pressure CO₂ establishing an interfacial layer to avoid direct contact of carbamate mass with carbon steel metallic interface, due to CO₂ pressure higher than that of carbamate inside stripper. Thorough safety reviews & hazard analysis were carried out. Box up was fixed after rigorous welding activity of around 20 hours. Bolts of flanges were grinded and seal welded (refer to fig-vii).

NDT techniques were used to verify the integrity of the box-up. Ultrasonic testing (UT) technique was used to identify CS shell thickness loss. This was the online test that could predict the impact on CS shell.

Throughout the six months, zero thickness loss was reported by inspection team, as this was the sign of no deterioration of CS shell.

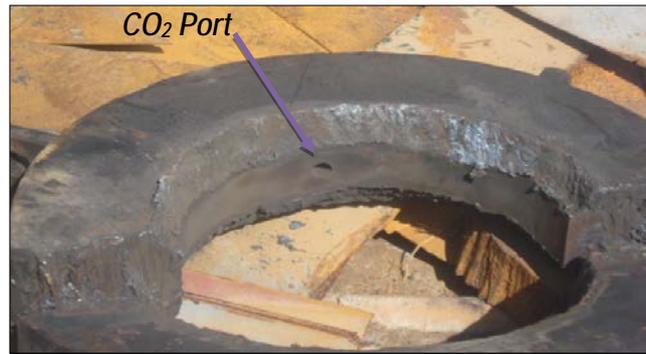
Fig(viii): High Pressure Box-Up (Internal Metallic Surface)

Plant remained operational for 6 months till the turnaround, during which CS box up was removed. Internal surface showed no evidence of internal grooving or corrosion on the exposed part.

It was revealed that the internal surface was smooth, with no internal grooves or pitting indications from the seam. Also the metallic color was intact with no corrosion clue through visual inspection.

Box up was removed, by cutting and grinding, as it was welded over the spool.
