Cleaning of Urea Strippers and Recirculation Heaters

Removal of deposits greatly enhances efficiency and capacity

Urea Stripper Cleaning Project:

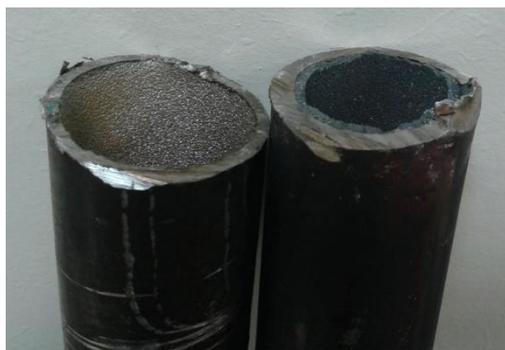
Photo 1 – typical fouling of the Urea Stripper

A typical deposit in the Urea Stripper and Recirculation Heater consists of ferric oxide (hematite) with admixtures of nickel, chromium and molybdenum oxides and is generally blueish/grey to black in color. This deposit causes reduced heat transfer resulting in a reduction of production process efficiency. Over time this will result in a decrease of production capacity as these become the “production-bottleneck”. To ensure sufficient production efficiency and capacity, it is required to periodically clean the Urea Stripper and Recirculation Heaters.

The total amount of iron-oxides removed was 1,800 kg as iron. The cleaning result was more than satisfactory and the loss in production was totally nullified after the commissioning of the plant. Photo 1 shows the typical fouling of the Urea Stripper in the bottom part of the tubes (blueish scales).

At a urea plant in Roemenia, Vecom performed a Urea Stripper cleaning. The Urea Stripper was fouled to the point that it was reducing the stripper efficiency and significantly limiting the plant capacity. Based on the estimated amount of iron oxide scaling and the design parameters, Vecom calculated the amount of EDTA required.

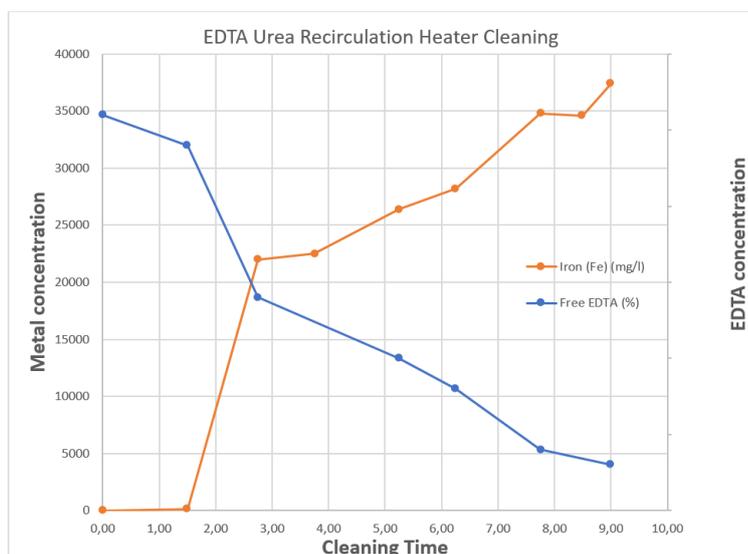
The graph below depicts the progress of the cleaning session performed in The Netherlands.
