# Helium Leak Detection in High Pressure Urea Reactor

Oman India Fertilizer Company

Oman India Fertilizer Company was commissioned in April 2005. The performance in the first ten commercial years of operation has been very good and the entire envisaged project target has been accomplished. This paper discusses high pressure reactor liner leakage issue in Urea-I unit. Leakage location could not be traced by conventional methods until OMIFCO strove for helium leak detection.

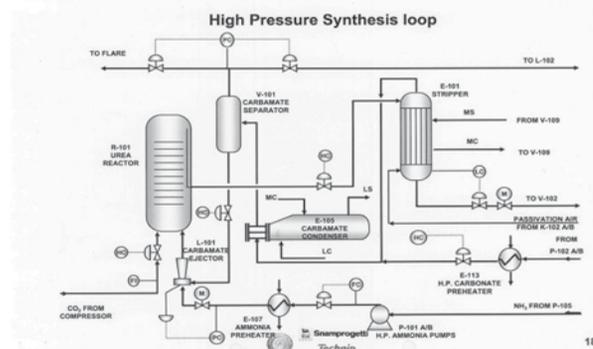
Fig. 2: (Urea HP Process Diagram)

where the liquid Ammonia acts as a propellant for the high pressure Ammonium carbamate solution. CO<sub>2</sub> gas from compressor discharge at 158 bar and at 104!C temp enters into the Reactor.(Figure-02)

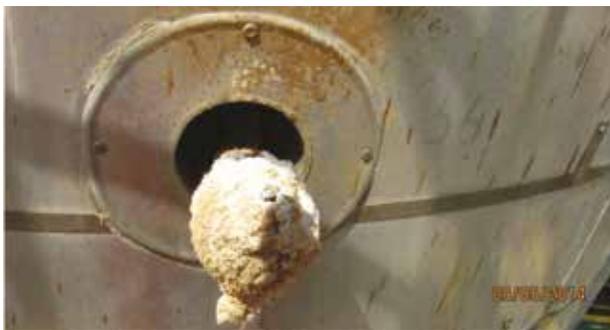
In Urea-11 unit during the plant shutdown inspection on 9th May 2014, a crystallized urea product is observed at the end of weep hole No.-56. This was the clear sign of leakage of the liner in progress during the operation of the plant. Also the same is confirmed by the lab reports. It was decided to ascertain the leakage location. No indication noticed on C-seam, L-seam & cleat joints by visual inspection & D.P. Testing corresponding to weep holes. (#55, 56, 23 & 24)

Fig. 3: (Leakage through Weep hole)

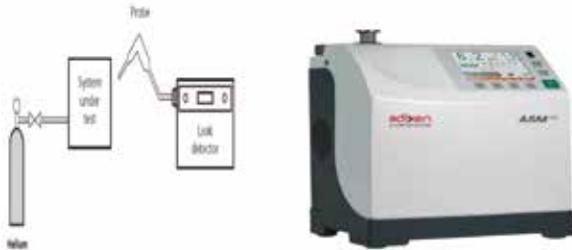
In Pressure Testing, the part is pressurized with helium or a mixture of helium and air. To Locate a Leak, the potential leak sites of the part are scanned using a Sniffer Probe connected to the inlet of the leak detector.

Figs. 4&Fig 05: (Testing Machine)

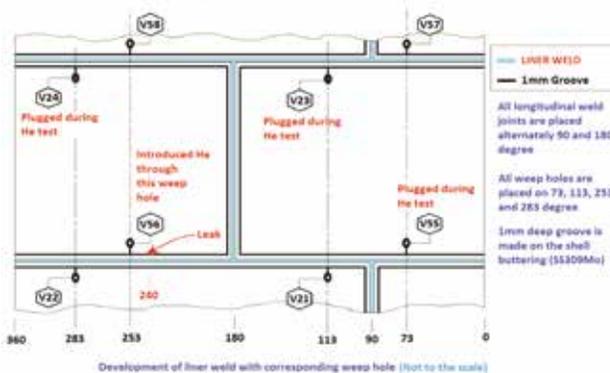
It was decided to perform helium leak detection using Sniffer probe method. Suspected area circumferential seam # 7, 8, interconnecting long seam & cleat joints are masked with polythene sheet divided into a number of segment and edge of polythene sheet is sealed with suitable tape. This polythene envelope over leak susceptible area segment acted as a reservoir for accumulating leaking helium. Thus helium concentration in the envelope would increase with holding period and probability of detection of minute leakages is increased. Instrument air is injected to dry the annular space then Helium was instilled through weep hole no. # 55 & 56 (weep hole no. # 23 & 24 kept plugged).

Fig. 6: (Liner Weld Area)

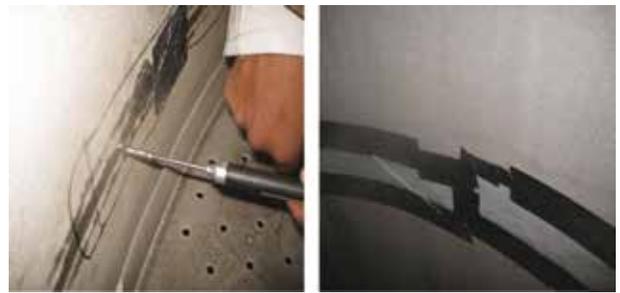
The annular space between inner lining and shell is pressurized with helium gas. Pressure is maintained around 0.5 Kg/Cm2 g. Since gas/air is already present in the annular space, concentration of helium gas reduces in the annular space. Four hour holding time was given. Presence of any helium under polythene sheet was checked by inserting tip of detector probe. Leakage is identified by Helium test in the 8th tray's circumferential liner weld joint. It was observed in the upper side wall of the weld approximately at 240 ! (Referred 0! from the internal overflow pipe clockwise).

Figs 7 & 8: (Test in Progress) & (Polythene sheet masked by sheet)

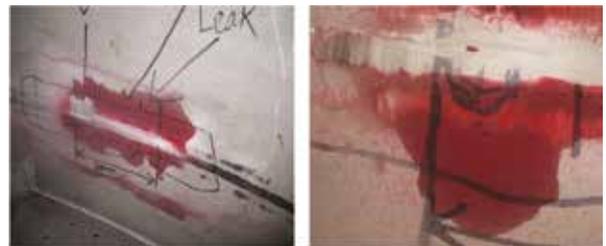
Figs. 9 & 10: (Leakage Area) & (Pinpoint Location)

The suspected area (approx 150 mm weld length) was grinded and the area is checked by DP Testing which revealed a defect indication. It was arrested by welding and followed by DP test for root and final run. Repaired portion was checked with detector probe and no further indication was observed by Helium Leak testing.

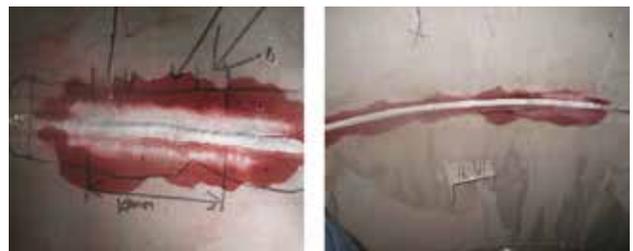
Figs.11 & 12: (Repaired area) &( Repaired Weld)
