# AMMO LASER Leak Detection System

## The #1 Safety Measure for Urea Plants with a Guaranteed Pay Back

### Question 6: What is reason #1 to choose for a vacuum system?

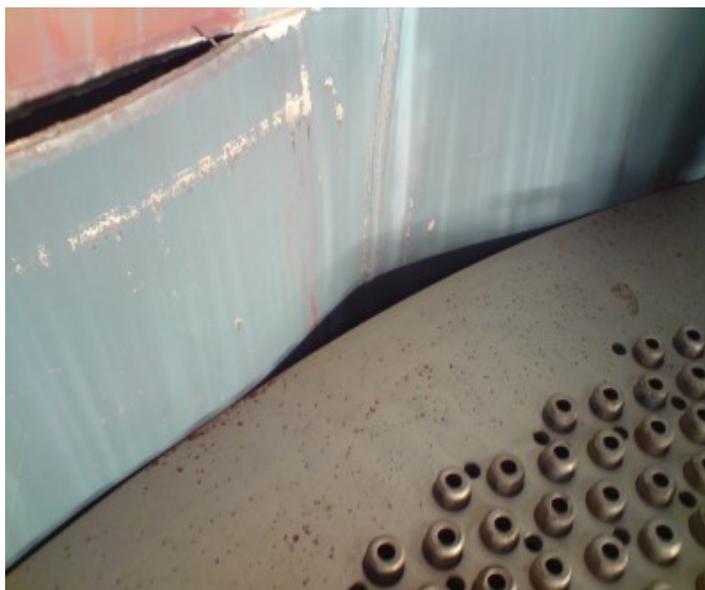
Figure 1 : Example of a bulged liner

A first reason is that when using a vacuum system there will be no risk for liner bulging and damage due a to too high pressure in the leak detection system behind the liner. Figure 1 shows a bulged liner compartment in the top of a CO<sub>2</sub> stripper.

Be aware that the relatively large liner compartments are welded to the carbon steel pressure bearing wall. These large areas allow only a very limited pressure difference between each side of the liner.
