Successful Repair of a Severely Damaged HP Scrubber Sphere

Alex Scheerder, Jan Geerlings
Stamicarbon BV, The Netherlands

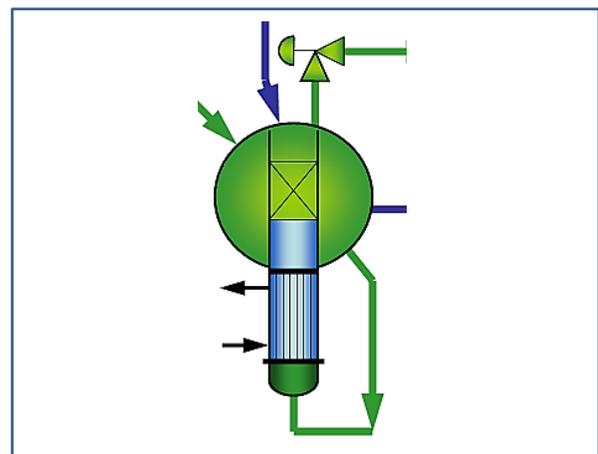
sphere is constructed of 20MnMoNi45 DIN 17201 carbon-steel plate; mono-wall, actual thickness is 53 mm (2.087”) protected at the inside with a 9 mm (0.354”) 316L UG liner.

Figure 4. HP Scrubber with dome
