Urea Reactor Liner Leakage - A Case Study

P.A. Wasekar, S.N. Saha, T.K. Batra and Jagdeep Shah Singh
National Fertilizers Limited, Vijaipur, Guna, Madhya Pradesh

Abstract

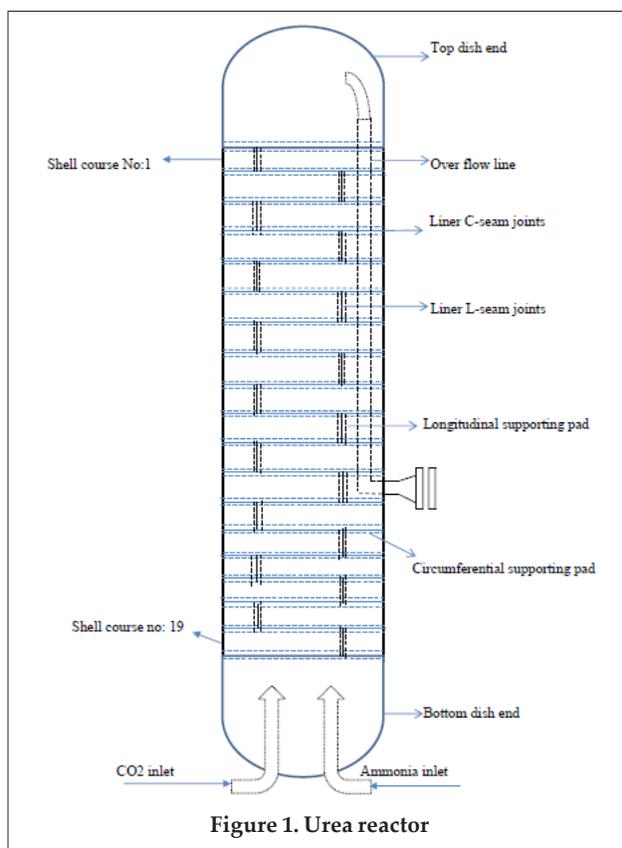
Figure 1. Urea reactor

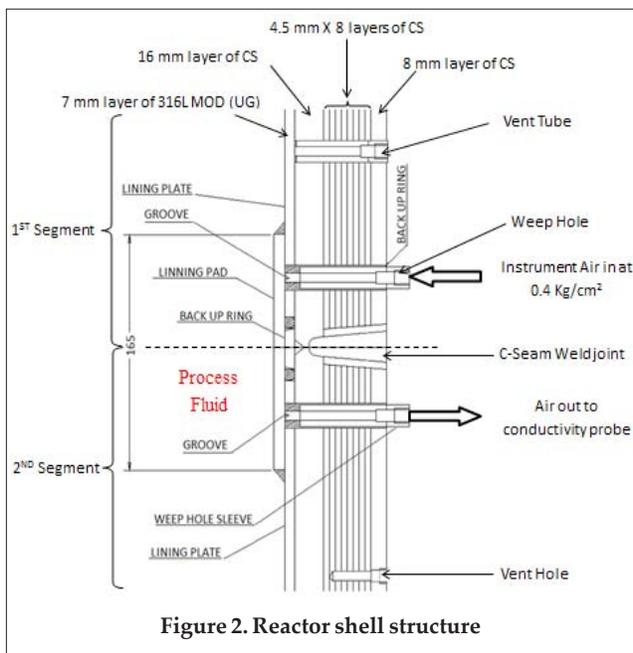
Figure 2. Reactor shell structure

Urea reactor is a multilayered carbon steel vessel with AISI-316L (Mod) liner. The carbon steel shell is of 60 mm thickness comprising of 16 mm CS plate subsequent to 8 x 4.5 mm coil sheets of CS and extreme outer layer of 8 mm CS (Figures 2 and 3). The vessel is made up of 19 cylindrical shell courses each of 2100 mm length. The top and bottom are hemispherical

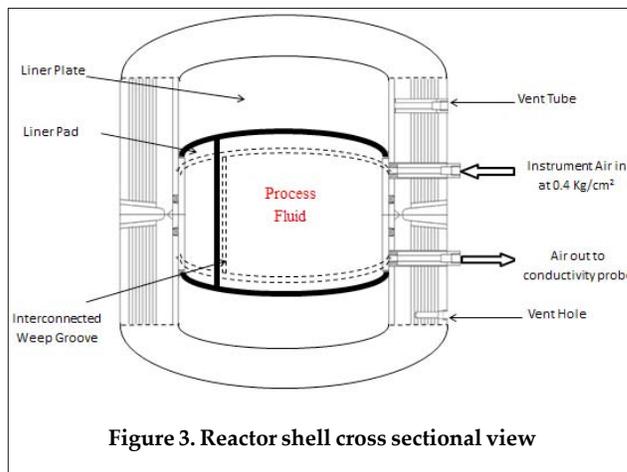
Figure 3. Reactor shell cross sectional view

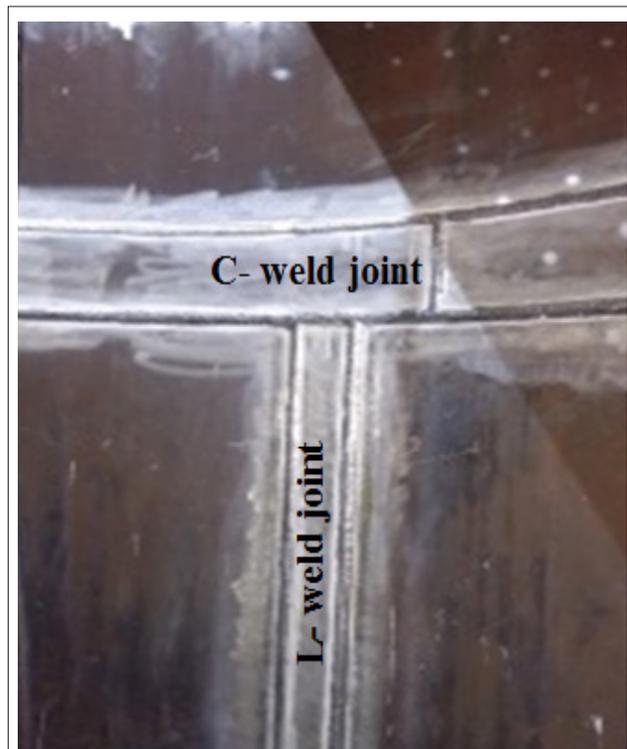
dish ends having 3 petals each. The entire vessel is lined with AISI-316L (Mod) having a thickness of 7 mm. The segmental circumferential and longitudinal weld joint of liner is further protected using pad of AISI-316L (Mod) with a thickness of 7 mm and width of 165 mm (Figure 4).

Figure 4. Urea reactor from inside showing C-weld & L-weld joint

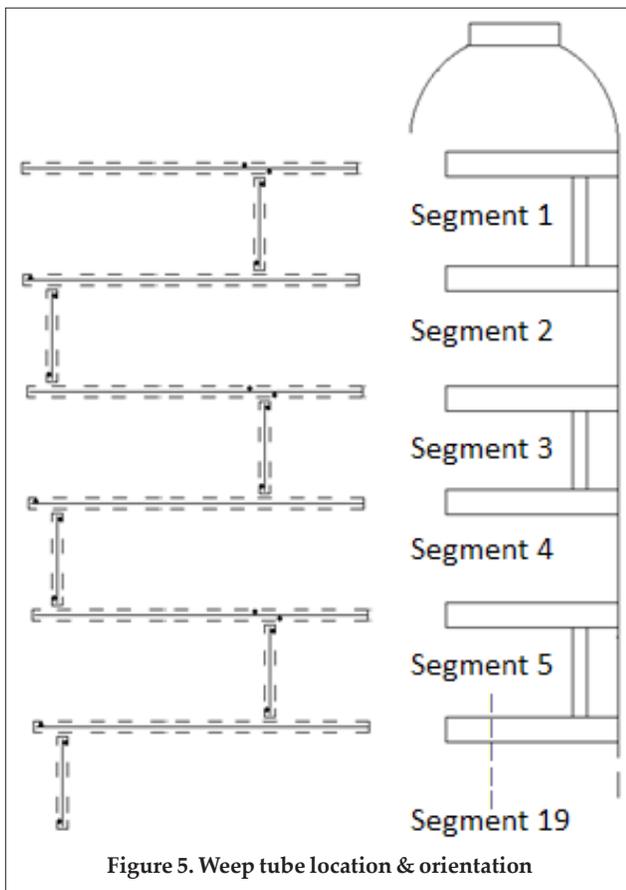
lethal effects. Hence, weep holes are provided to detect the leakage from the welding joint at earlier stage (Figure 5). Behind the welding joint of the liner pad groove is provided to which the weep tubes are connected. Each welding joint is provided with 2 weep tubes, one as inlet for instrument air, which will push any leaked fluid through the groove towards outside from the second weep tube connected with conductivity probe. Conductivity probe will show reading variation in the control room based on the changes in the resistance of the flowing fluid. There are total of 20 circumferential weld joints having 40 weep tubes, 19 longitudinal weld joints having 38 weep tubes, 3 weld joints for both top and bottom dish end each having 12 weep tubes in total and 2 weep tubes of the outlet line, 2 weep tubes for the top man hole cover and 2 weep tube for the top neck (total weep tubes = 96 out of which 48 are provided with conductivity probe).

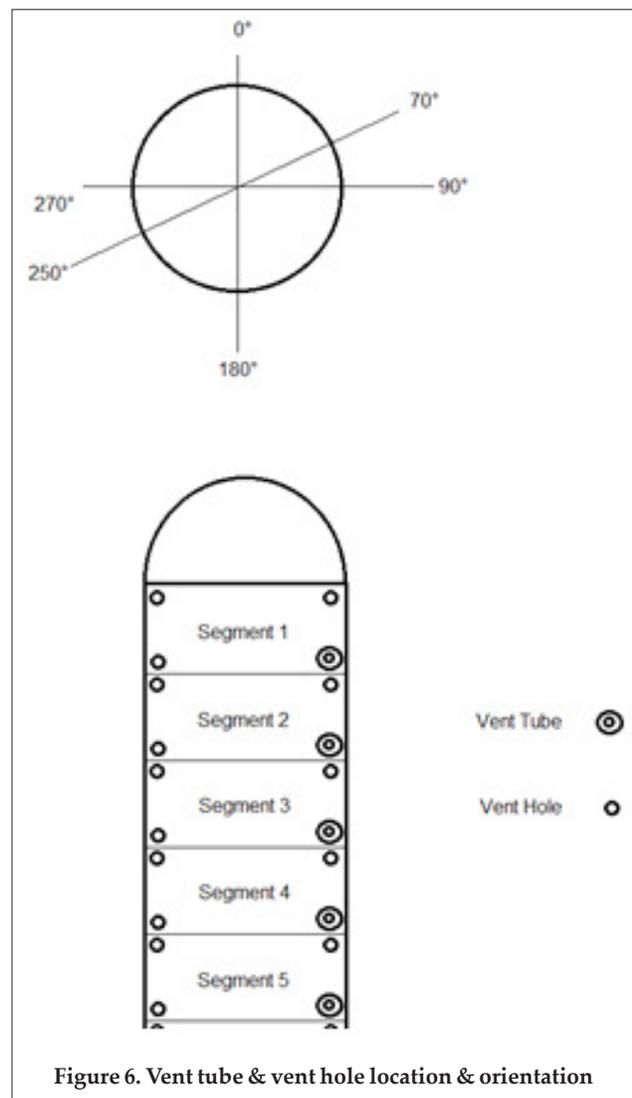
Coil layered shell course is provided with one vent tube and three vent holes for each of the longitudinal segments. Vent tube is terminated at the back side of liner plate and vent holes are terminated at the back side of 8th coil layer, these are interconnected (Figure 6). These vent holes and vent tubes are provided to release welding fumes during fabrication of equipment.

During transportation these were plugged to avoid equipment damage.

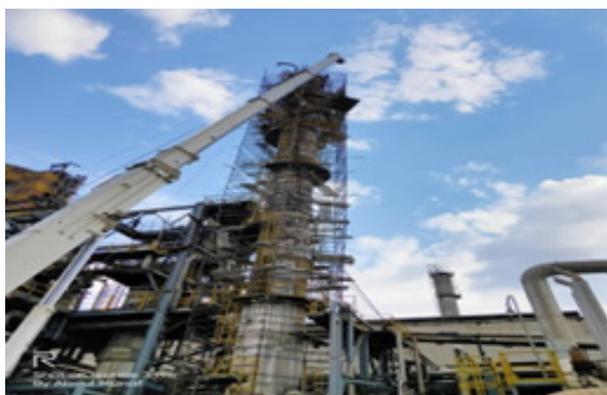
Figure 11. Temporary scaffolding erected around and for complete length of reactor

tubes and vent holes as well as to carry out the job (Figure 11). Subsequently, whole insulation was removed from reactor. All the vent holes and vent tubes plugs were de-plugged. All vent tubes' depth was measured, which was found in the range 62 mm and depth of vent holes was found as 40-42 mm. Further cleanliness of the vent tubes and connected vent holes of each segment was checked with instrument air pressure at 0.3 kg cm⁻²g and found at clear condition.

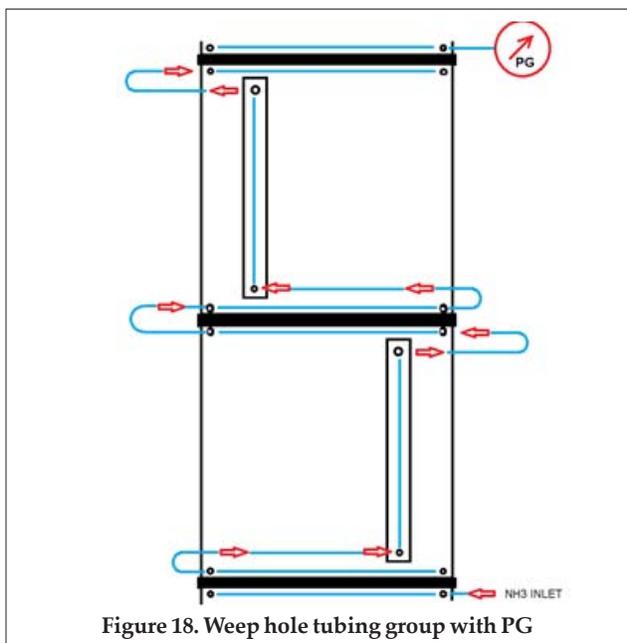
To facilitate air and ammonia leak test, small loops connecting weep (Figure 18) and vent (Figure 19) system of 2/3 segments each were made to cover up

Figure 18. Weep hole tubing group with PG

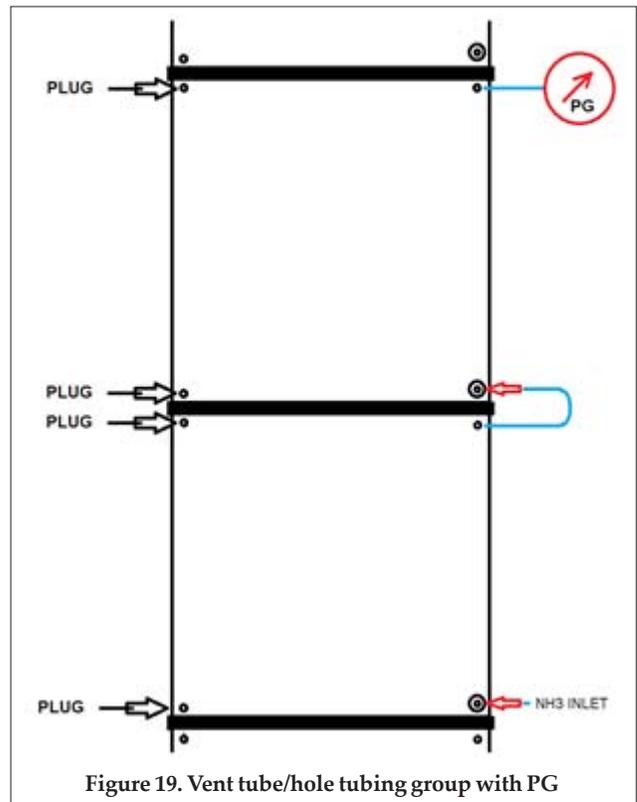
Figure 19. Vent tube/hole tubing group with PG
