# AMMO LASER Leak Detection System

## The #1 Safety Measure with a Guaranteed Pay Back

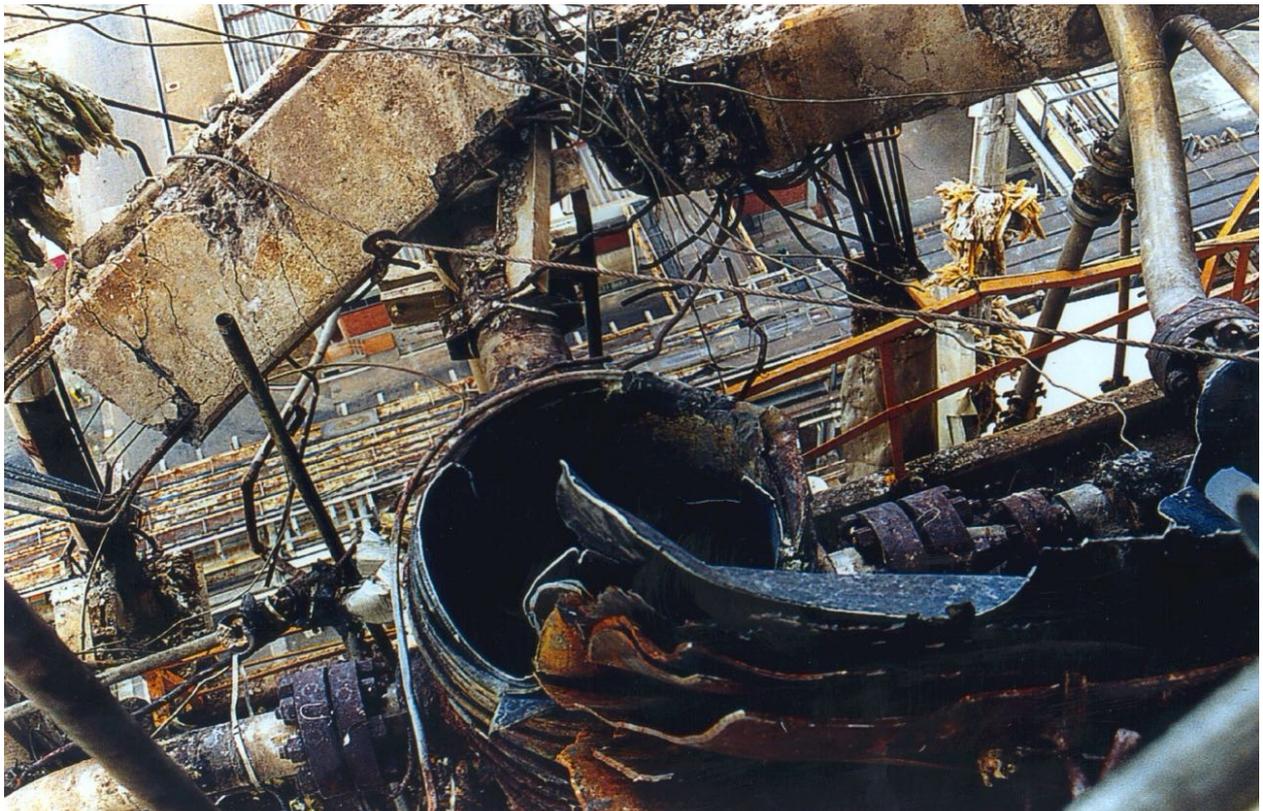
Figure: Rupture of a high pressure scrubber due a not properly working leak detection system

At the same time crystallization of the leaking medium is very likely which will lead to clogging of the leak path. Once clogging occurs, one may not be warned anymore that there is a leak leading to an extremely dangerous situation as the corrosion of the carbon steel pressure bearing wall will continue. Suddenly a rupture of the vessel will occur.
