Reverse Rotation in Centrifugal Compressors

40th Turbomachinery Symposium
12-15 September 2011 – Houston, TX
Presented by Amr Gad

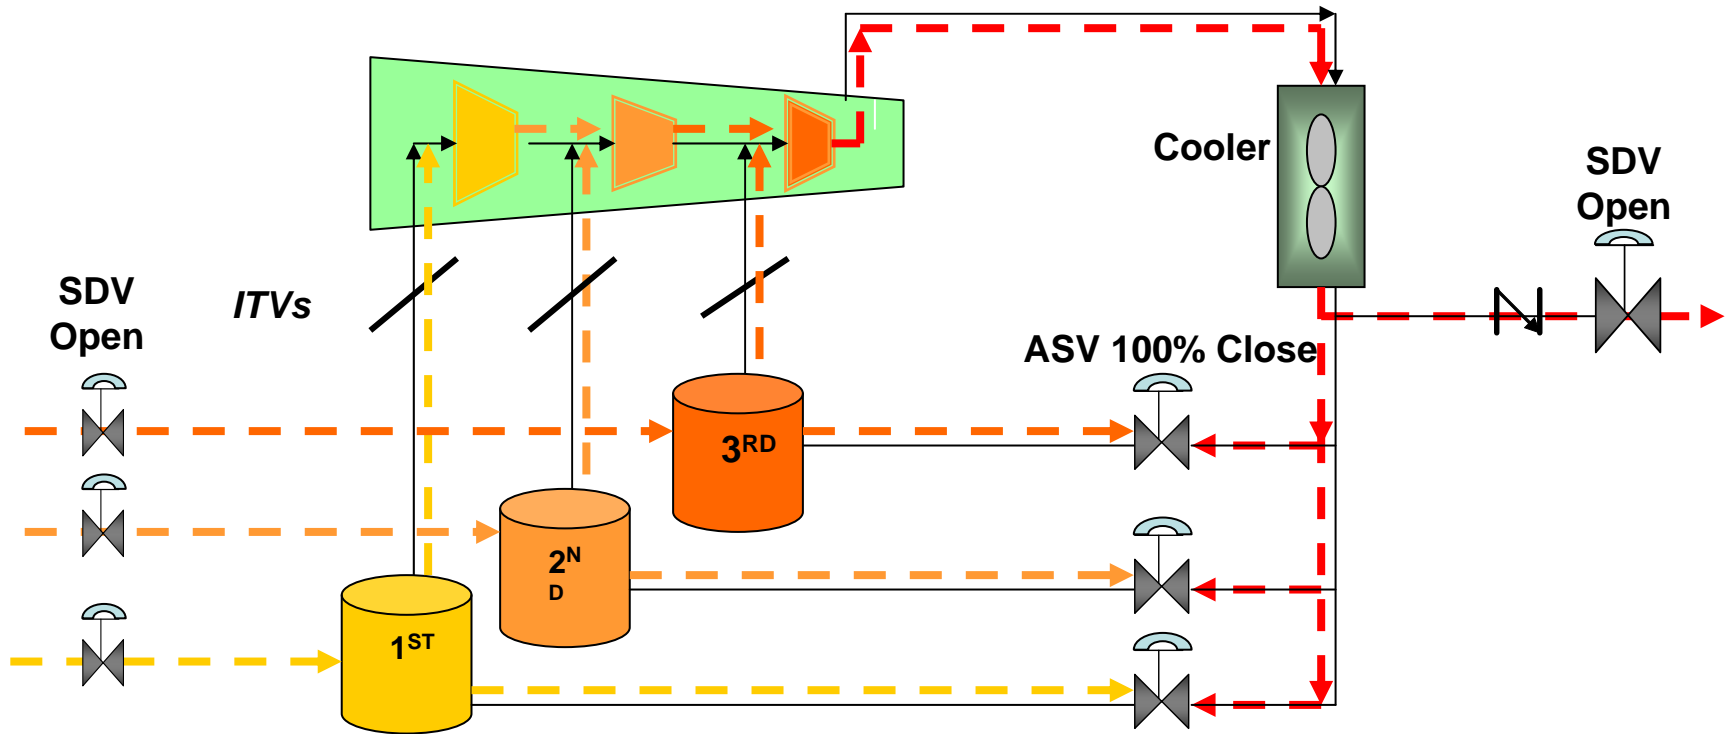
Process Overview

Machines During Normal Operation

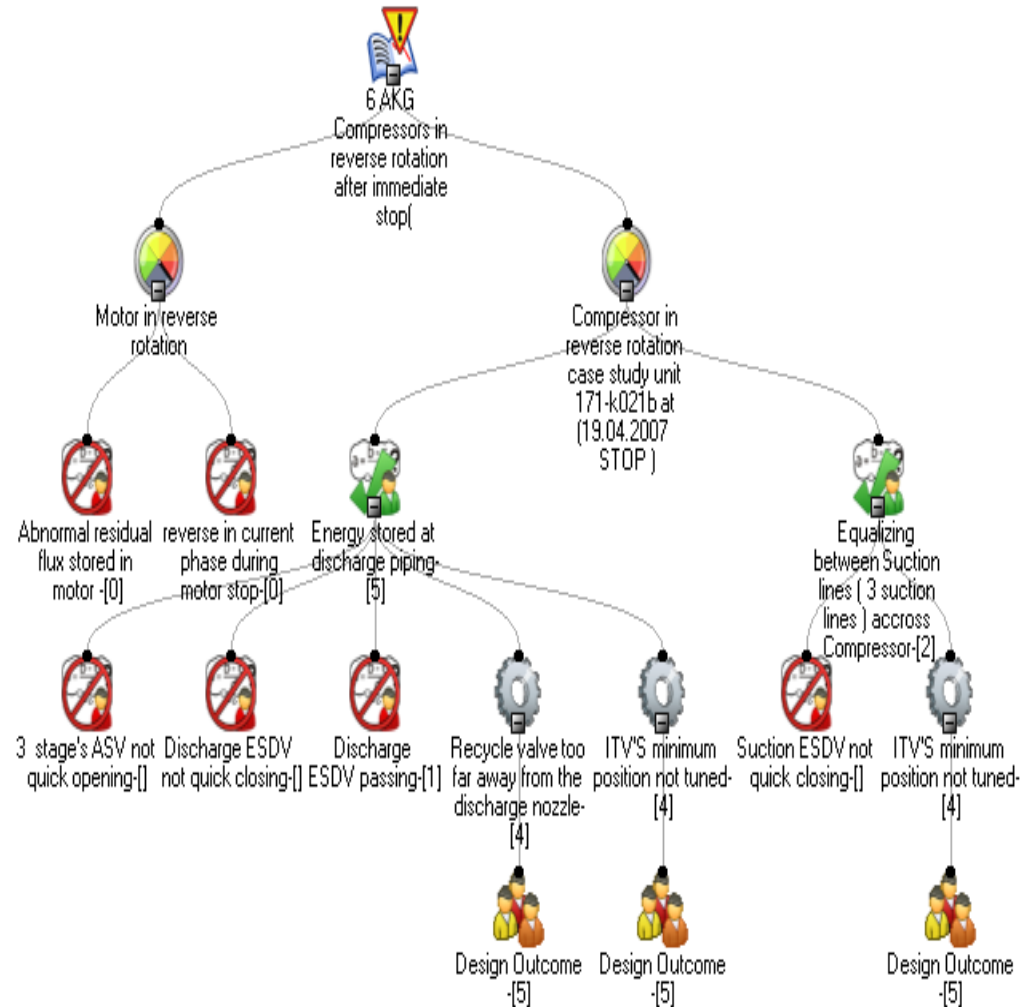
- Reverse hydraulic flow due to large amount of entrapped hydrocarbon volume in the piping and suction vessels of the MP & HP sections.

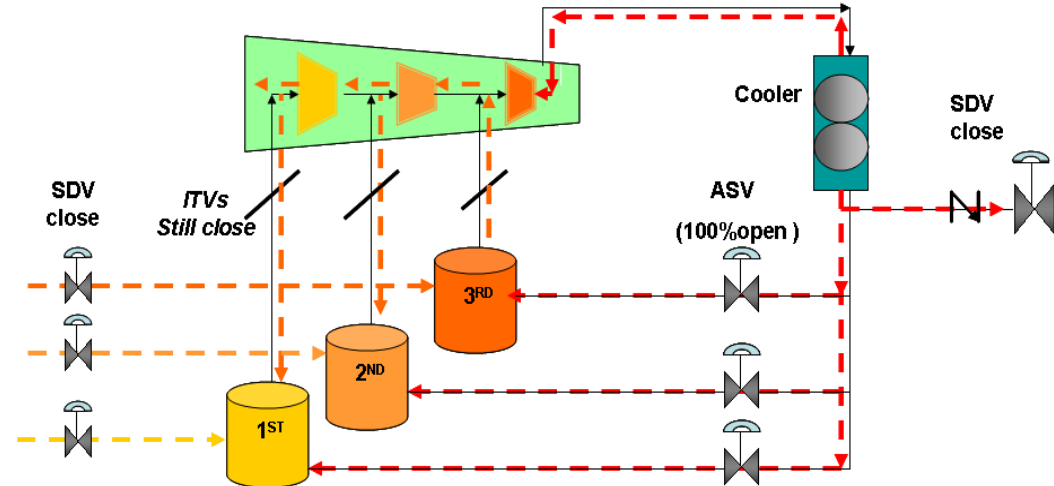
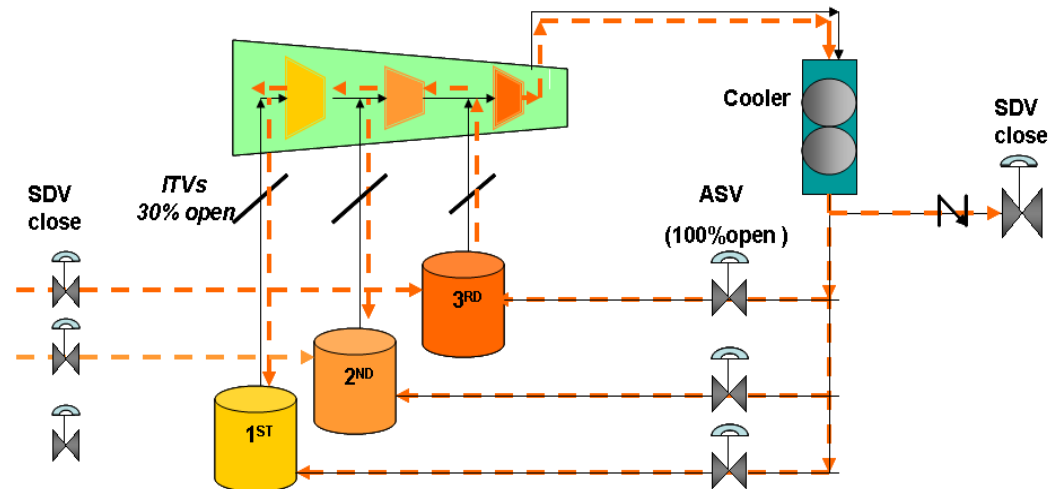
- Hydraulic flow occurs after 10-15 seconds from a stop command till compressor coast down to zero RPM speed.
- Hydraulic flow during the reverse rotation from zero speed till 5000 RPM and back to zero again within 4 to 6 minutes.

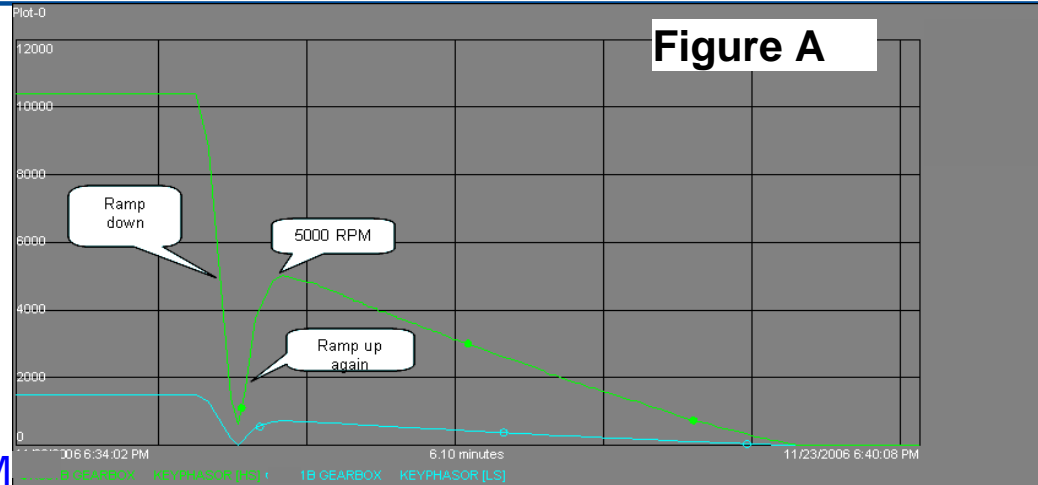
Speed trend (Figure A)

- Unit stop very fast after stop command.
- Unit speed ramp up again in reverse rotation to almost 5000 RPM for the compressor.
- After speed reaches 5000 RPM it cost down again to zero speed in about 4-6 minutes.
- This phenomena is repeated each time the machine stops.

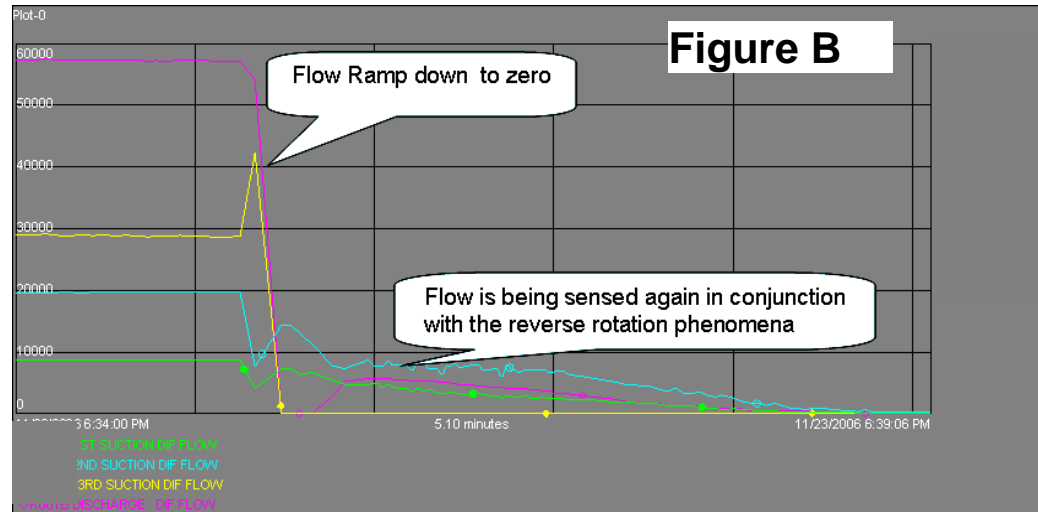
Flow rate trend (Figure B)

- Showing flow exchange & equalizing between stages.

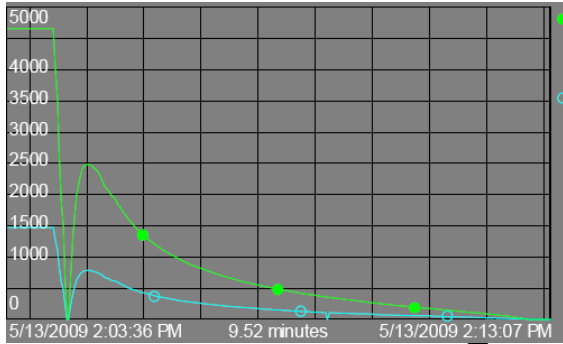
Shutdown with ITV closing before tuning

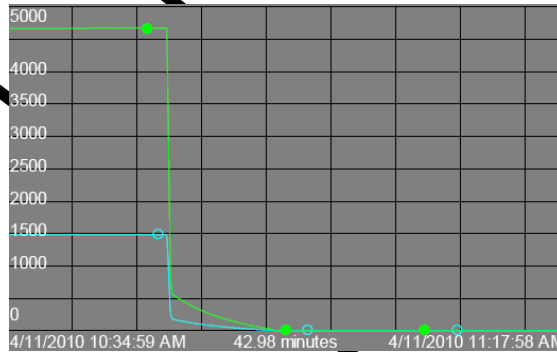
Shutdown With ITV closing after tuning

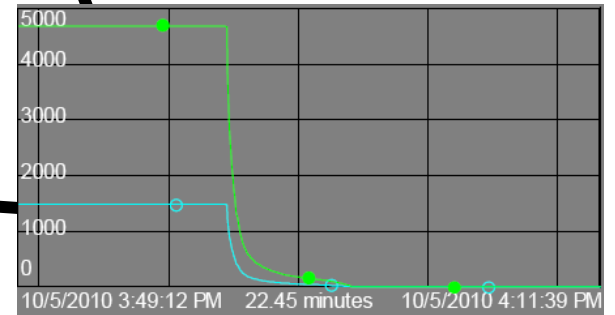
Shutdown with check valve installed and ITV closure removed

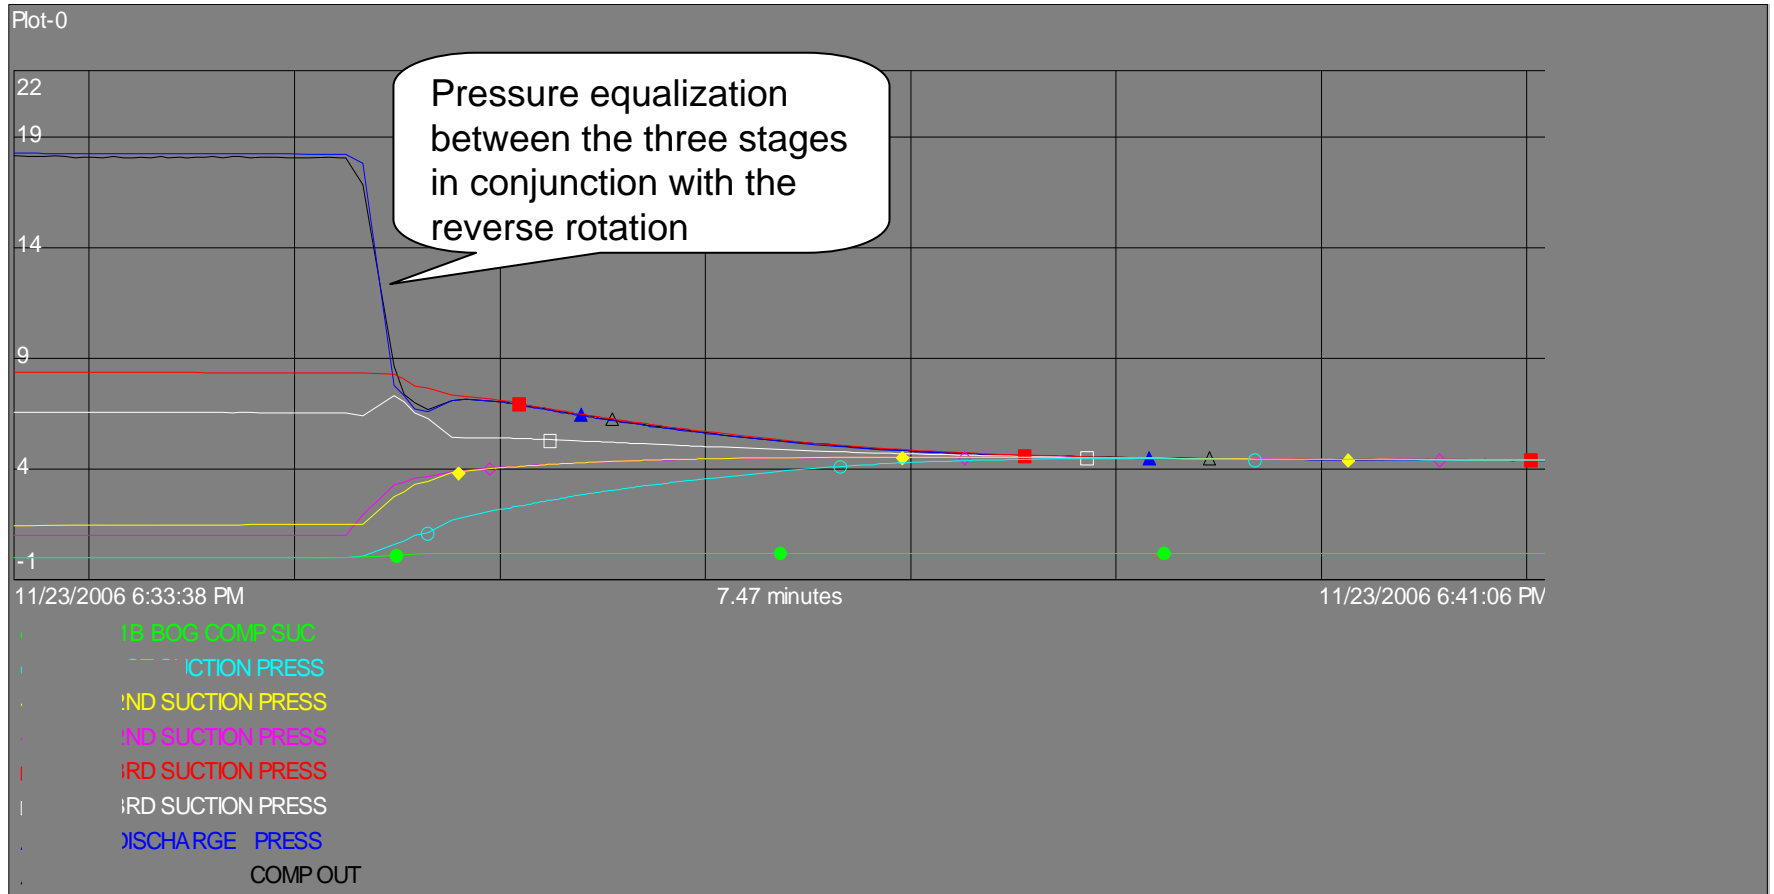
Pressure trends for unit stop

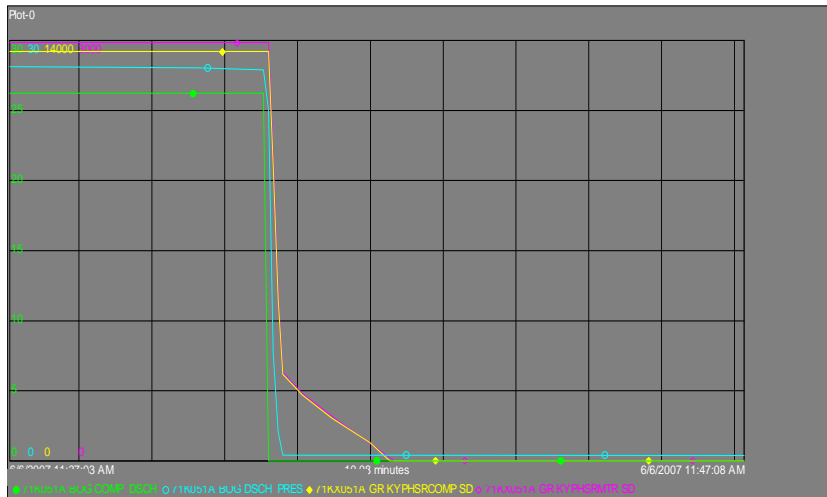
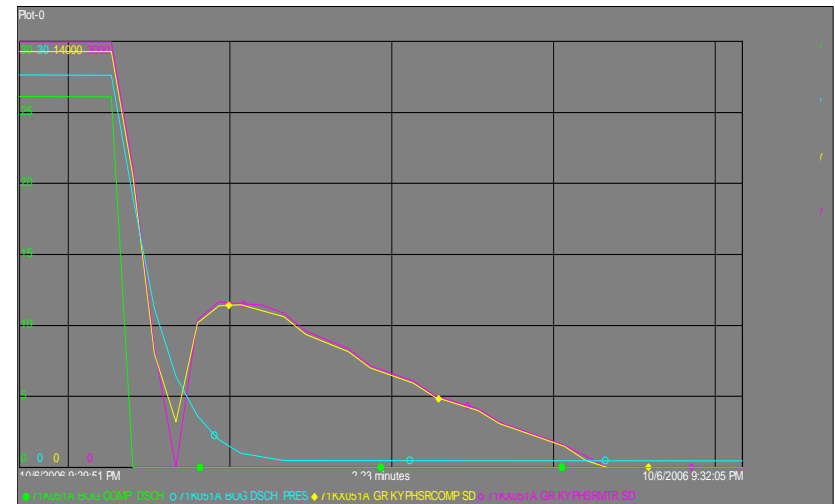
- ASV improper function is potential cause for reverse rotation during coast down.
 - Experienced in LNG BOG compressor when opening time upon shutdown is more than 2 seconds due to valves stuck or instruments failures.
