AMMO LASER Leak Detection System

The #1 Safety Measure for Urea Plants with a Guaranteed Pay Back

Why is a passive leak detection system not acceptable anymore ?

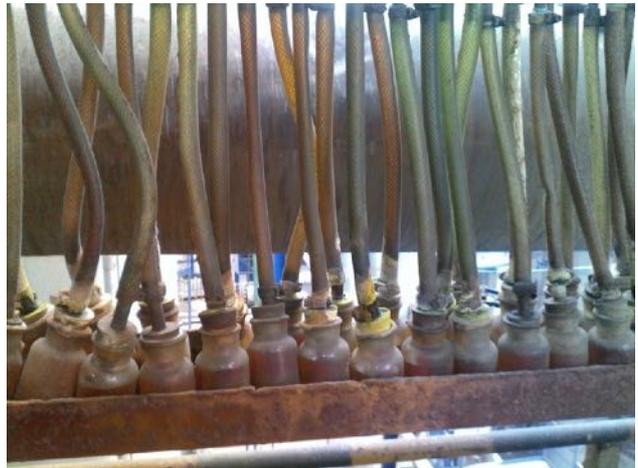
Figure 1: An example of a passive leak detection system (bottles with phenolphthalein).

In a passive leak detection system an indication of a leak in the liner only shows up when the leak emerges from the leak detection hole.

Or, in case the leak detection hole is connected via tubing to for example a bottle with a phenolphthalein solution, when the colour of the liquid in the bottle changes (refer to Figure 1).

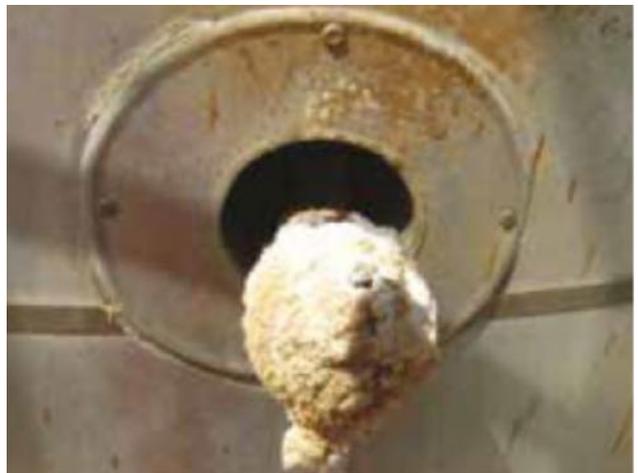
Figure 2. Clogged leak detection hole

The detection occurs at a later moment than when the leak occurs in the liner. Time passes (dwell time) between the moment the leak occurred and the moment the leak emerges at the leak detector or when a field operator notifies the leak. The latter case is even worse as the dwell time can be much larger. Figure 2 shows a clogged leak detection hole.

During that dwell time the risk that the leak detection path gets clogged is realistic. That means that there will be **a serious threat to the integrity of the carbon steel pressure bearing wall.**

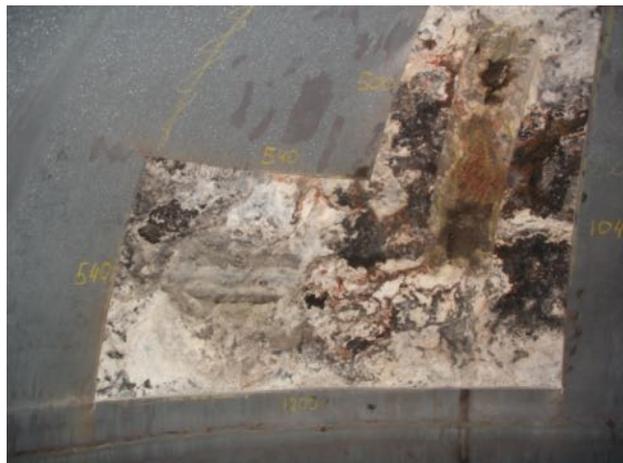
Figure 3. Clogged behind the liner

A much more critical situation arises when the clogging occurs in the tubing or underneath the liner and no solids are visible. **Nobody will be aware of an extremely dangerous situation.**

In case of clogging, the pressure and temperature increase preventing the dissociation of ammonium carbamate into the less corrosive components ammonia and carbon dioxide.

The trapped ammonium carbamate causes very high corrosion rates for carbon steel (1000 mm/year have been measured). Ammonium carbamate under these conditions can also actively corrode stainless steel as after some time oxygen is not available anymore for passivation. These risks will endanger the integrity of the high pressure vessel as history has shown us numerous times.
