Risk and safety management of ammonium nitrate fertilizers: keeping the memory of disasters alive

Dr. Zsuzsanna Gyenes, EC Joint Research Centre, Italy;
Nicolas Dechy, CHAOS association, France

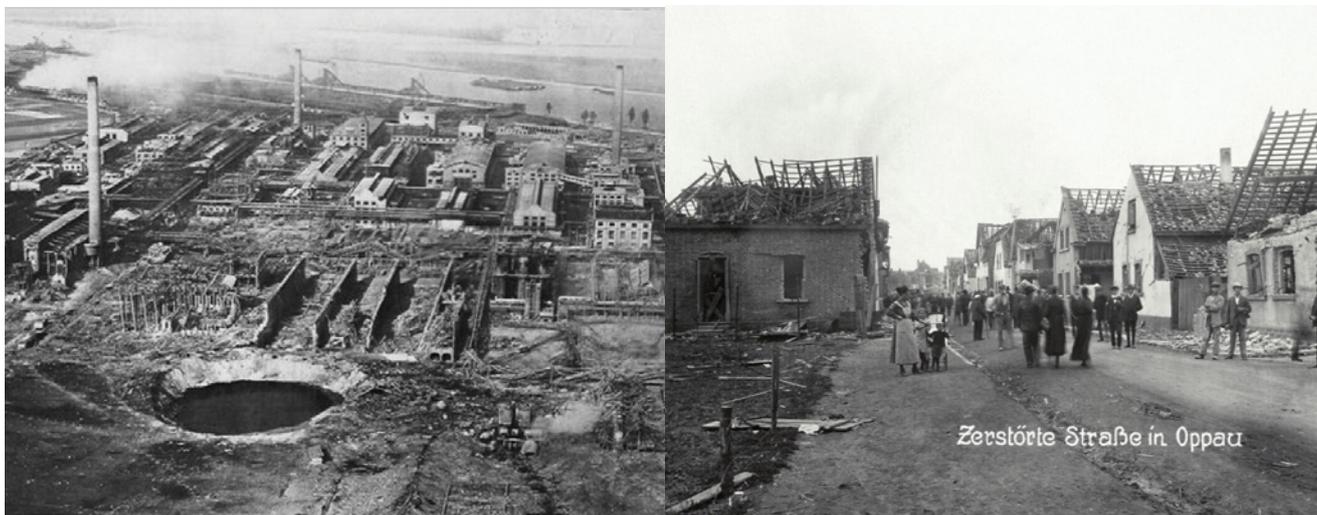
Figure 1: Oppau – The consequences of the explosion¹

On 21 September in 1921, two consecutive explosions occurred in a silo in the BASF plant in Oppau, Germany, creating a 20m deep, 90x125m large crater. The entire area was covered by dark green smoke and there were several additional fires and small explosions. At the time of the event 4500 tonnes of ammonium sulphate nitrate compound fertilizer (ASN) were stored in the silo. The explosion killed 507 people and injured 1917. The plant and approximately 700 houses nearby were destroyed²¹.

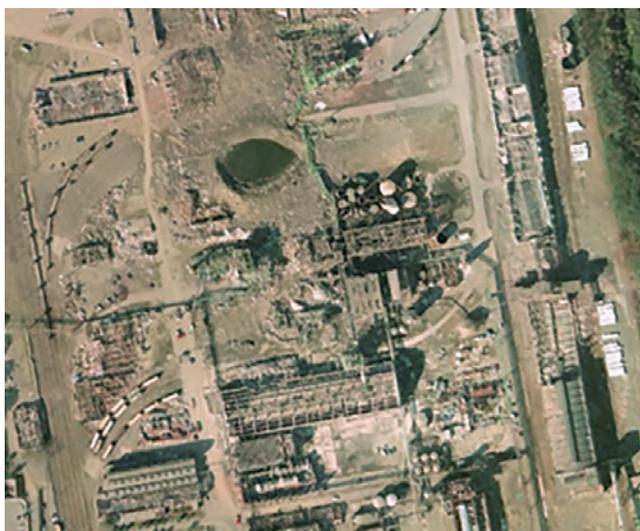
Figure 2: The area affected by the explosion (Source: Archives Grande Paroisse¹⁷)

Exactly 80 years to the day after Oppau, a severe explosion occurred in a temporary storage for off-specification and downgraded ammonium nitrates at 10.17 a.m. on 21 September in 2001 at the AZF industrial site in Toulouse, France. The detonation, felt several kilometres away, corresponded to a magnitude of 3.4 on the Richter scale. A 7m deep crater (65x45m) was observed outside the plant and a large cloud of dust and red smoke drifted to the north-west. The accident resulted in 30 fatalities, with up to 10,000 people injured and 14,000 people receiving therapy for acute post-traumatic stress. The cost was estimated by insurers to be in the region of 1.5 billion Euro³.

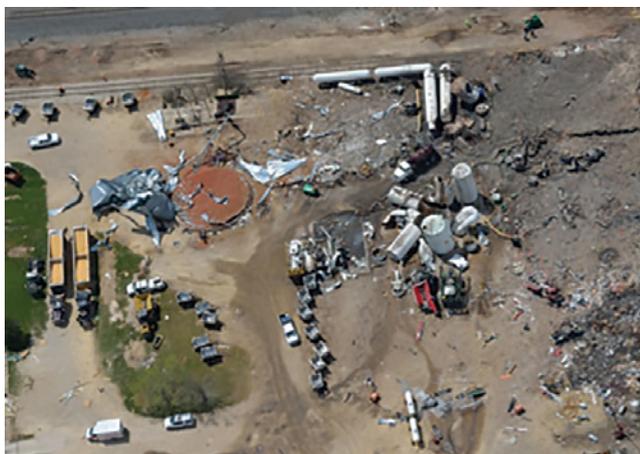
Figure 3: West explosion aerial photo (Source: Shane Torgerson)

More than 60 years after the Texas City disaster, a significant explosion of fertilizers shook the inhabitants of Texas again. On the evening of 17 April 2013, a fire of undetermined origin broke out at the West Fertilizer Company in West, Texas, USA. After their arrival, firefighters started to fight the fire when a detonation occurred. Although the firefighters were aware of the hazard from the tanks of anhydrous ammonia, they were not informed of the explosion hazard from the 30 tonnes of fertilizer grade ammonium nitrate with a 34 percent total nitrogen content, which was stored in bulk granular form in a 7 m high bin inside the wooden warehouse⁷. As a consequence of the explosion, the shock wave crushed buildings, flattened walls, and shattered windows. Twelve firefighters and emergency responders were killed along with three members of the public who were volunteer firefighters. The accident also resulted in more than 260 injured victims, including emergency responders and members of the public, and more than 150 buildings were damaged or destroyed in the accident. The cause of the initial fire remains unknown; nonetheless, the US Chemicals Safety Board investigated the factors that likely contributed to the intensity of the fire and detonation of the ammonium nitrate fertilizer. They found two possible scenarios as following:
